T Level Technical Qualification in Engineering, Manufacturing, Processing and Control (8713-33)

Composites Manufacturing Technologies (333)

Guide Standard Exemplification Material

Threshold Competence – Sample 2022

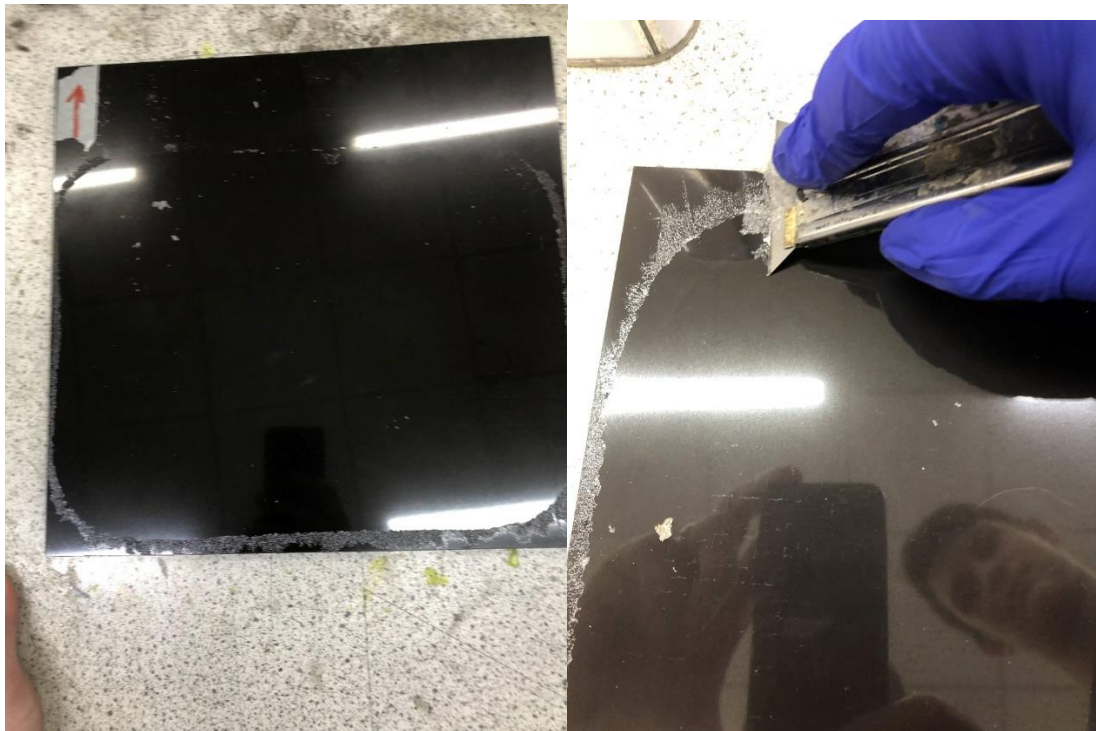
Mould preparation (photographs 3 – 5)

Photographs 3 and 4 – showing mould prior to preparation and cleaning. Residue from previous moulding activities is present and needs to be removed without damage to the mould occurring. Candidate is seen using a scraper to remove the residue.

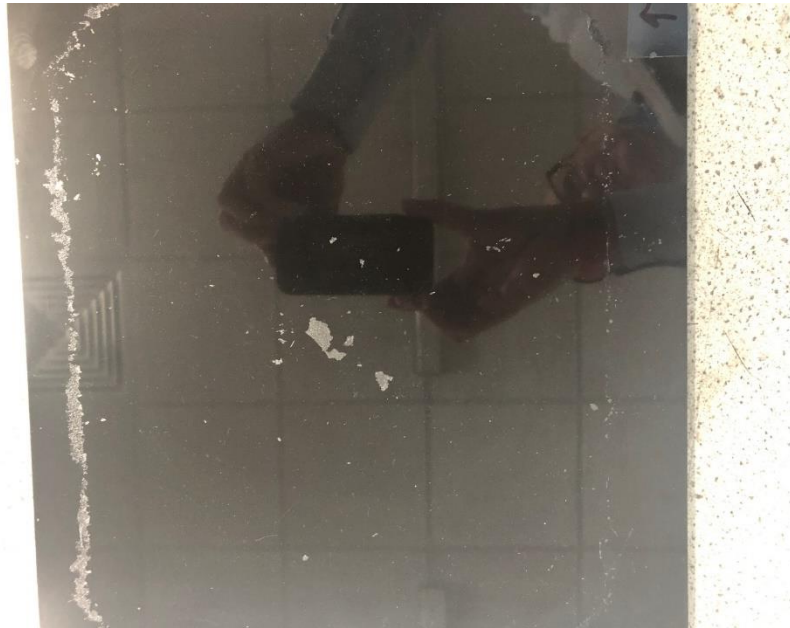
Photograph 5 – showing a prepared mould but with some residue still showing on outer edge. The residue left on the mould will create adhesion issues during the creation of the vacuum bag. The candidate should remove all residue to prevent this from arising later in the consolidation process.

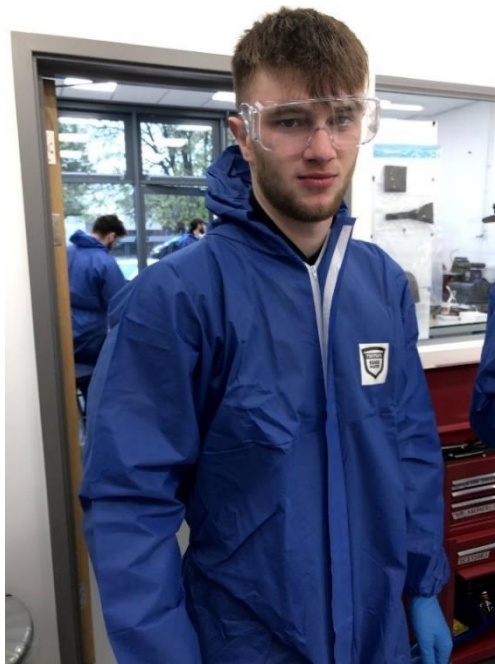
Photograph 6 – showing candidate wearing suitable PPE which has been checked for integrity. The candidate is safe but did not put the hood up and apply the zip cover to prevent FOD occurring within the production of the spacer block components and assembly which is required when simulating a clean room environment.

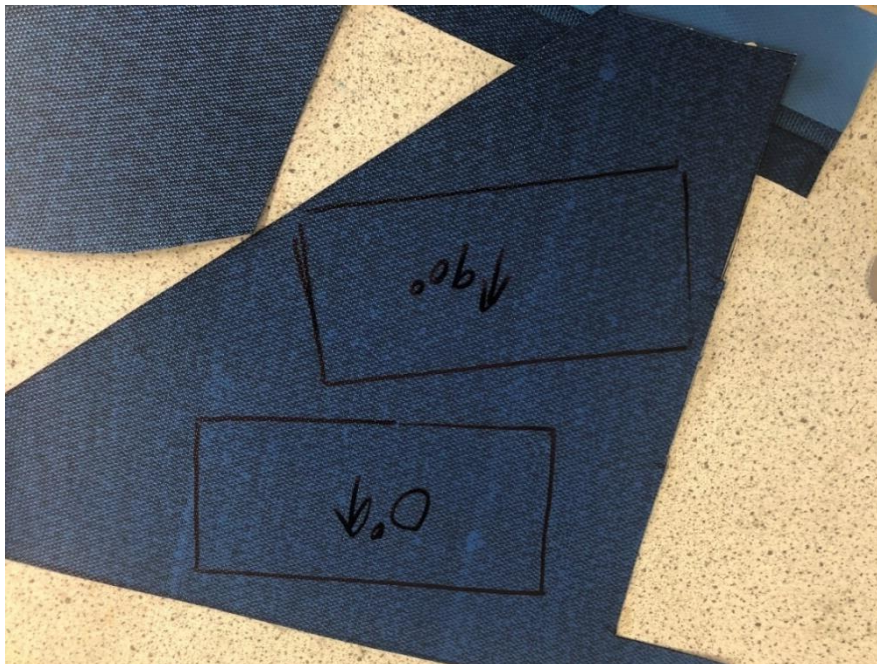
Photograph 9 – showing the material marked out ready for cutting. Orientation of plies is identified and marked on the backing film. Material to be cut-out to form the “kit” of parts using scissors.

Note: some poor marking out and wastage of material as it is some way from the edge of the sheet and the positioning of the marked out plies should be closer together and not angled.

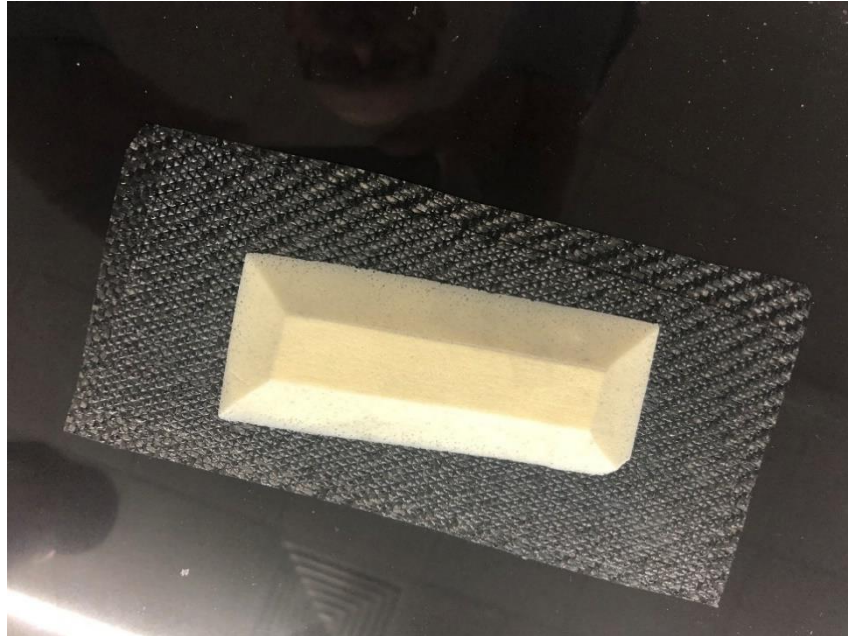
Photograph 10 – showing the core material cut to near shape ready for final reduction to dimensions. Note: Poor cutting of the foam material, there is some damage to the core edges, the dimensions are not square and the angles are not as per specification. One corner is rounded.

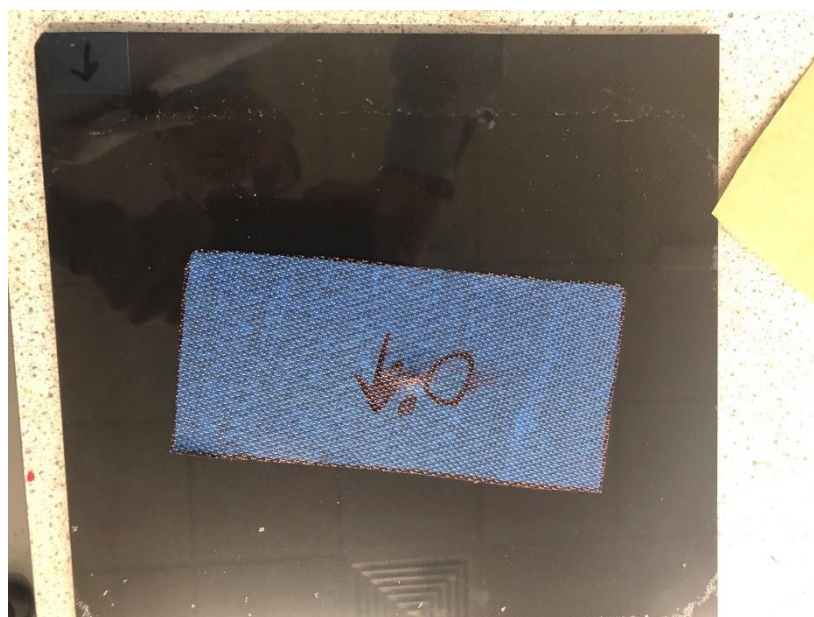
Photograph 11 – showing the first ply laid onto the prepared mould surface. Some waviness of cutting of materials and blemishes on the mould surface.

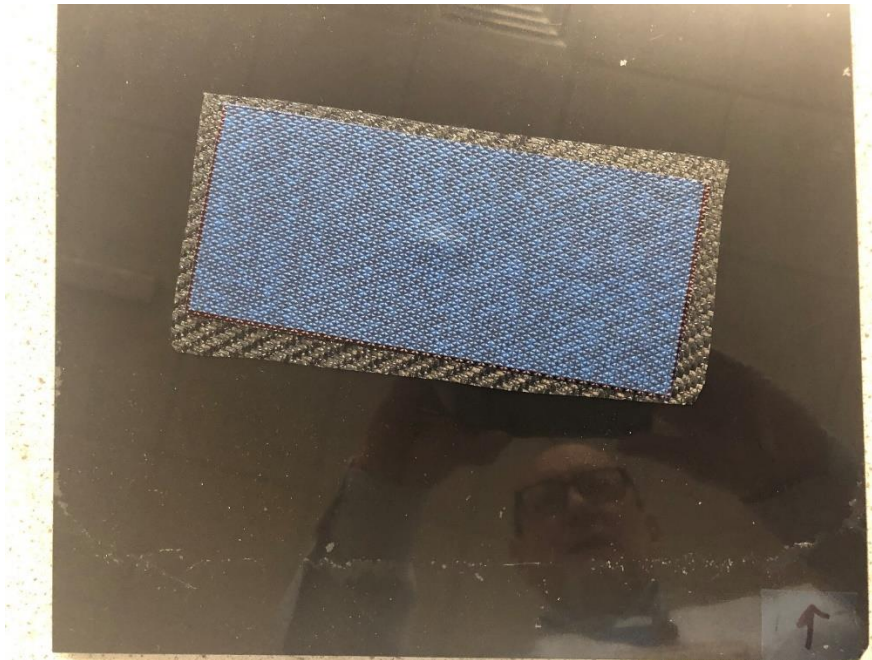
Photograph 12 - showing subsequent plies laid up onto the mould and the core placed on the upper sheet. Some evidence of “out-of-square” and disruption of the warp and weft pattern.

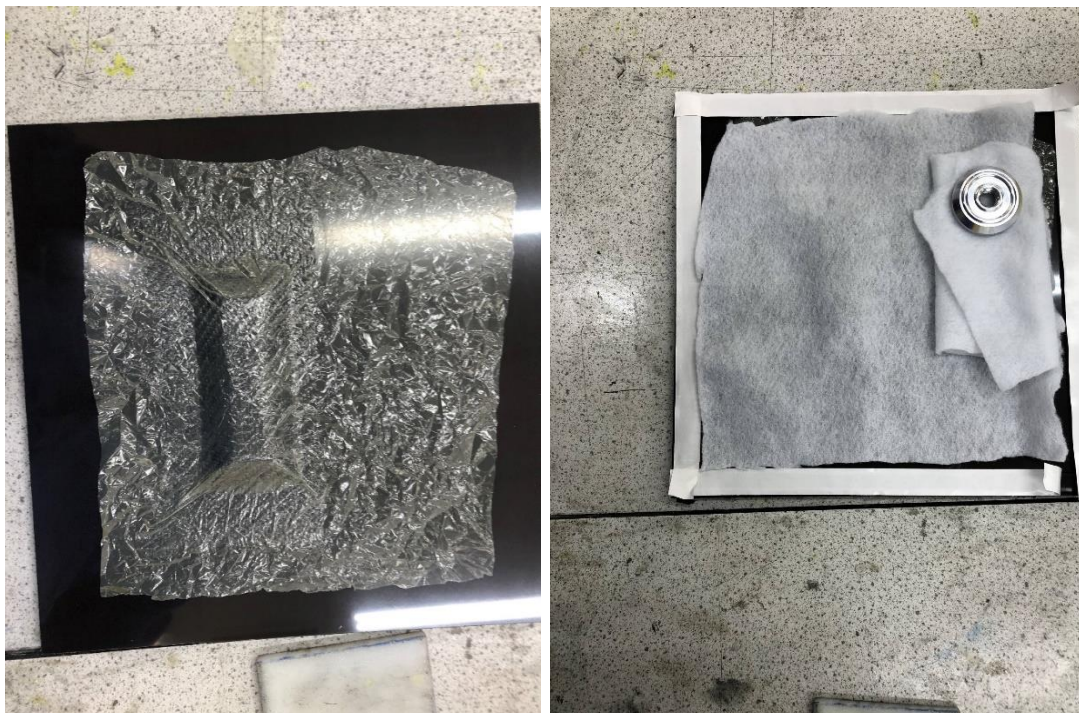
Photographs 13 and 14 - showing the upper plies applied and consolidated using a moulding tool. De-bulk applied according to method statement. Release film has been wrinkled and placed on top of the final ply. Peel ply applied on top of the release film with additional breather fabric cut to make an air passage out of the moulding. VBU lower portion placed on top of breather fabric but on the moulding. Some issues with adherence to the mould surface.

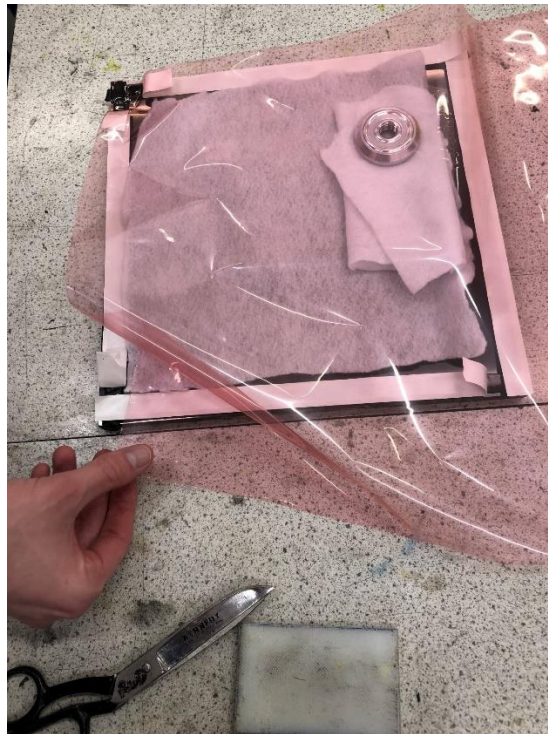
Photograph 15 - showing one corner sealed and the adjacent corner is stuck down leaving (in this case, too much material) slack to allow the bag to drape across the laminate.

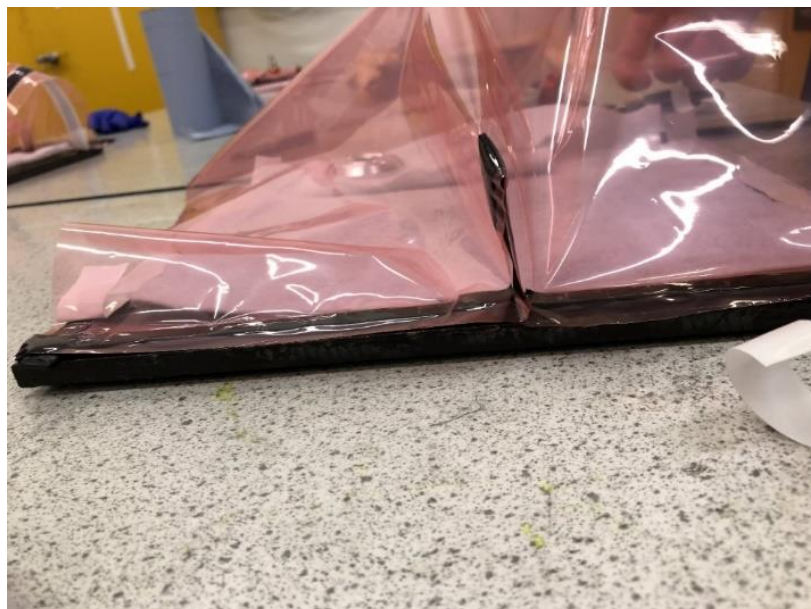
Photographs 16 - showing the first pleat created to create the vacuum tight seal to ensure good application of consolidation pressure. Some issues with the adhesion of the film to the mould.

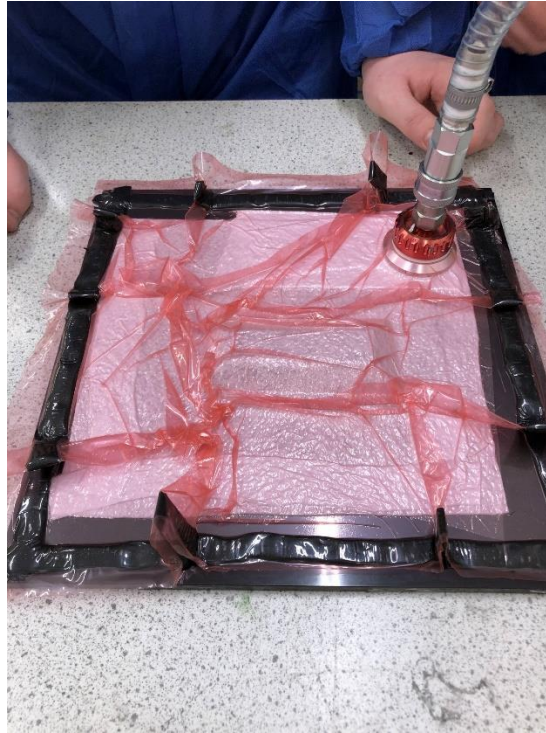
Photograph 17 – showing the vacuum bag is airtight. A hole has been created for the VBU and placed on top of the vacuum bagging material. With vacuum applied to the VBU to consolidate the laminate. Candidate checking for, and rectifying any leaks, to ensure the wrinkles are spaced equally around the moulding. Some leaks were present and were eventually remedied.

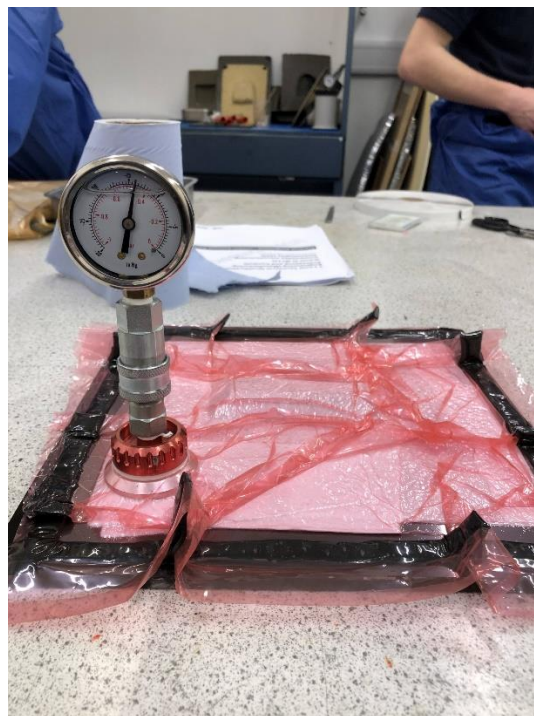
Photograph 18 – showing a drop test has been performed with a loss of vacuum, no less than specified in the method statement. Some remedials required.

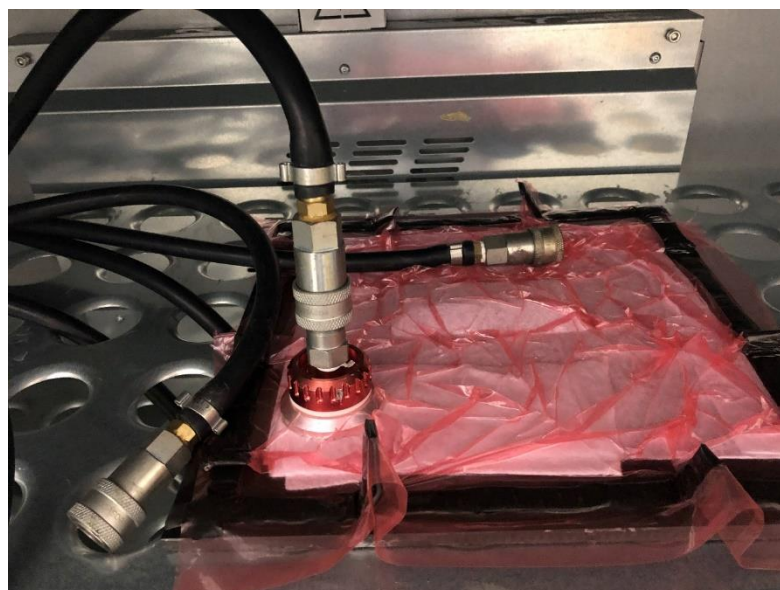
Photograph 21 - showing the mould placed in the oven, not touching the sides, with the vacuum applied to the VBU in the oven. A vacuum hose has been left draped across the mould which is not best practice.

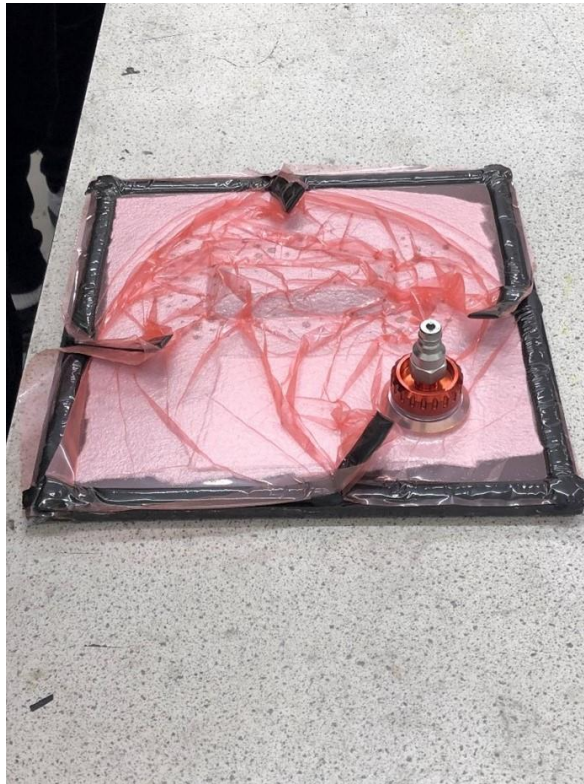
Photograph 22 – showing the mould removed from oven after curing and allowed to cool. Wrinkles are present across the mould surface.

The result of the consolidation and curing was acceptable however this could be improved. For example, there was some wrinkling observed across the top of the mould which could leave some marks on the top layer. If the candidate had adjusted the vacuum bag before curing and removed or better distributed the creases this could have been avoided.

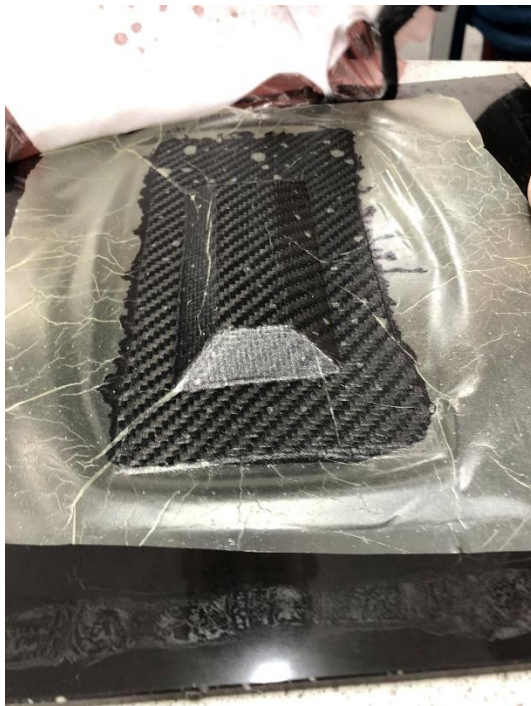
Photograph 23 - showing bagging film being removed to reveal the release film. Evidence of good consolidation and curing. Some wrinkling of release film but the surface of the moulding is acceptable. Some resin bleed identified.

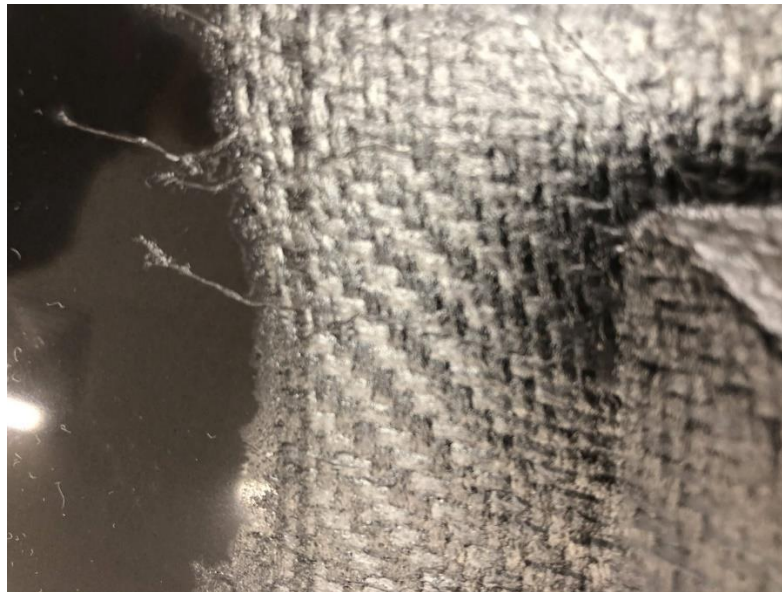
Photograph 24 – showing detail of edges, corners and transitions showing inconsistent definition and orientation of fibre.

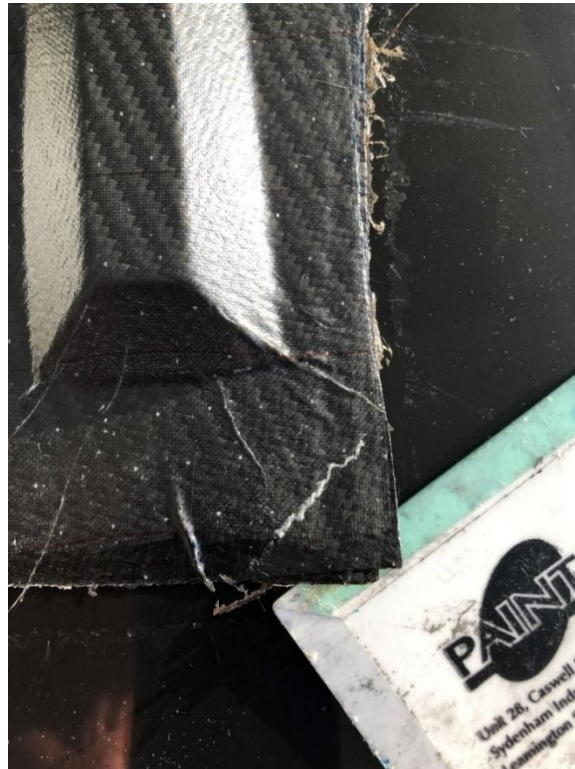
Photograph 27 – showing the lower corner has been cracked because of poor mould preparation and inserting a wedge that was too large. Some evidence of surface imperfections caused by the wrinkling of the moulding consumables.

The candidate's lower level of understanding of the material properties is demonstrated by their approach to demoulding the cured laminate. They followed the correct procedure to remove the laminate from the mould, using the correct tools for the job and for the type of mould used but the excess pressure applied to the lifting tool caused the corner of the material to crack, see photograph 27.

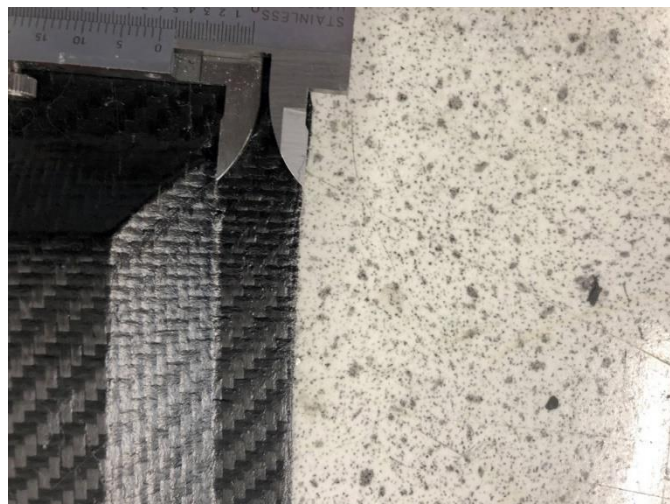
Photograph 28 – showing candidate performing measurement checks to ensure dimensions meet specification prior to safe edging. Correct tools were utilised however calibration checks were not thorough.

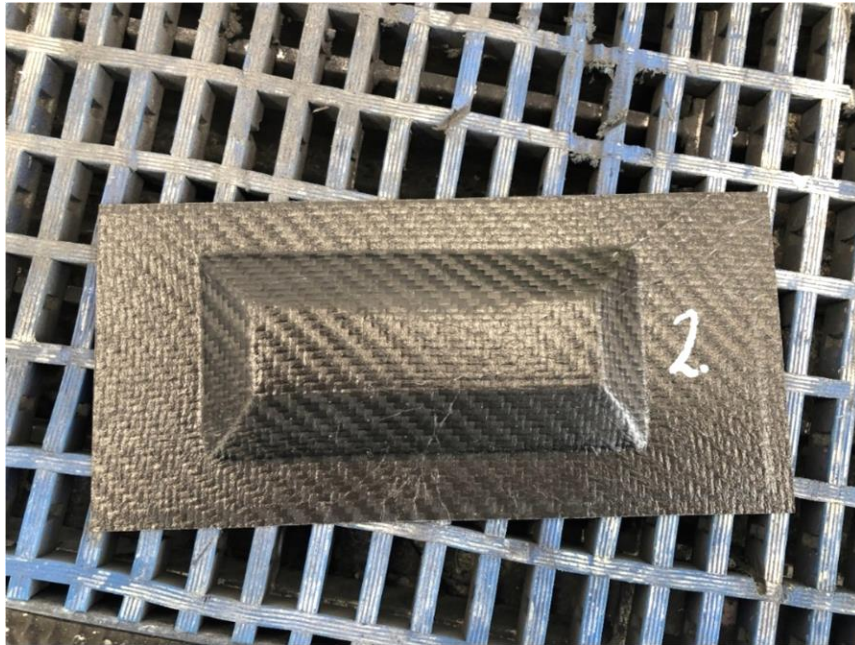
Photograph 29 – showing finished component safe edged prior to final dimensioning. The photo depicts some non-conformities and issues with squareness and dimensions of the core, surface imperfections resulting from the peel-ply and consumables.

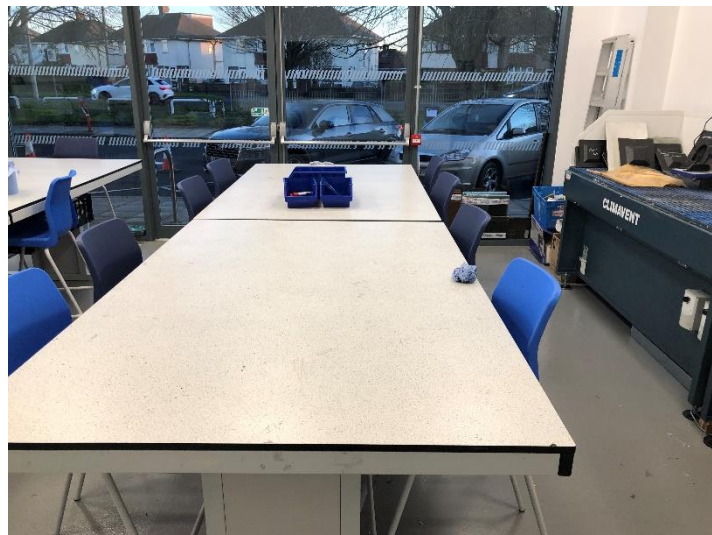
Photograph 30 – showing the reinstated work area. Note: The surfaces have been cleaned but not all waste has been disposed of.

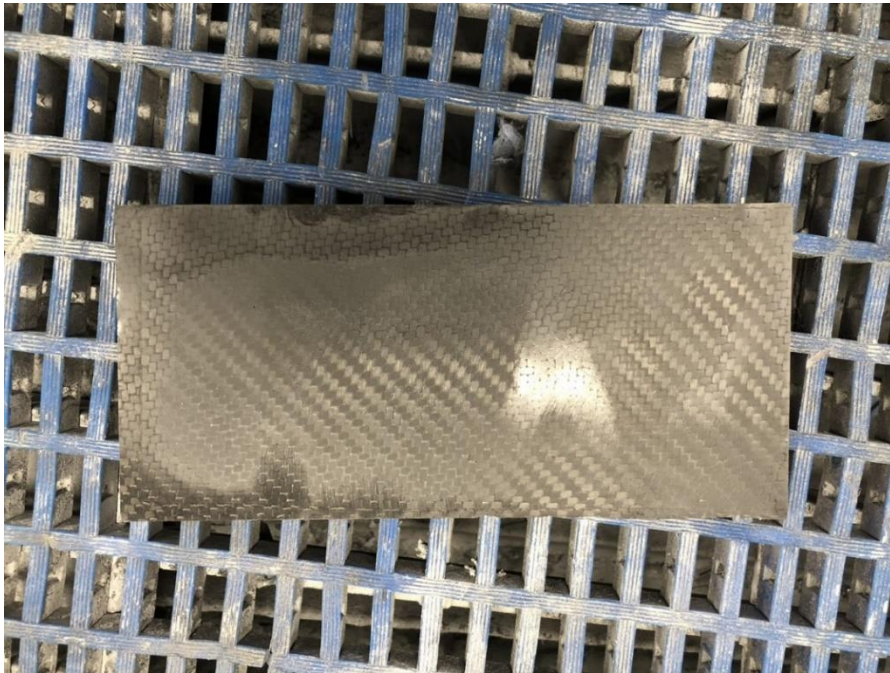
Photograph 31 – showing the underside of the spacer block on completion of being abraded. Abrasion of the lower surface showing signs of inconsistent application of abrasive medium and a lack of consistent colouration and texture.

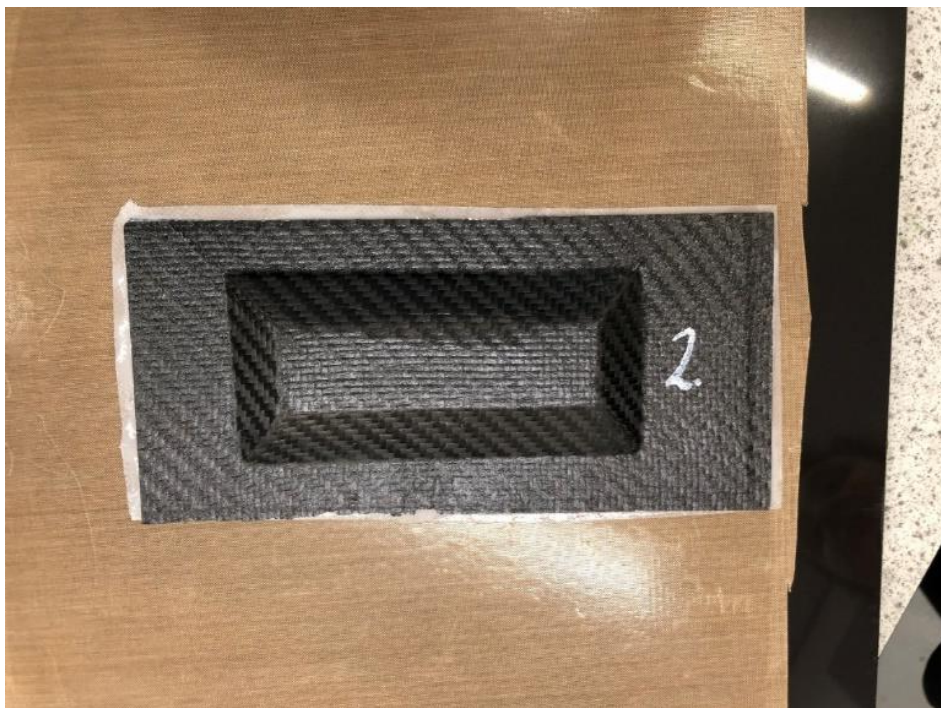
Photograph 34 – showing the spacer block component placed on top of release film. Note bottom left corner has no adhesive film overlap. The film should melt into this area during curing, but it is not good practice. Bottom edge showing some signs of inconsistent trimming activities.

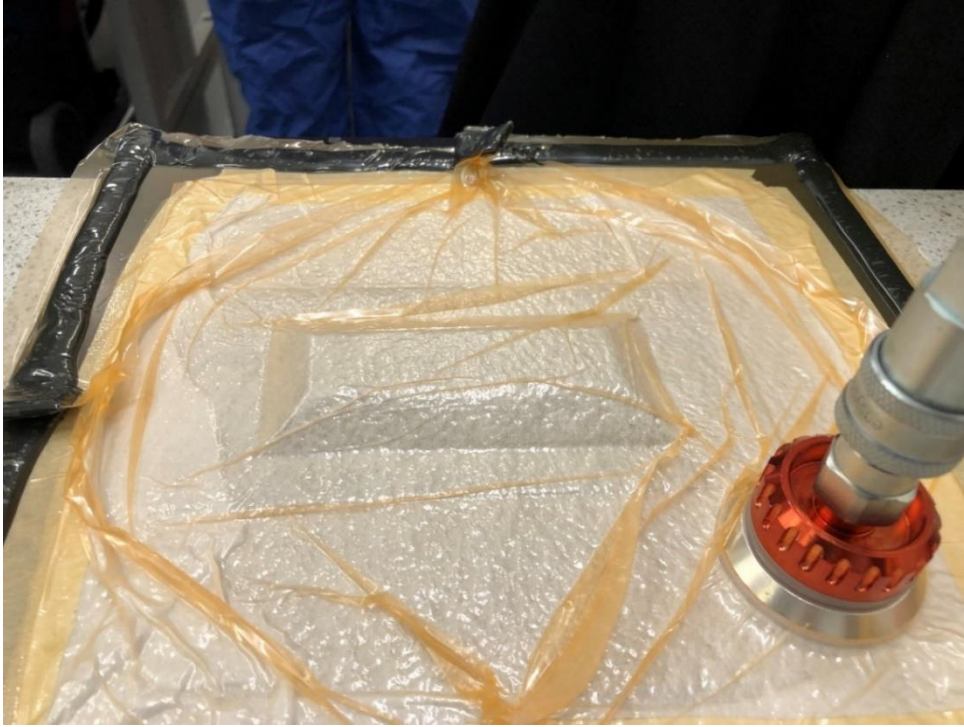
Photograph 38 - showing full consolidation pressure applied and wrinkles or pleats spaced out ready for curing in the curing oven. Some are still left across the surface which should be removed for best practice, but it should be remembered that the upper half is already cured.

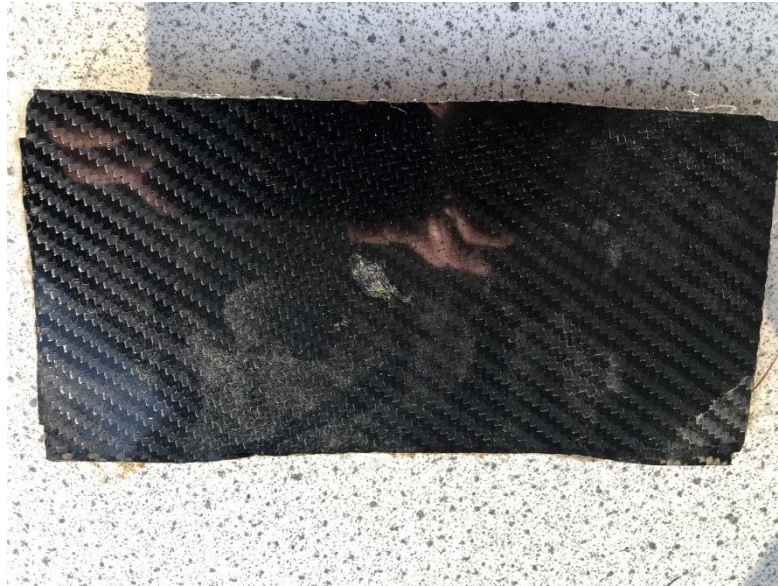
Photograph 40 – showing the checking of “A” side for defects or FOD. Some inclusions present.

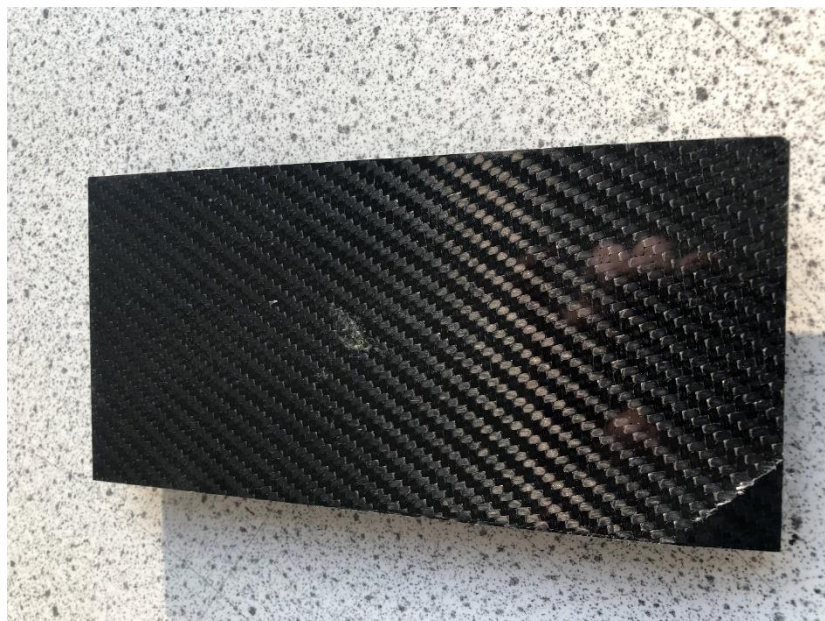
Photograph 41 - showing the final assembly which has been safe edged and ready for machining to final dimensions. Note the cracking of the bottom left corner and the presence of FOD embedded in the laminate that was present as a result of not cleaning the mould sufficiently.

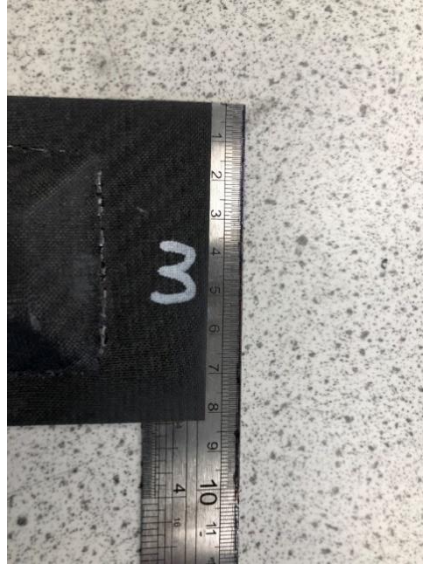
Photograph 42 – showing candidate checking the width of the assembly. Note: some run-out of the core in terms of not being parallel with the edge. Dimension not consistent with drawing.

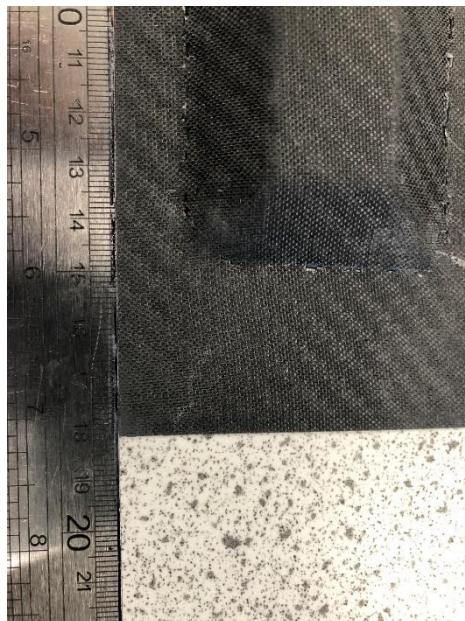
Photograph 43 – showing dimensional check of length. Some more material removal required. Note poor definition of edge or core and evidence of poor consolidation over the core and in the transitions.

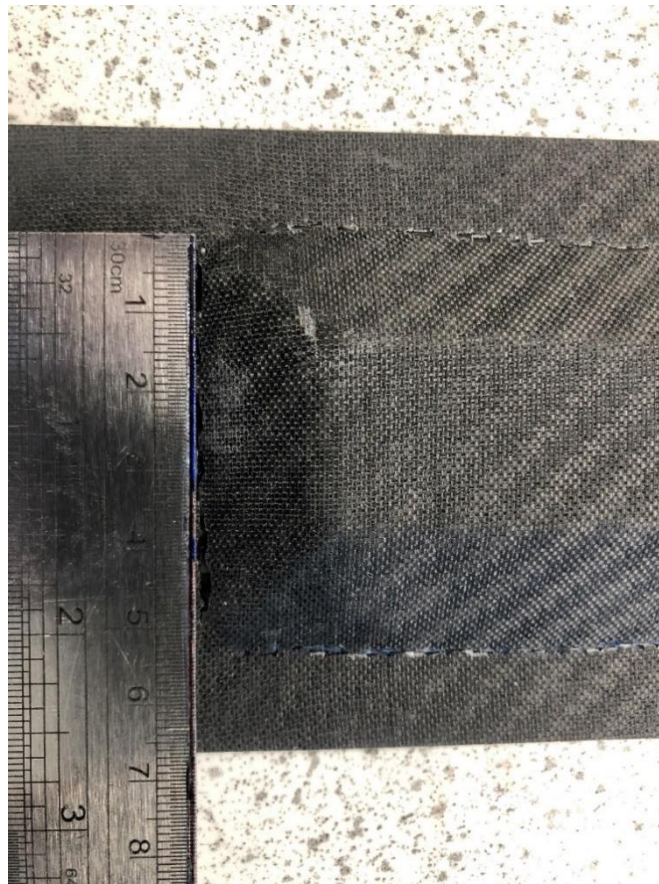
Photograph 44 – showing the candidate checking the core width. Note: poor consolidation of laminates around the core to laminate transition.

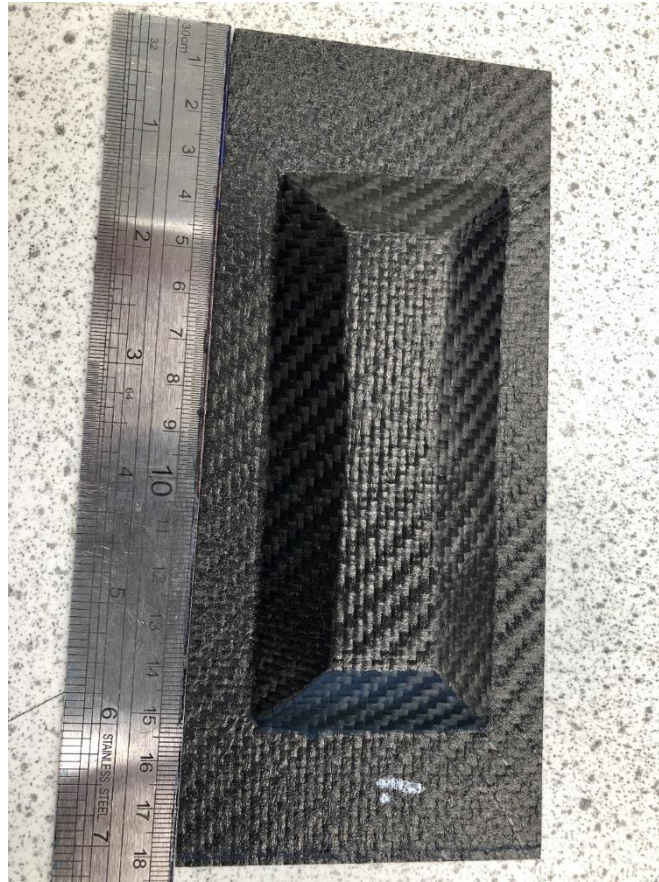
Photograph 46 – showing candidate checking straightness of long edge. Note: some taper of the laminate at the top edge. The core is also not sat straight onto the lower laminate.

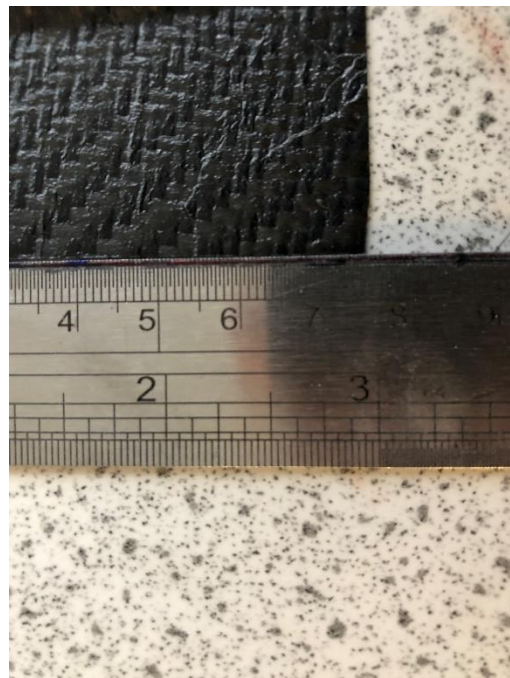
Photograph 47 – showing candidate checking straightness of short edge. Note: the tapering of the edge and lack of straightness.

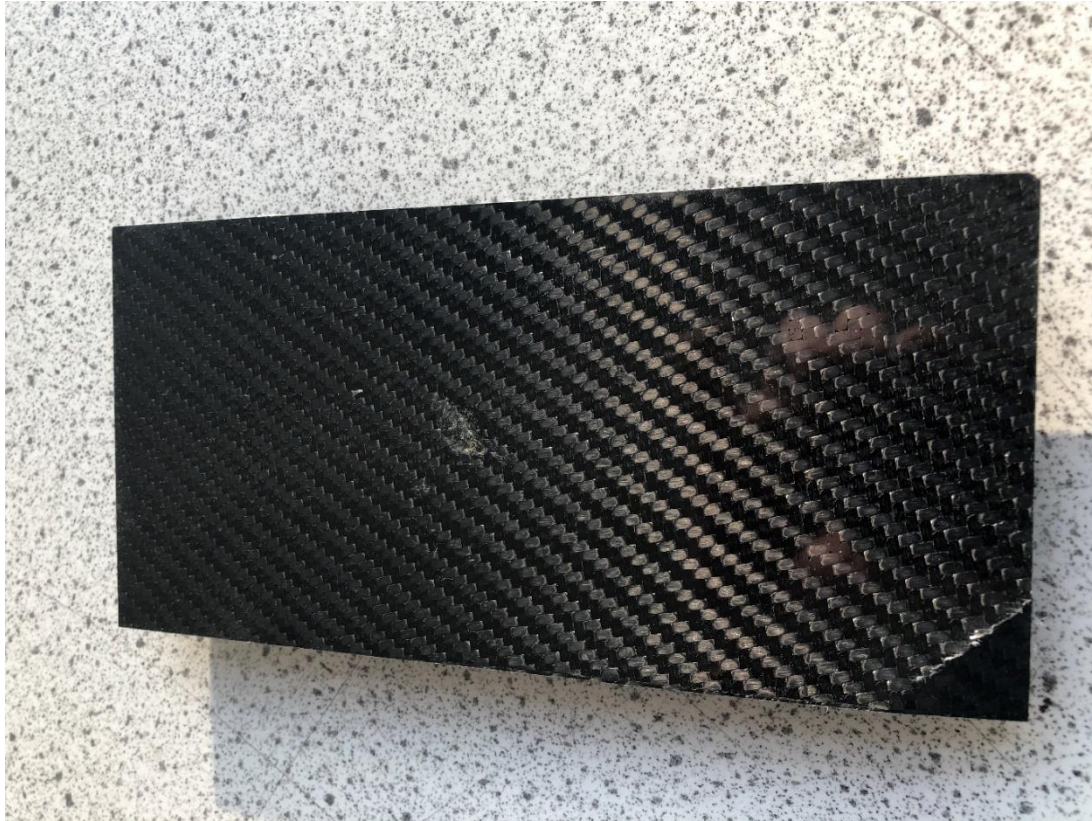
Photograph 48 - showing check of surface finish and warp and weft patter. Note: a warp or weft position is selected, and a check is made to ensure that the feature remains constant along the length of the assembly. Some tapering of this is evident.
