**T Level Technical
Qualification in
Building Services
Engineering for
Construction**

Gas Engineering

Guide standard exemplification material

Threshold competence – Sample 2021

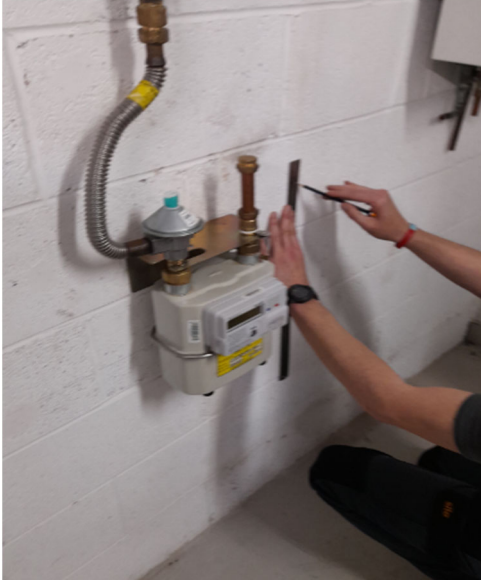
Photograph 1

Candidate marking out a work area using a straight edge that is not the approved method.

The candidate used measuring and marking out equipment which was not best practice for this task. This resulted in some minor inaccuracies, which could impact on the installation pipework not being plumb and level and the finished aesthetics of the installation.

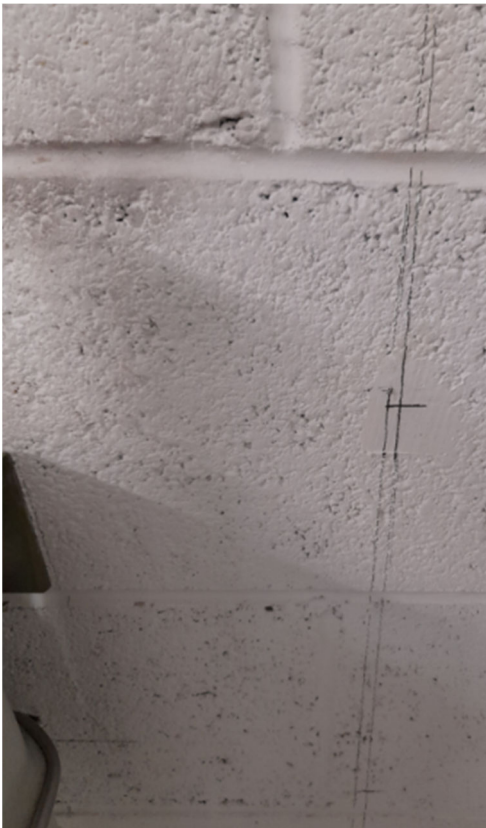
Photograph 2

Work area shows multiple marks on work surface from marking out due to initial inaccurate measuring and marking out.

The marking out took several attempts resulting in lines left on wall.

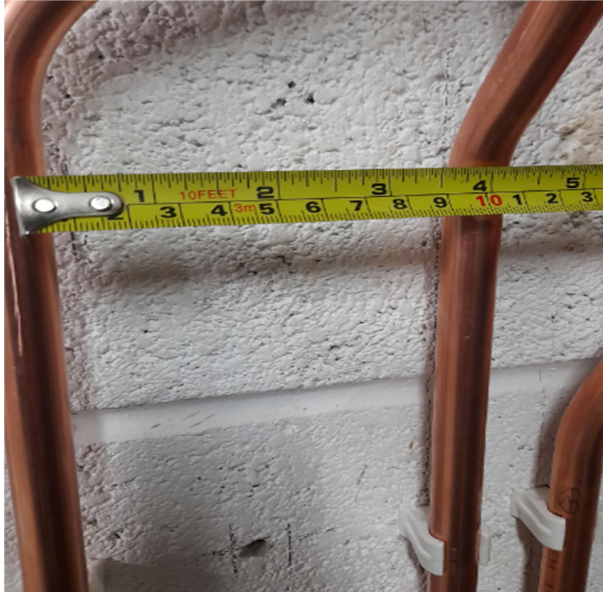
Photograph 3

Tolerances (+/-5mm) have been met during the installation of pipework.

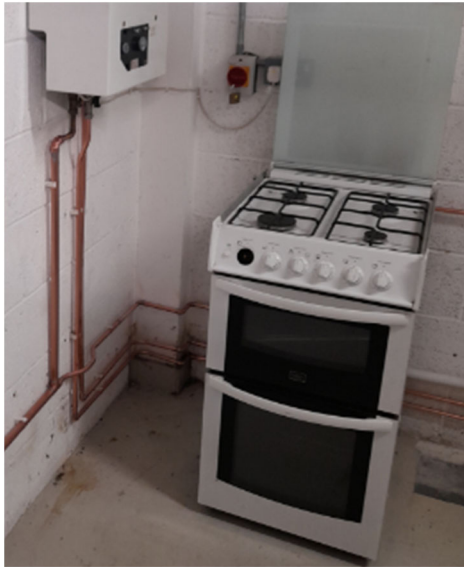
Photograph 4

Finished installation of the gas cooker and associated pipework.

Overall aesthetics of the installation have

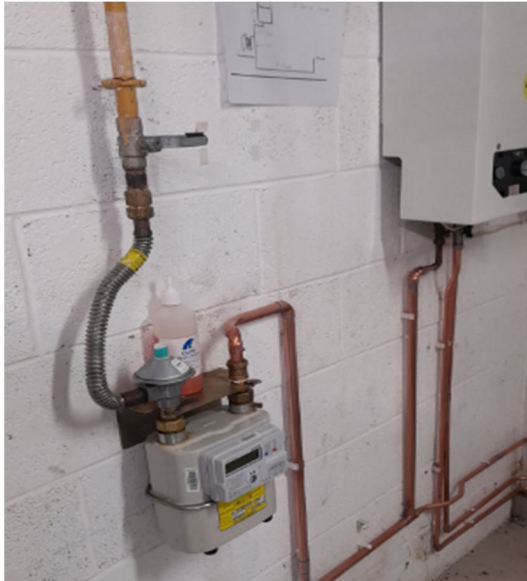
Photograph 5

Finished installation of the water heater and associated pipework.

Overall aesthetics of the installation have been met.

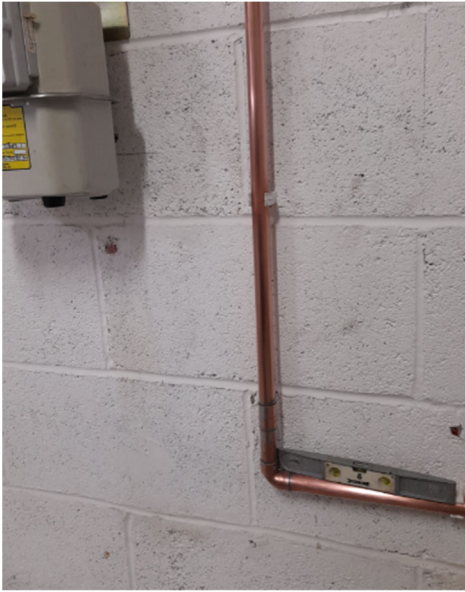
Photograph 6

Pipework not level but within tolerance.

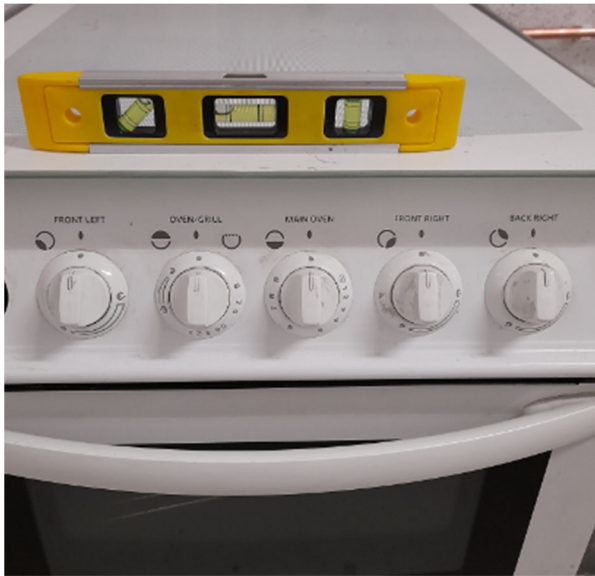
Photograph 7

Components correctly installed but not level.

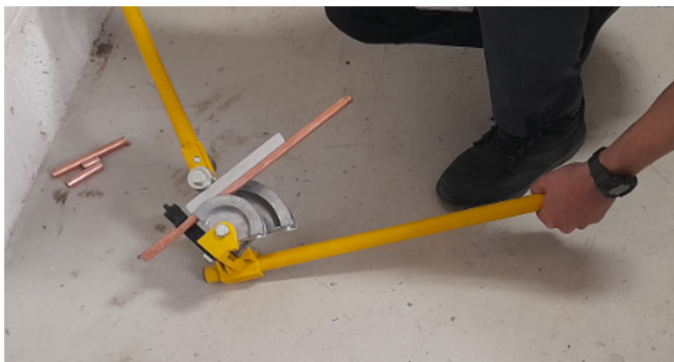
Photograph 8

The correct operation/use of pipe bend machine and pipe cutting tools.

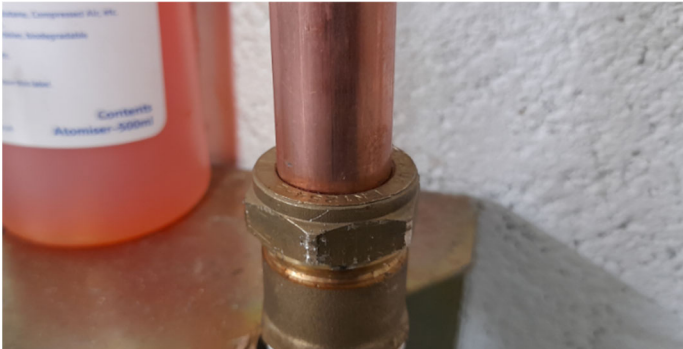
Photograph 9

Component fitted correctly with signs of tool marks from installation.

The candidate is mostly confident in the practical elements of the task, however, they require some reassurance from the assessor, for example with the selection and use of appropriate tools and components. The candidate can successfully select correct tools and components but at times looks for confirmation from the assessor before proceeding with the task. The use of tools is mostly good, however, some tasks require more than one attempt/ or the wrong tool is used, for example water pliers incorrectly used on brass fittings, resulting in tooling marks to pipework/ components.

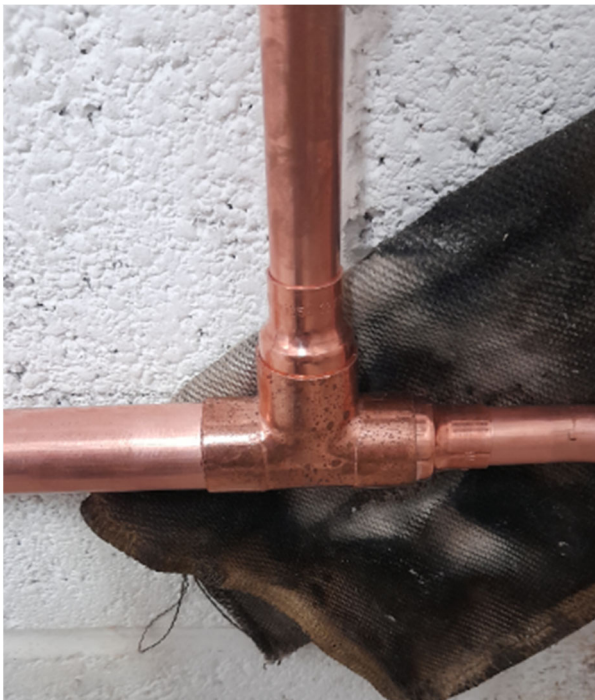
Photograph 10

Correct use of blow lamp, safe soldering, correct selection of solder and protection of customer property although heat mat not centrally positioned.

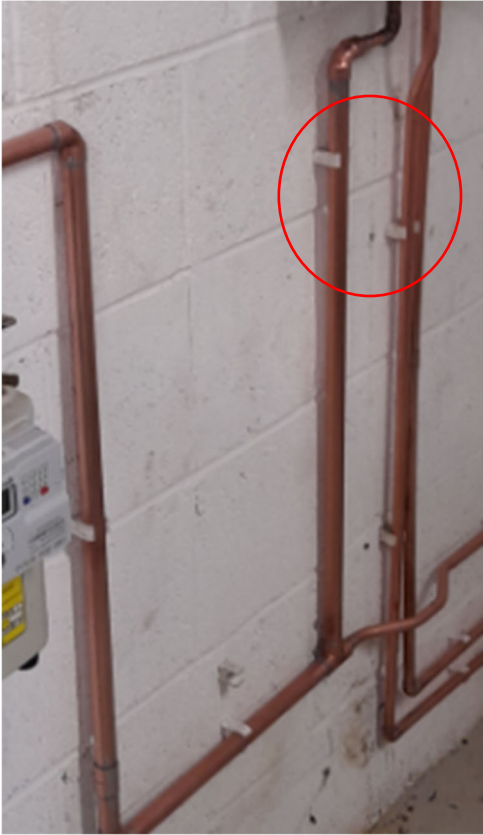
Photograph 11

Incorrect clipped pipe, not plumb.

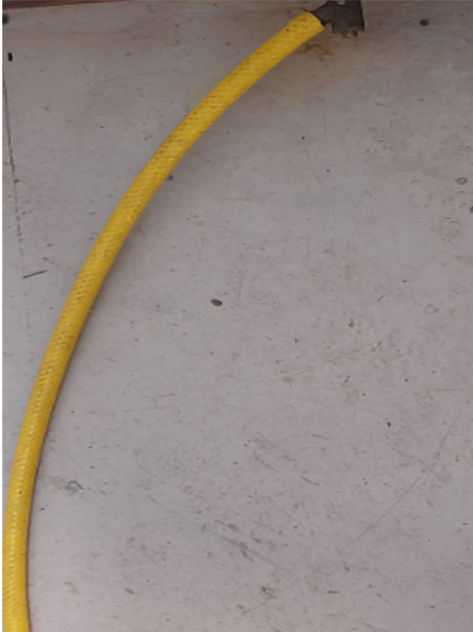
Photograph 12

Preparation for draining down: correct equipment and drain point used to drain down system pipework for decommissioning activities.

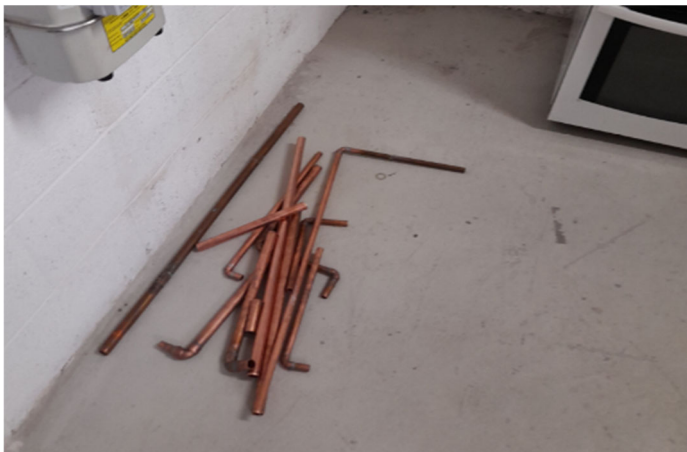
Photograph 13

Pipework decommissioned correctly with minimal consideration of recycling.
No separation of different materials.
No separation of clean/dirty copper.

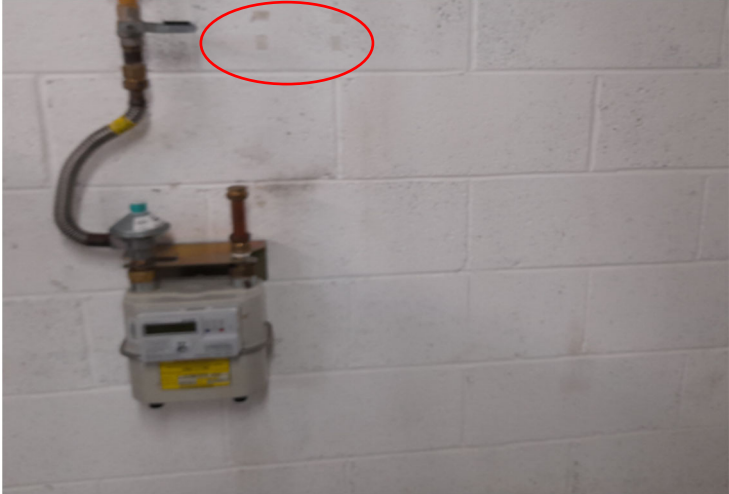
Photograph 14

Some holes and marks still evident from complete decommissioning of pipework.

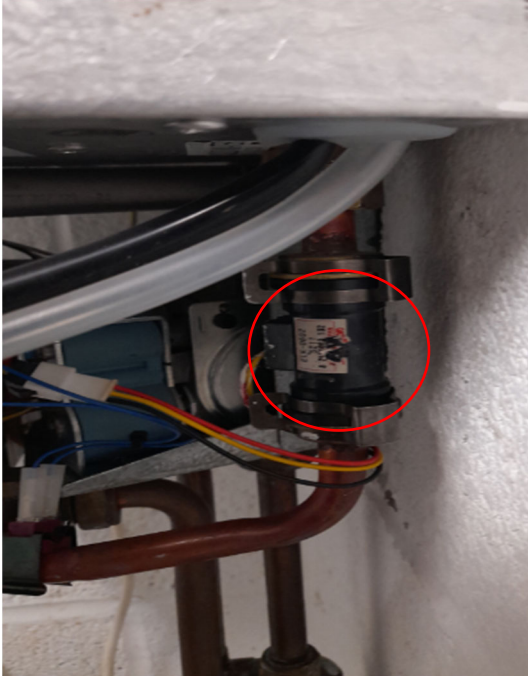
Photograph 15

Component fitted correctly with signs of tool marks from installation of replacement component.

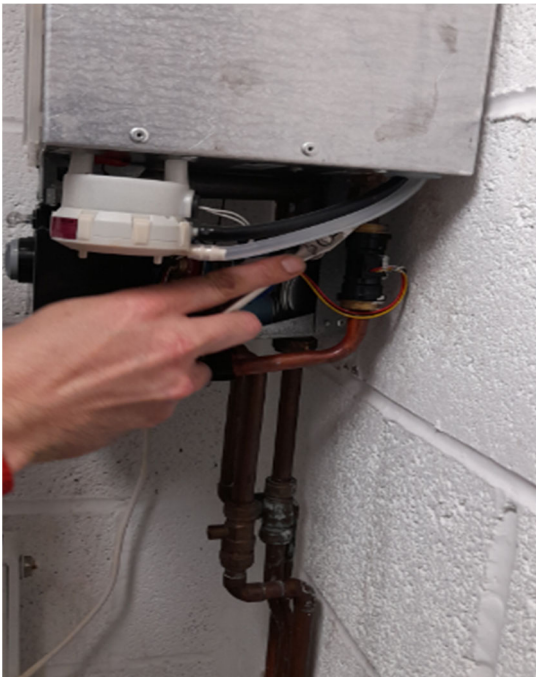
Photograph 16

Loosening of faulty component using the correct tool.

- Isolate the gas/electric/water supply
- Remove the faulty component
- Replace the component
- Reinstate all supplies
- Commission water heater as per manufacturer instructions.

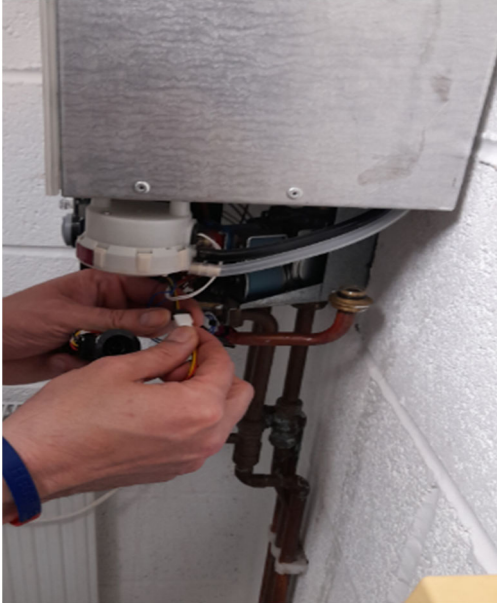
Photograph 17

Removal of faulty component.

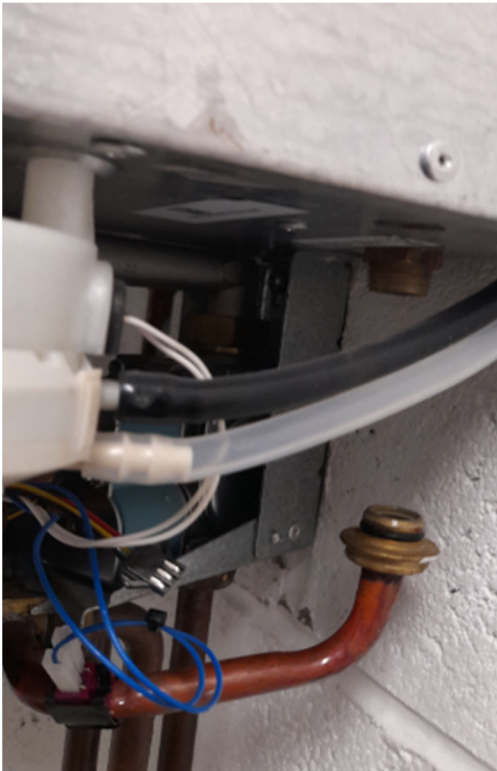
Photograph 18

Component removed during repair activity.

I checked if the water heater was working in accordance with manufacturer's instructions. After investigation and discussion with my assessor, I confirmed that there was a faulty flow control, this would need to be replaced

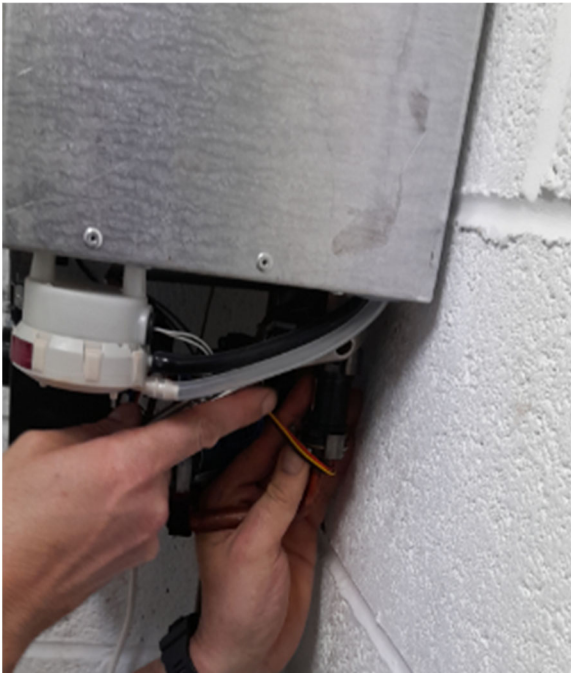
Photograph 19

Replacement of component.

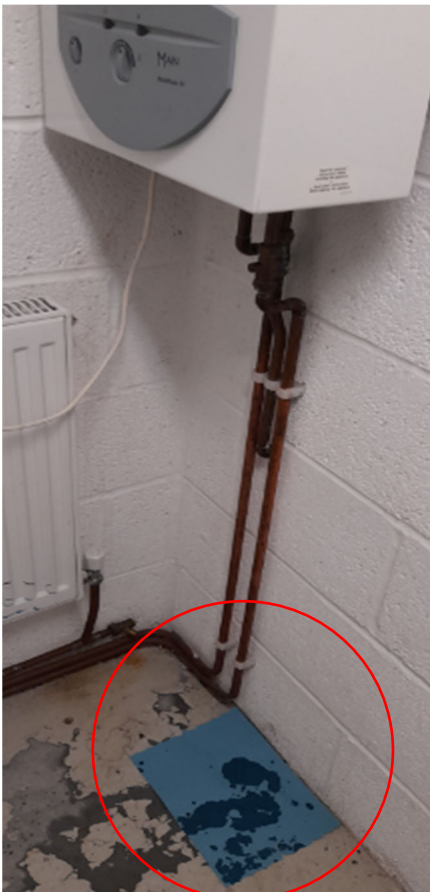
Photograph 20

Repair completed with signs of leaks which have been repaired.
