**T Level Technical  
Qualification in  
Building Services  
Engineering for  
Construction**

**Plumbing Engineering**

**Guide standard exemplification material**

**Threshold competence – Sample 2021**

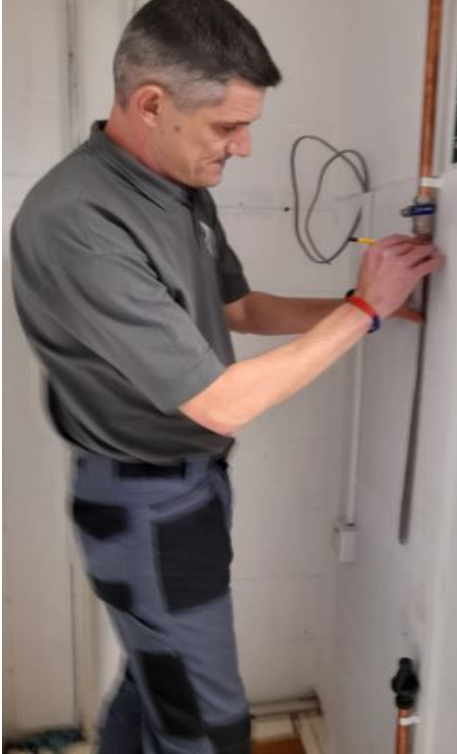
### Photograph 1

Candidate marking out a work area using a straight edge that is not the approved method.

The candidate used measuring and marking out equipment which was not best practice for this task. This resulted in some minor inaccuracies, which could impact on the installation pipework not being plumb and level and the finished aesthetics of the installation.

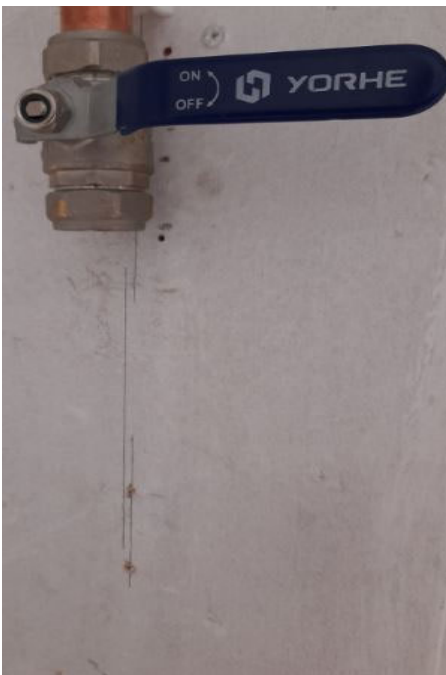
### Photograph 2

Work area shows multiple marks on work surface from marking out due to initial inaccurate measuring and marking out.

The marking out took several attempts resulting in lines left on wall.

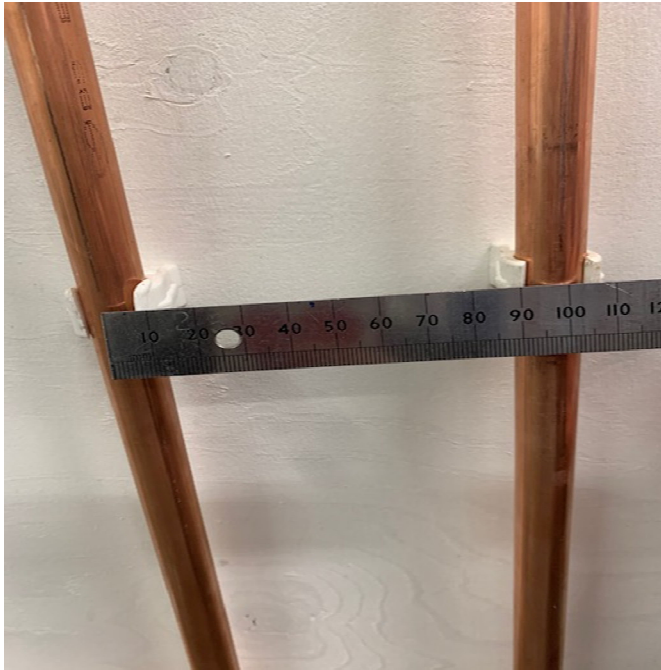
### Photograph 3

Tolerances (+/-5mm) have been met during the installation of pipework.

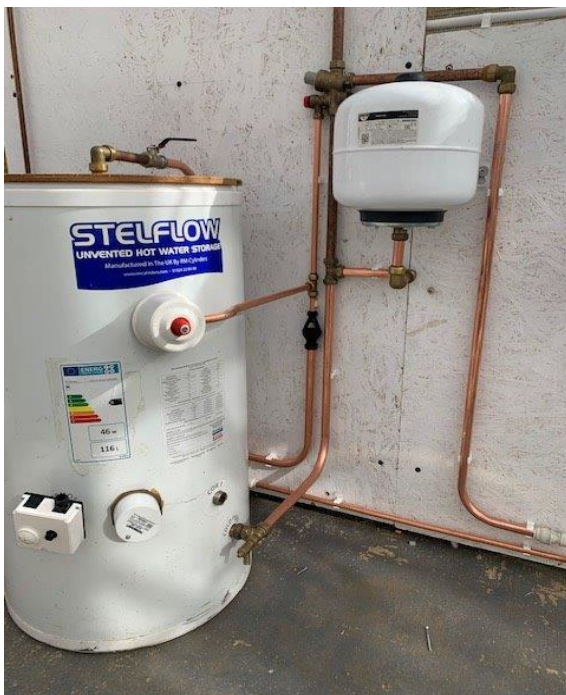
### Photograph 4

Finished installation of the unvented hot water cylinder and associated pipework including the installation of both functional and safety controls. Overall aesthetics of the installation have been met.

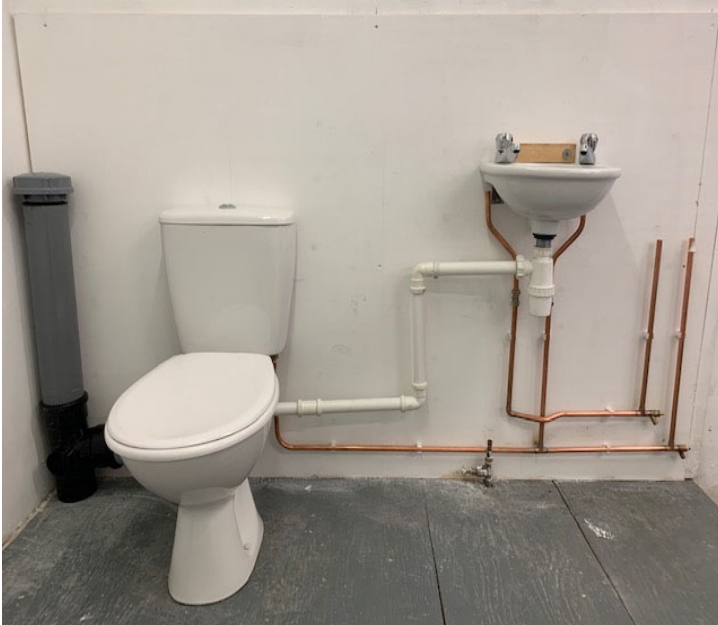
**Photograph 5**

Finished installation of the cloakroom including appliances and pipework to tolerances/standards.

Overall aesthetics of the installation have been met.

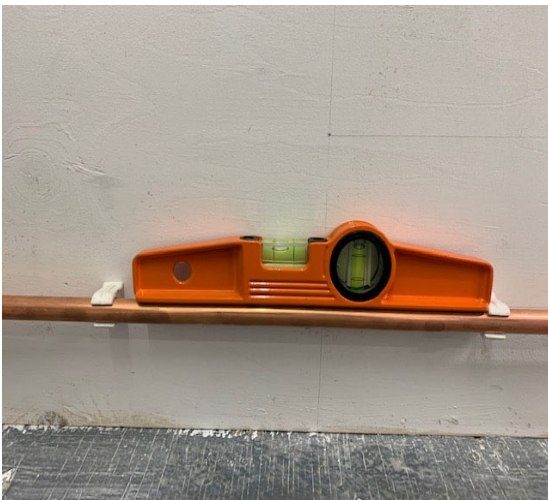
**Photograph 6**

Pipework not level but within tolerance.

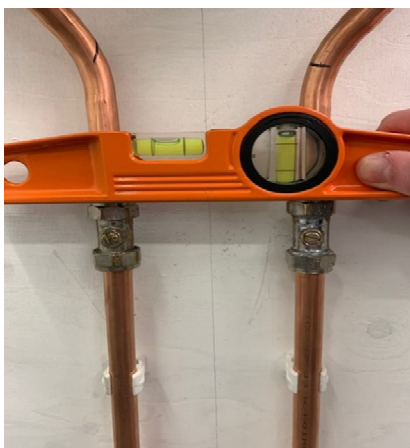
**Photograph 7**

Components correctly installed but not level.

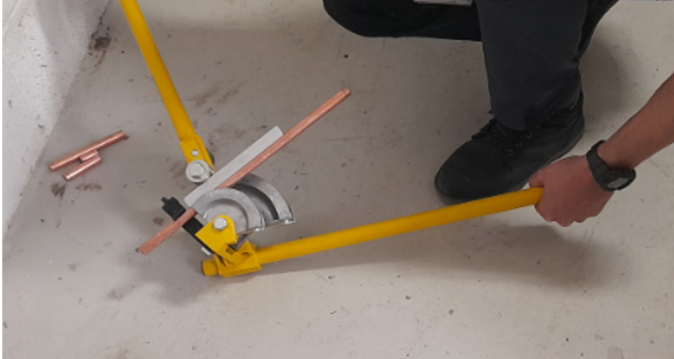
**Photograph 8**

The correct operation/use of pipe bend machine and pipe cutting tools.

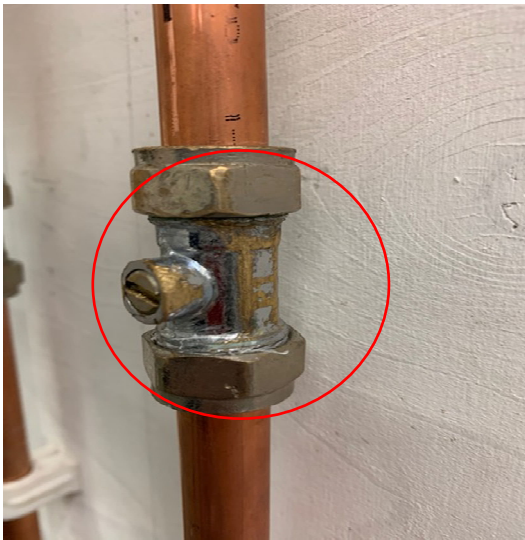
**Photograph 9**

Component fitted correctly with signs of tool marks from installation.

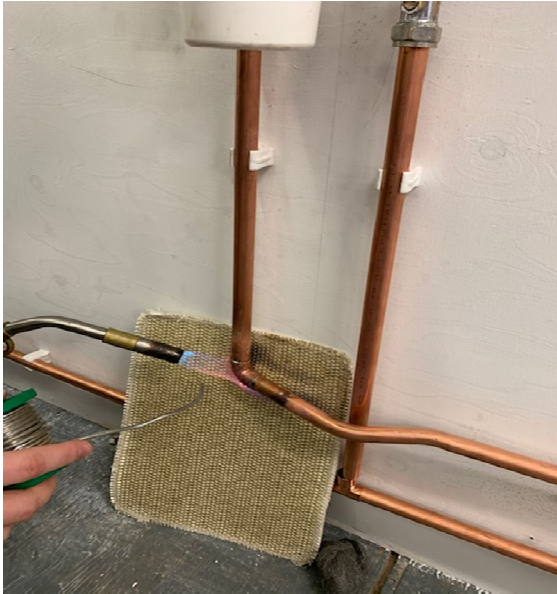
**Photograph 10**

Correct use of blow lamp, safe soldering, correct selection of solder and protection of customer property although heat mat not centrally positioned.

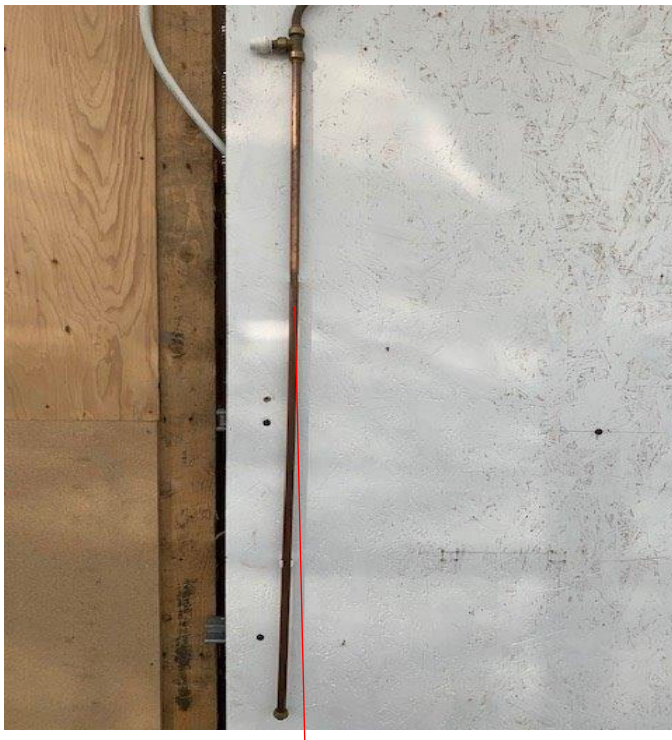
**Photograph 11**

Incorrect clipped pipe, not plumb.

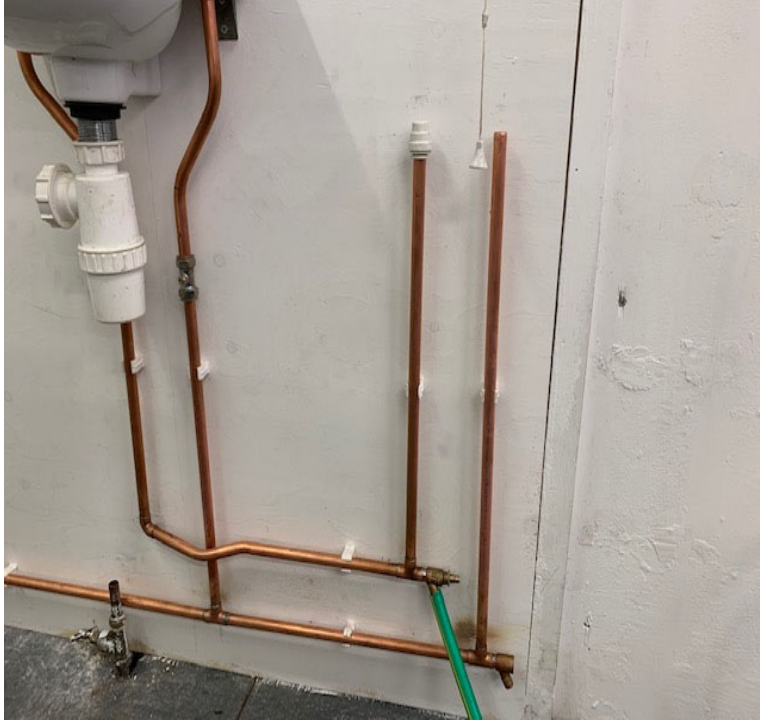
### Photograph 12

Preparation for draining down: correct equipment and drain point used to drain down system pipework for decommissioning activities.

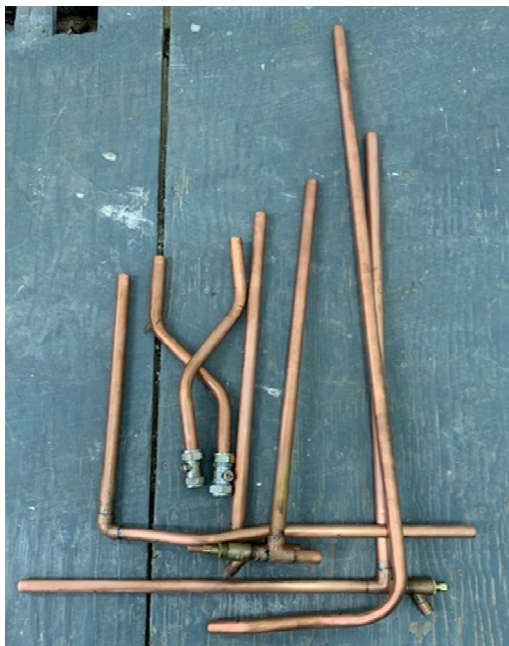
### Photograph 13

Pipework decommissioned correctly with minimal consideration of recycling.  
No separation of different materials.  
No separation of clean/dirty copper.

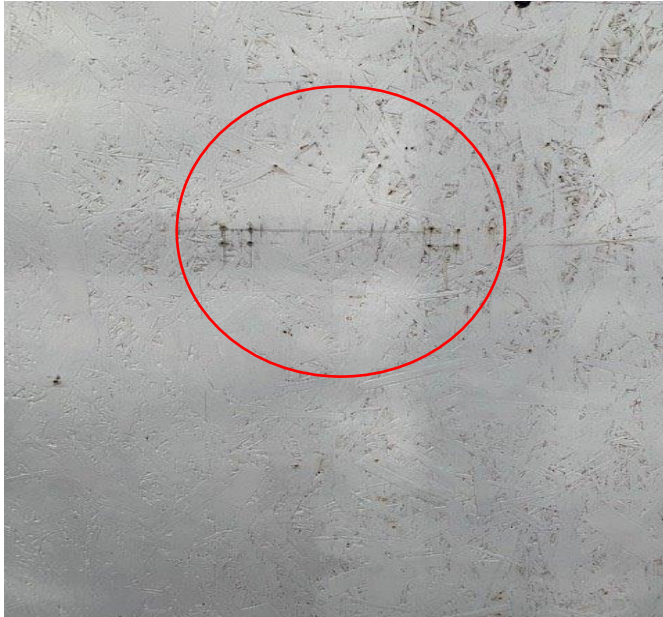
### Photograph 14

Some holes and marks still evident from complete decommissioning of pipework.

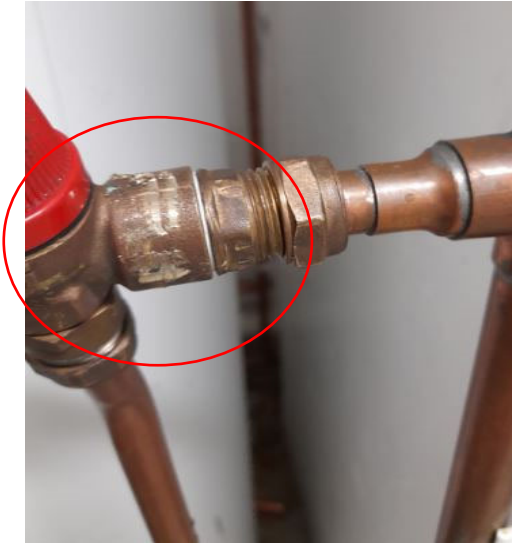
### Photograph 15

Component fitted correctly with signs of tool marks from installation of replacement component.

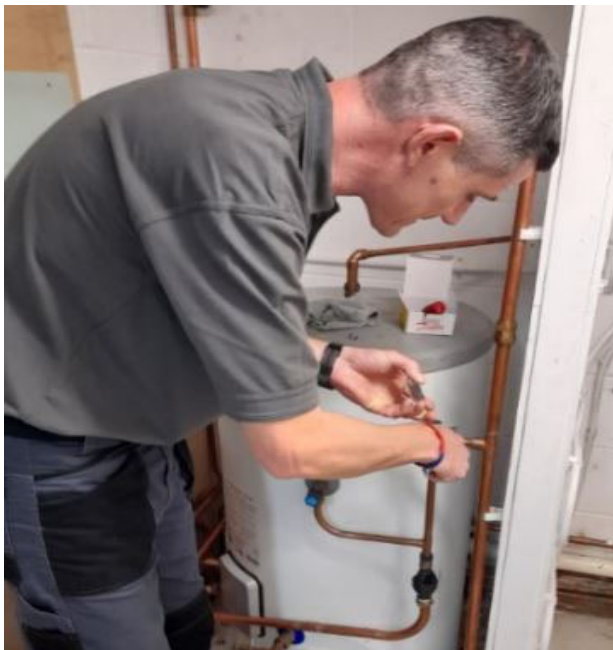
### Photograph 16

Loosening of faulty component.

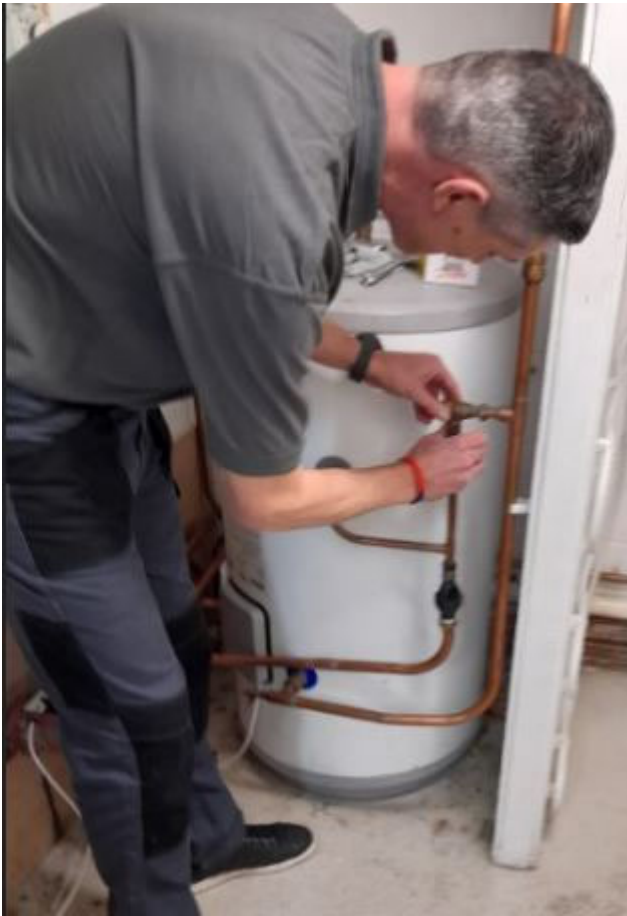
**Photograph 17**

Removal of faulty component.

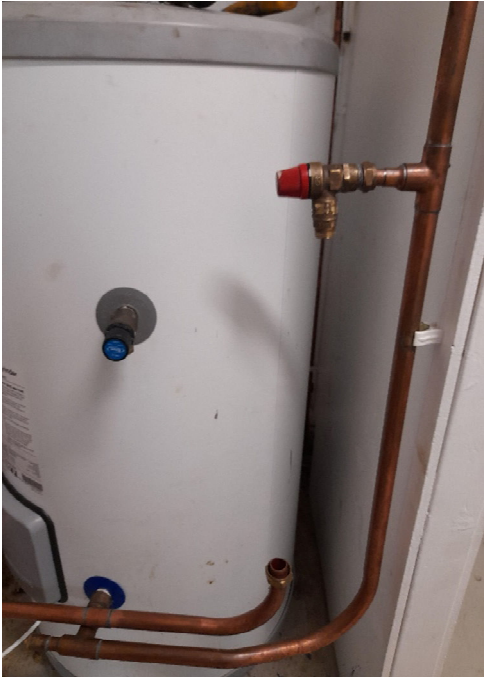
**Photograph 18**

Excess pipework removed during repair activity.

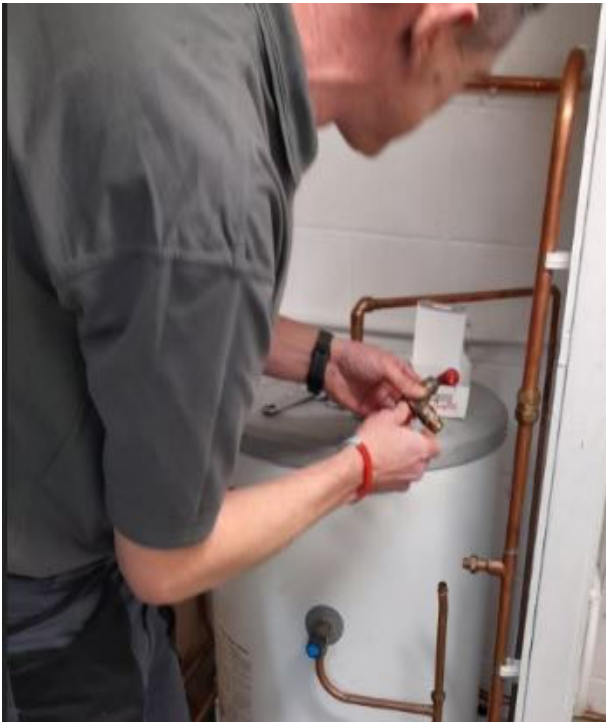
**Photograph 19**

Replacement of component.

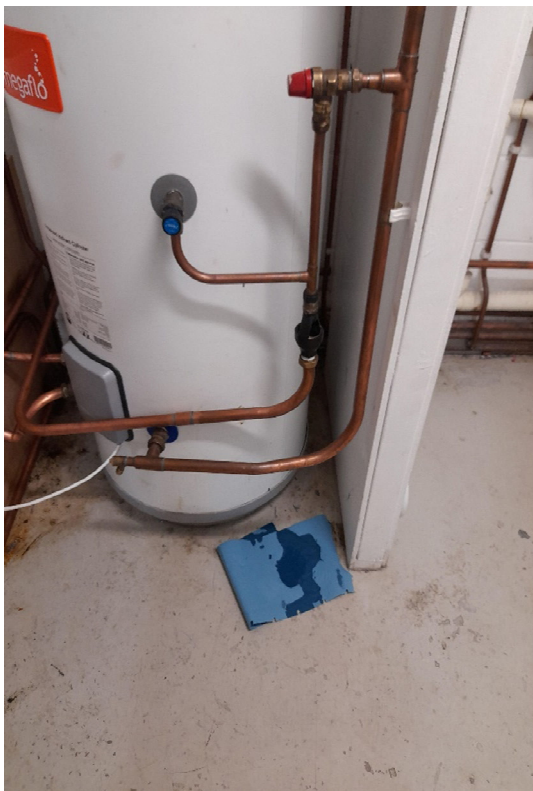
**Photograph 20**

System on completion of all works.

Repair completed with signs of leaks which have been repaired.
