**T Level Technical  
Qualification in  
Building Services  
Engineering for  
Construction**

**Air Conditioning  
Engineering**

**Guide standard exemplification material  
Threshold competence – Sample 2021**

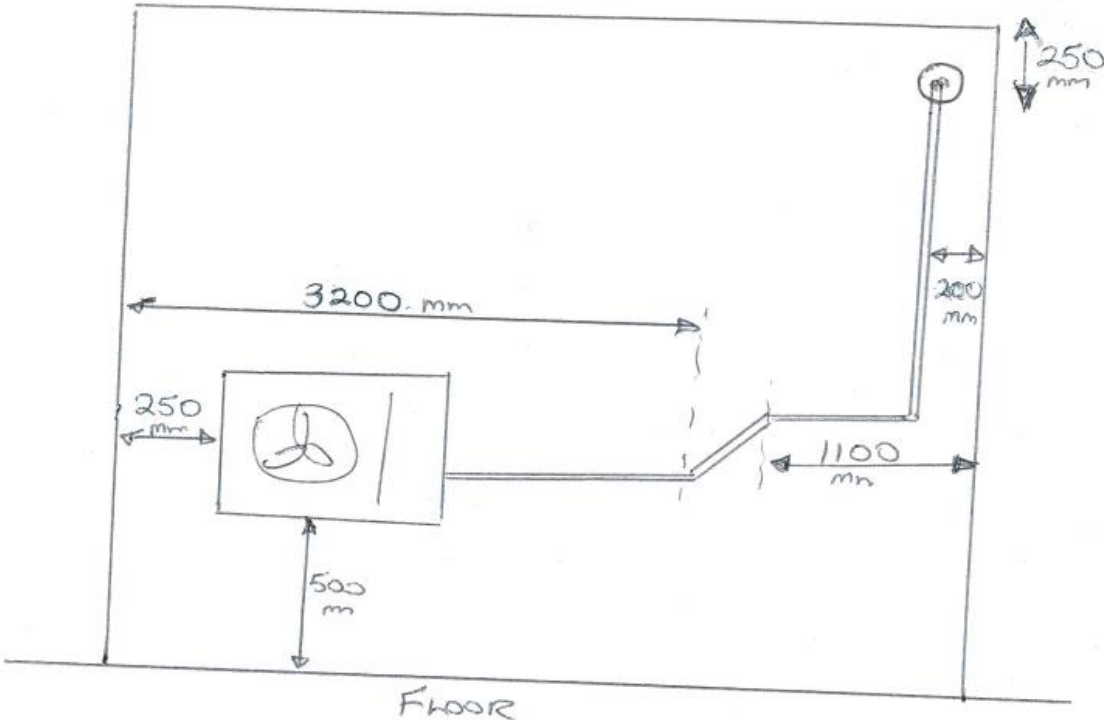
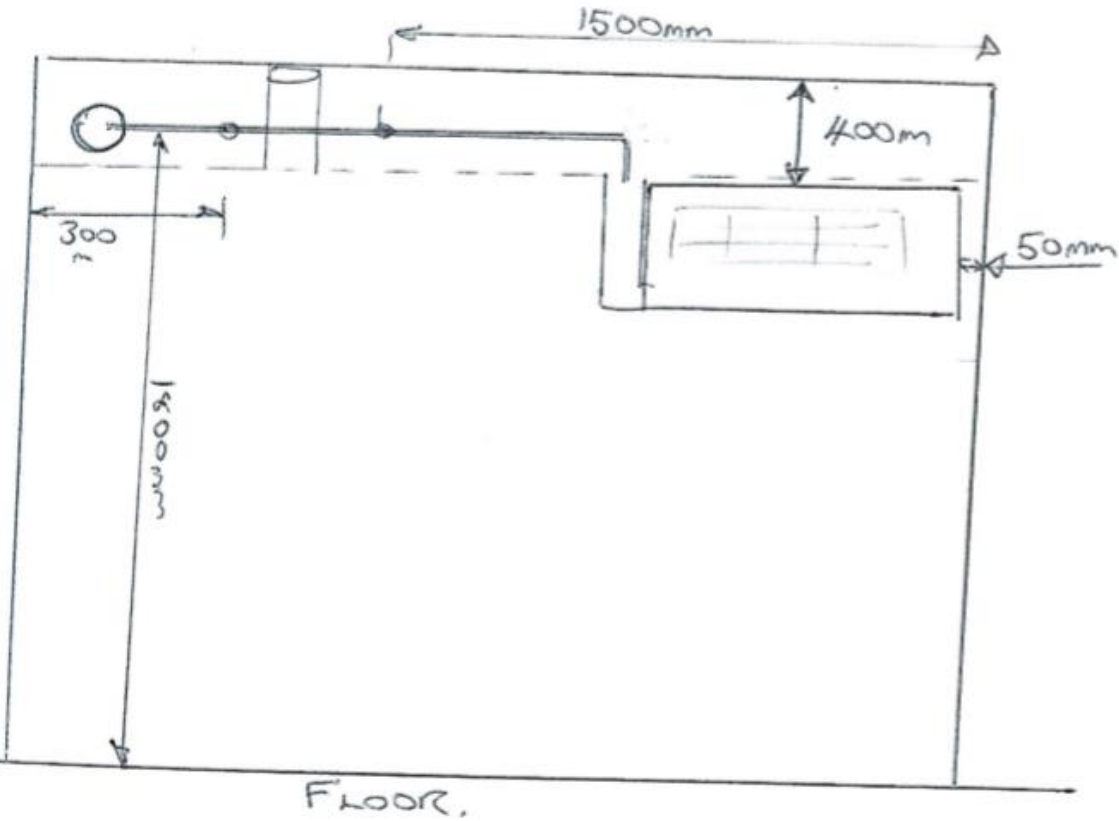
Installation drawing

The candidate has completed the drawing considering all aspects of the design brief. They have correctly identified all the components and made a good attempt to draw pipe layout and pipe sizes. However, the candidate has not used datum lines to reference the measurement from, resulting in confusion when the component positions were marked out ready for installation. However, the drawing itself does meet the assignment brief.

The completed drawing does have minor inaccuracies. Some dimensions are missing, the distance of the pipe clips are not clearly displayed, but overall the drawing is understandable and well presented. The lack of the consistent datum to measure from will mean that the candidate may have to make some adjustments to the installation whilst it is in progress, due to the inconsistencies introduced in the layout.

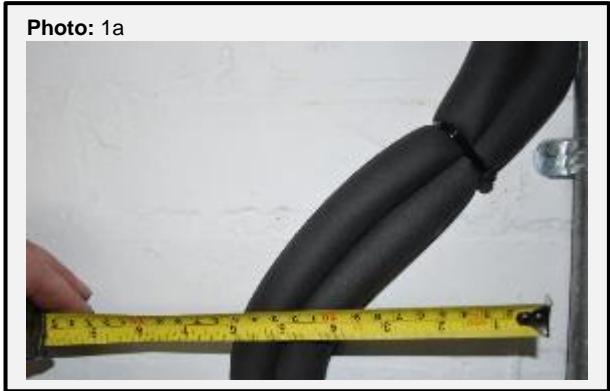
(Photograph 1a and 1b) This photo demonstrates the candidate being able to work to +/- 5mm tolerance. Shows offset conforming to the 150mm dimension. – demonstrates that the candidate can bend pipe accurately to a tolerance.

- Photograph of the offset conforming to the 150mm dimension. – demonstrates that the candidate can bend pipe accurately to a tolerance. **(photograph 1a and 1b)**

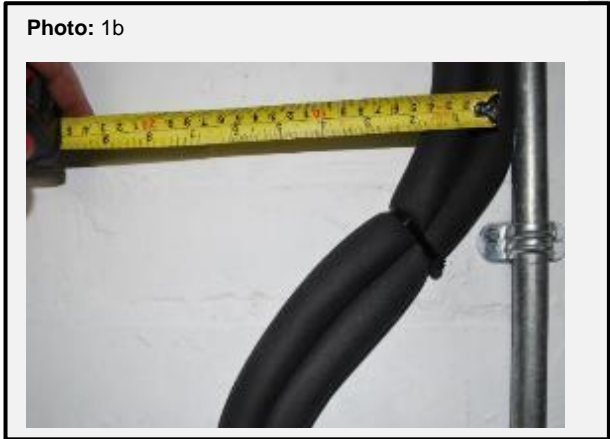
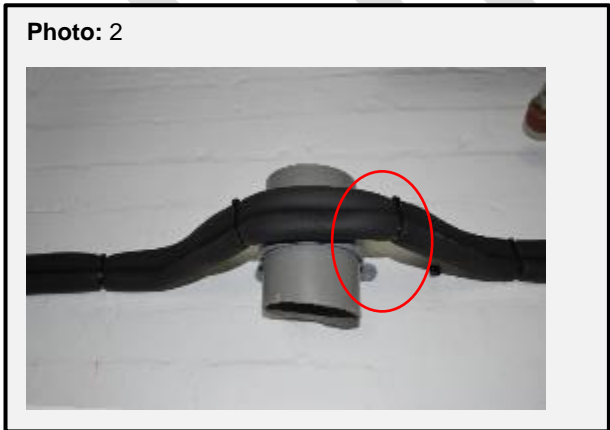
(Photograph 2) Demonstrates the candidate's pipework skills forming bend around the soil pipe. The photo demonstrates how the pipework visibly varies in distance from the soil pipe.

- Photograph showing the offset around the soil pipe obstruction – demonstrates the candidate's pipework skills forming bend around the soil pipe. The photo demonstrates how the pipework visibly varies in distance from the soil pipe. **(photograph 2)**

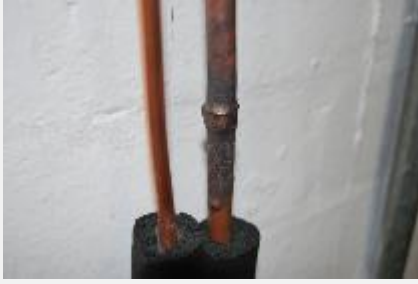
**Photo: 5**

(Photograph 5,6,7,8)

Demonstrates how well the joint is finished. This photo demonstrates some excessive solder and scorch marks on the wall surfaces.

- Four to six photographs of each brazed joint – Demonstrates how well the joint is finished. This photo demonstrates some excessive solder and scorch marks on the wall surfaces. **(photograph 5,6,7,8)**

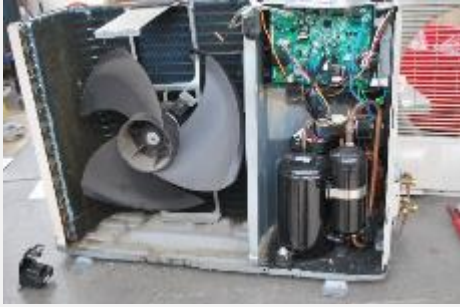
**Photograph 9.**

Disassembly of condensing unit demonstrating showing the existing state of the system prior to removal of the compressor.

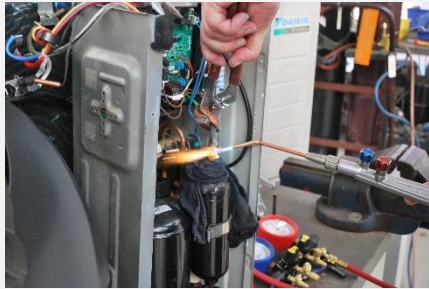
**Photograph 10:**

Un-brazing and removal of compressor demonstrating lack of protection to the surrounding area where the torch is.

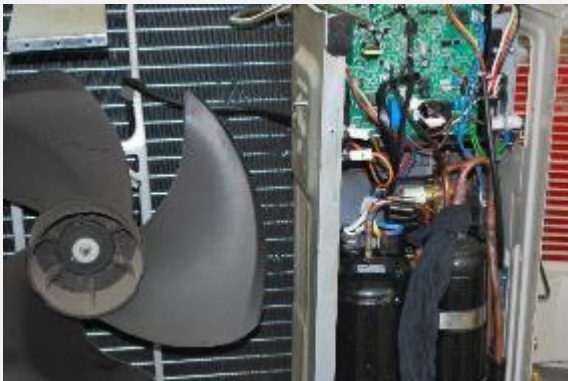
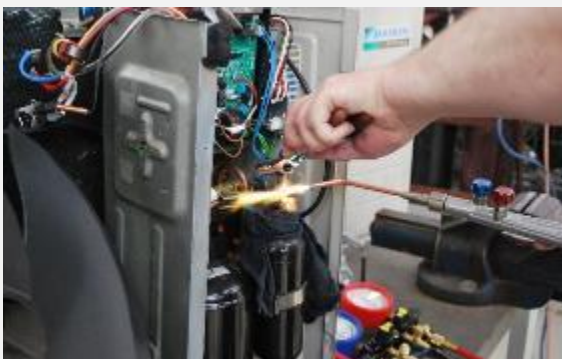
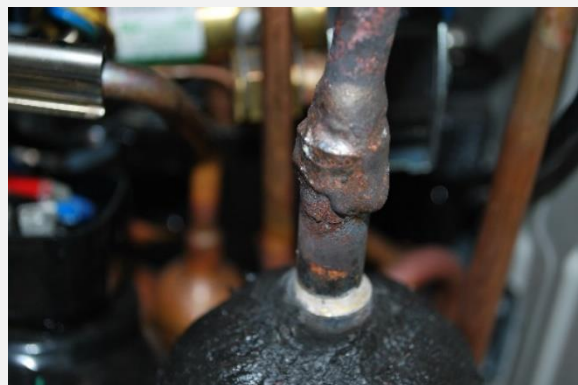
**Photograph 11:**

Refitting and brazing of compressor showing lack of protection to surrounding fittings and casing resulting in a burn mark on the casing.

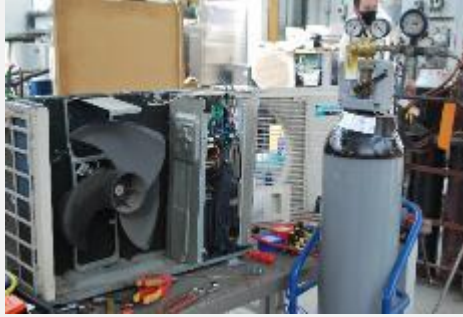
**Photograph 12:**

Set up of pressure testing equipment and gauge reading showing that barriers had not been erected around the test area.

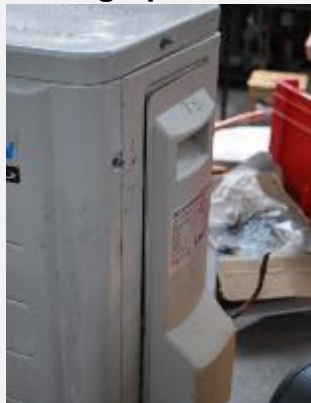
**Photograph 16:**

Final reassembly of condensing unit. Some screws are missing and a new burn mark is seen on the casing.
