**T Level Technical  
Qualification in  
Building Services  
Engineering for  
Construction**

**Refrigeration  
Engineering**

**Guide standard exemplification material  
Threshold competence – Sample 2021**

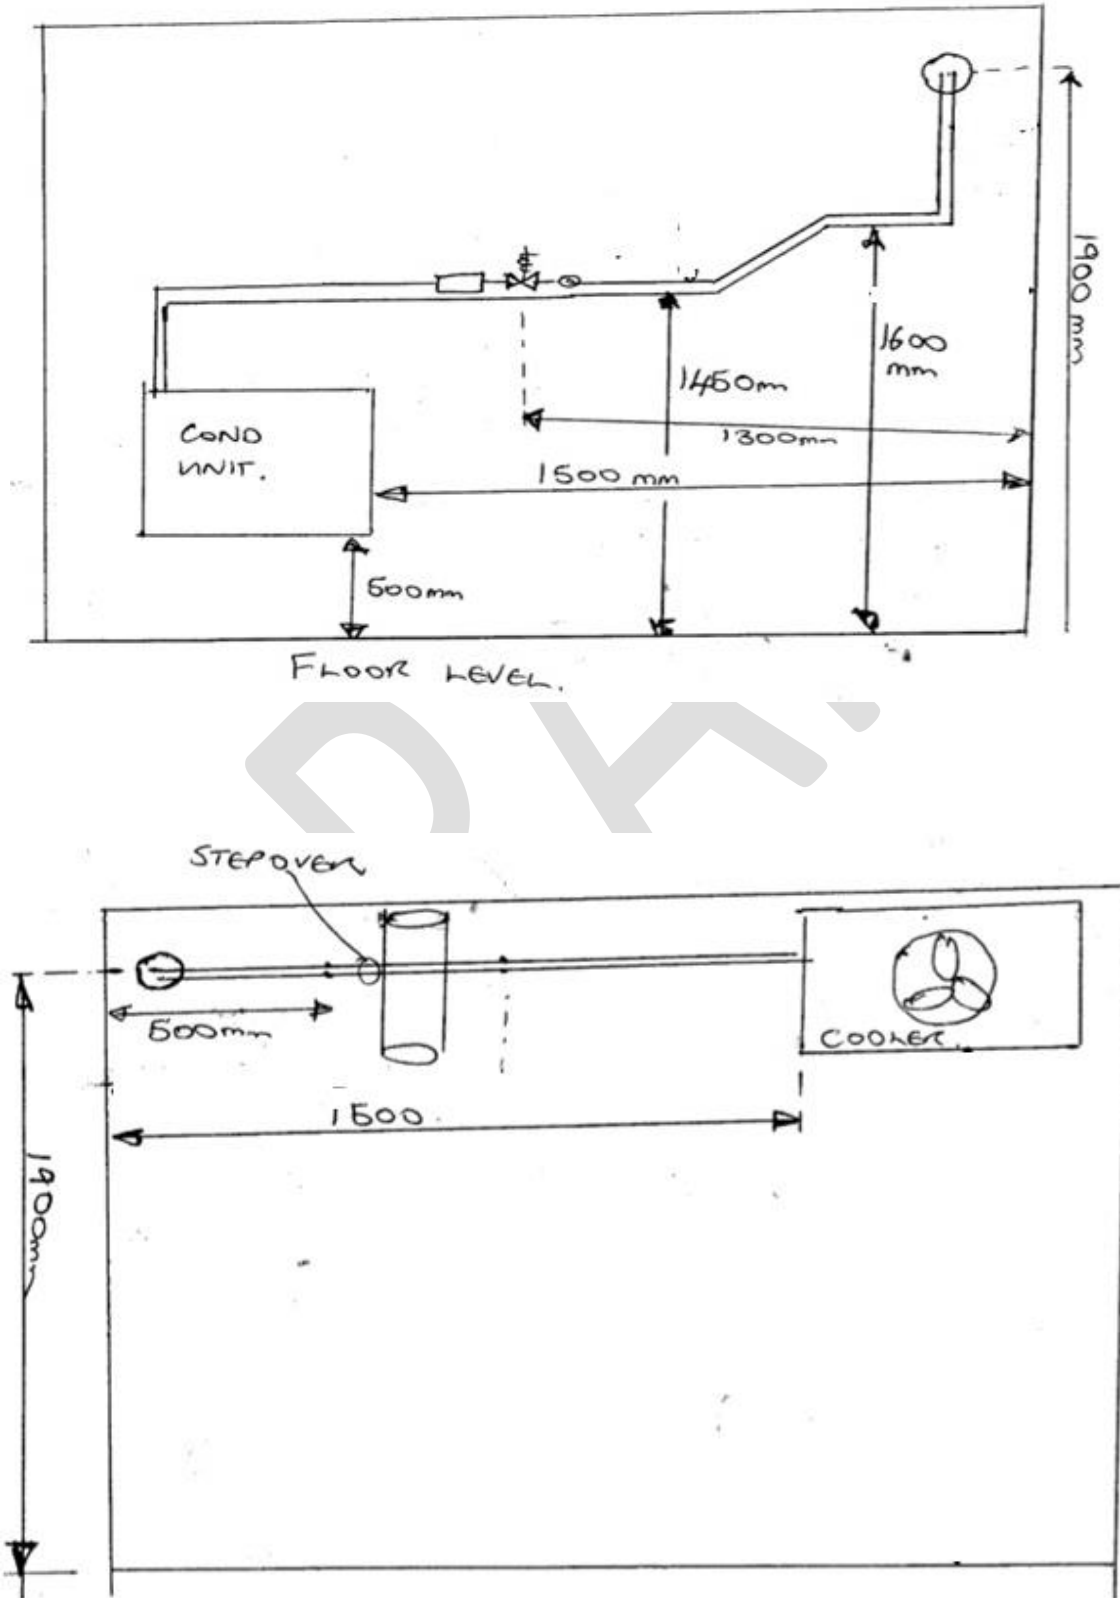
## Installation drawings

The candidate has demonstrated good knowledge and understanding through the completion of the drawing considering all the aspects of the design brief. They have correctly identified all the components and made a good attempt to draw pipe layout and pipe sizes.

The completed drawing does have minor inaccuracies. Some dimensions are missing, and the distance of the pipe clips are not clearly displayed but overall drawing is understandable and well presented.

Terminology is not always accurate such as the term cooler which should be labelled as evaporator. The lack of the consistent datum to measure from will mean that the candidate may have to make some adjustments to the installation whilst it is in progress, due to the inconsistencies introduced in the layout.

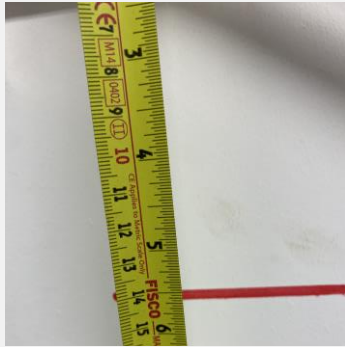
Photo: 1

**(Photograph 1)** The offset conforming to the 150mm dimension. – demonstrates that the candidate can bend pipe accurately to a tolerance +/- 5mm.

- Photograph of the offset conforming to the 150mm dimension. – demonstrates that the candidate can bend pipe accurately to a tolerance. **(photograph 1)**

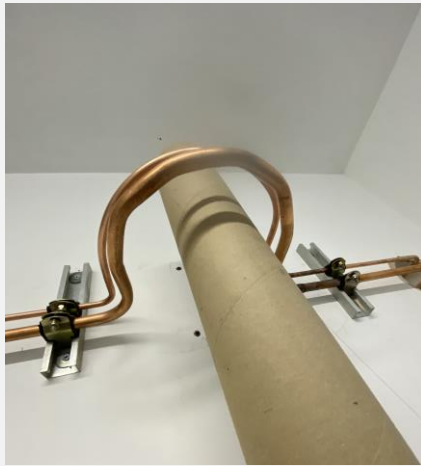
Photo:2

**(Photograph 2)** Demonstrates the candidate's pipework skills forming bend around the soil pipe. The photo demonstrates how the pipework visibly varies in distance from the soil pipe.

- Photograph showing the offset around the soil pipe obstruction – demonstrates the candidate's pipework skills forming bend around the soil pipe. The photo demonstrates how the pipework visibly varies in distance from the soil pipe. **(photograph 2)**

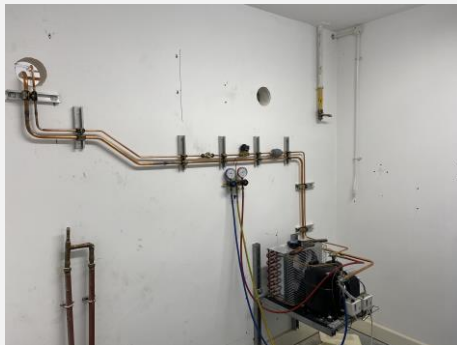
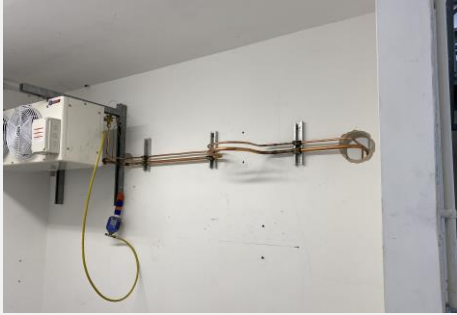
Photo: 3

**(Photograph 3 and 4)** Installed components where the condensing unit and evaporator match the installation drawing. These photos demonstrate the candidate's ability to install components to a +/- 5mm tolerance. This demonstrates the aesthetics of the completed installation.

- Photograph of installed components where the condensing and cooling unit match the installation drawing. This photo demonstrates the candidate's ability to install components to a +/- 5mm tolerance. **(photograph 3 and 4)**

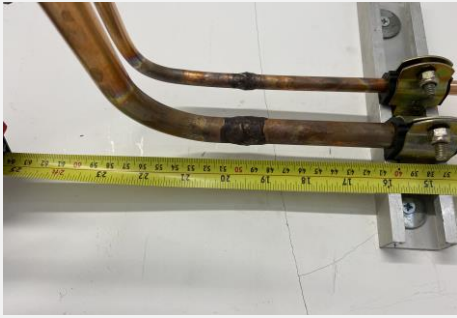
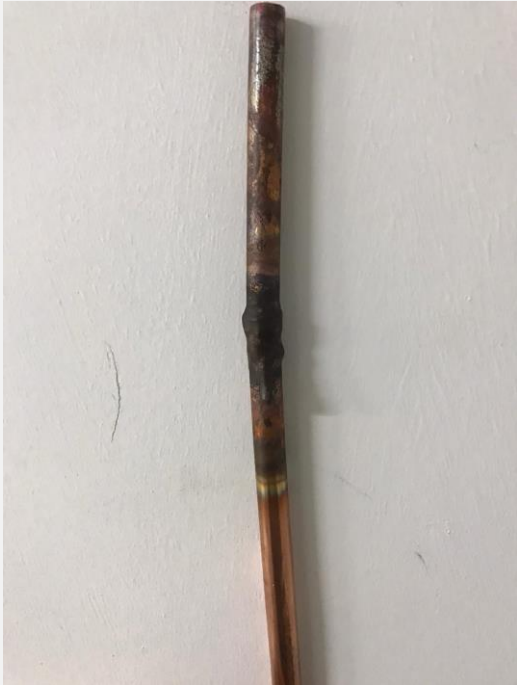
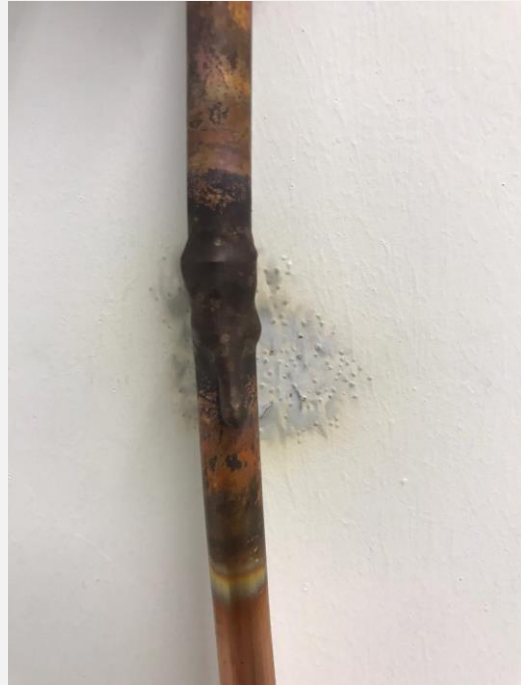
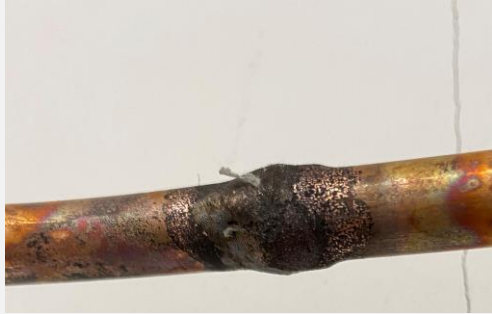
Photo:5

**(Photograph 5,6,7,8)** Demonstrates how well the joint is finished. These photographs in the main, demonstrate excessive solder in and around the joint and scorch marks are present on the wall surfaces.

- Four to six photographs of each brazed joint – Demonstrates how well the joint is finished. This photo demonstrates some excessive solder and scorch marks on the wall surfaces. **(photograph 5,6,7,8)**

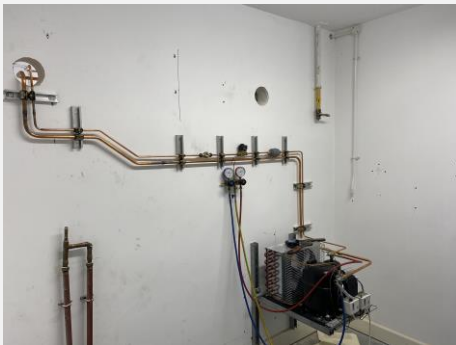
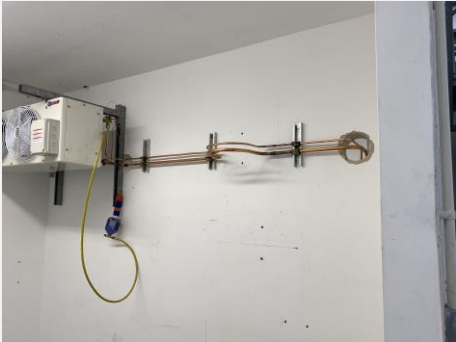
**Photo:9**

**(Photograph 9 & 10)**

Two photos one each side of the wall showing finished pipework (without insulation). This demonstrates the aesthetics of the completed installation. There are visible signs of pipework damage. Pipe are runs not perfectly vertical or horizontal and pipe bends are visibly poorly executed.

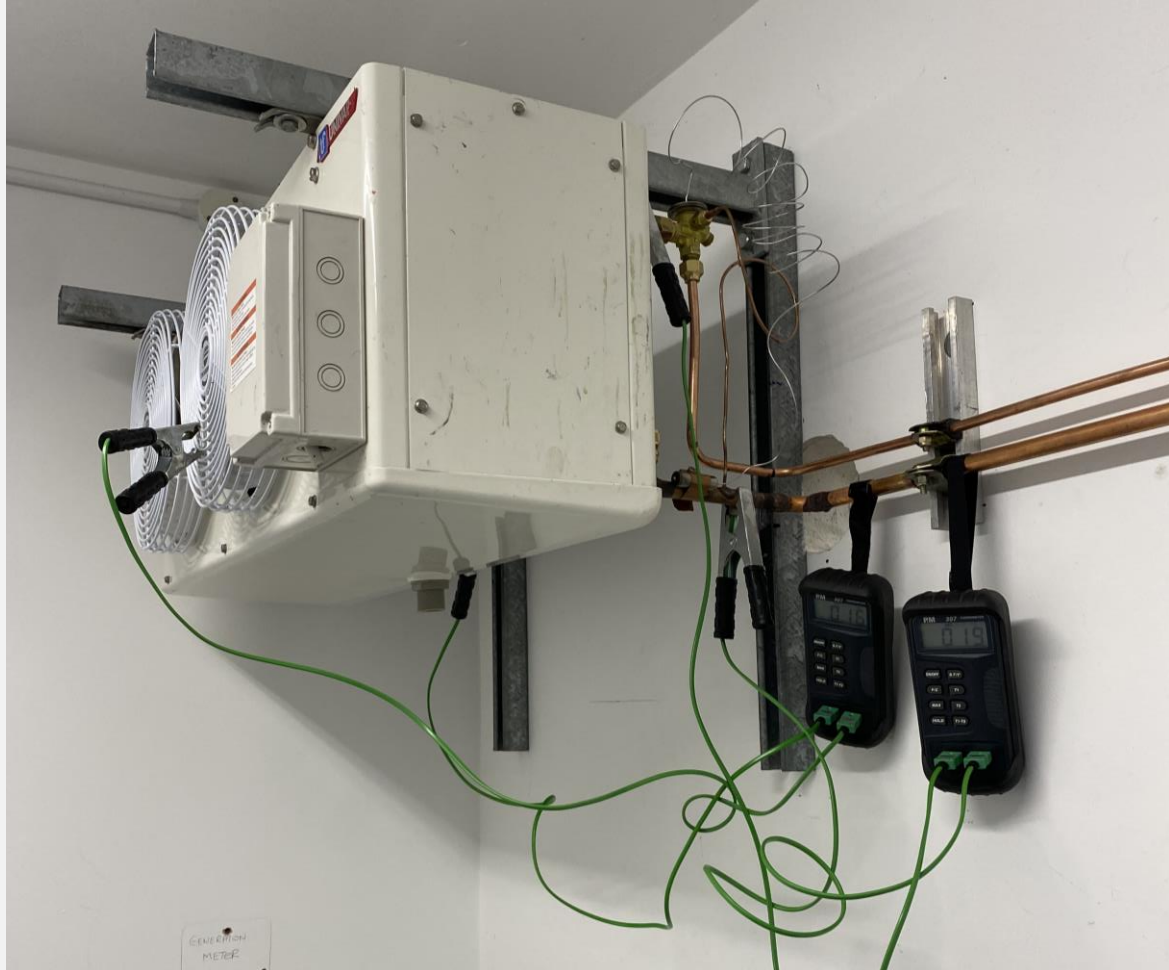
Photo:13

**(Photograph 13)** pipework leading up to and including the evaporator. Temperature probes and instrument incorrectly installed and showing unacceptable readings.
