# **T Level Technical Qualification in Building Services Engineering for Construction - Gas Engineering**

## **Centre Standardisation Materials**

Gas engineering (8710-34) (354)

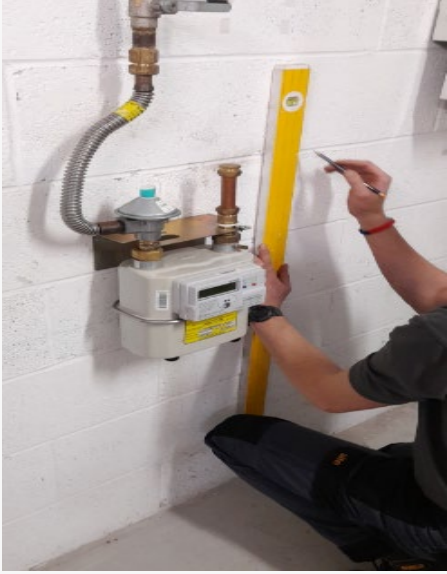
Evidence description	Photo
<p><b>Photograph 1</b></p> <p>Candidate marking out a work area using a spirit level to provide a straight and vertical line on the first attempt.</p>

A person is kneeling on a light-colored floor, using a yellow spirit level to mark a vertical line on a white wall. The wall has a gas meter and associated pipes. The person is holding the spirit level vertically against the wall and using a pen to mark a line. The spirit level shows a bubble in the center, indicating it is perfectly vertical.
<p><b>Photograph 2</b></p> <p>Work area shows accurate and clear marking out on work surface.</p>

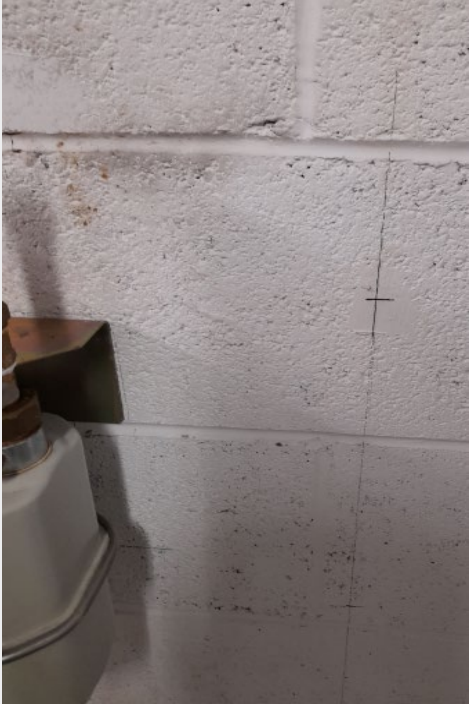
A close-up view of the white wall showing a clear, straight vertical line marked with a pen. The line is perfectly vertical and extends from the floor to the top of the frame. The wall has a slightly textured appearance.

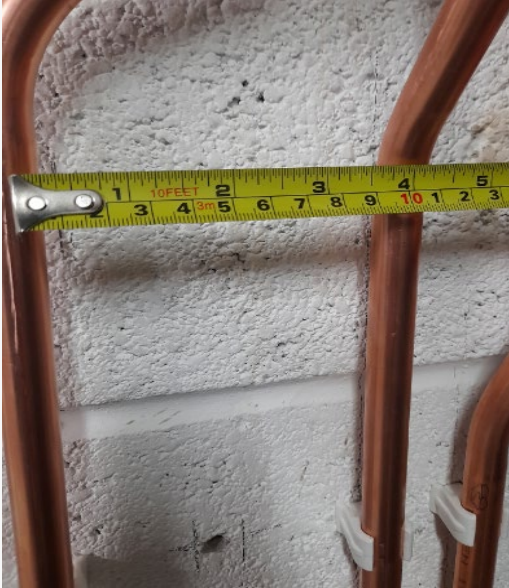
Evidence description	Photo
<p><b>Photograph 3</b></p> <p>Photograph 3 and 4, two photos, one each of each installation showing finished pipework and component positioning which demonstrates the aesthetics of the completed installation.</p> <p>Tolerances of (+/-2mm) have been met during the installation of pipework.</p>

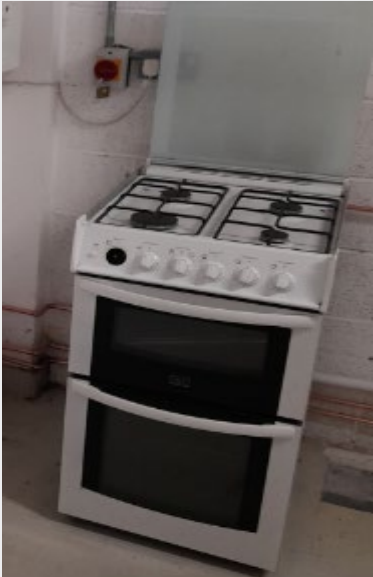
<p><b>Photograph 4</b></p> <p>Finished installation of the gas cooker and pipework meet all tolerances/standards.</p> <p>Overall aesthetics of the installation have been met.</p>

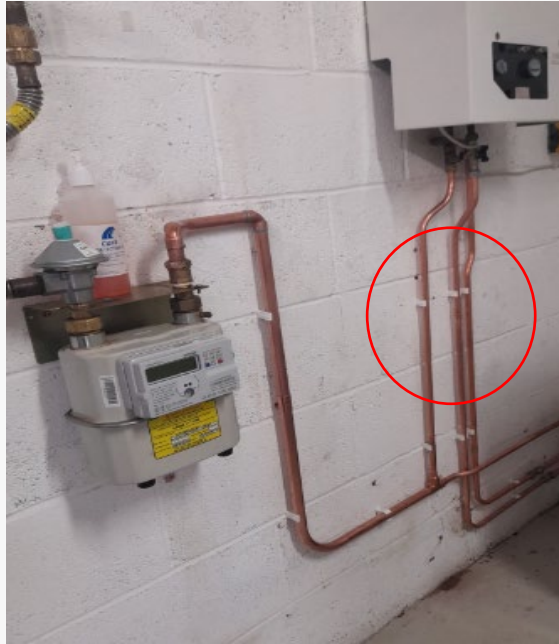
**Photograph 5**

Finished installation of the water heater and pipework meet all tolerances/standards.

Overall aesthetics of the installation have been met.

Copper pipework installation.

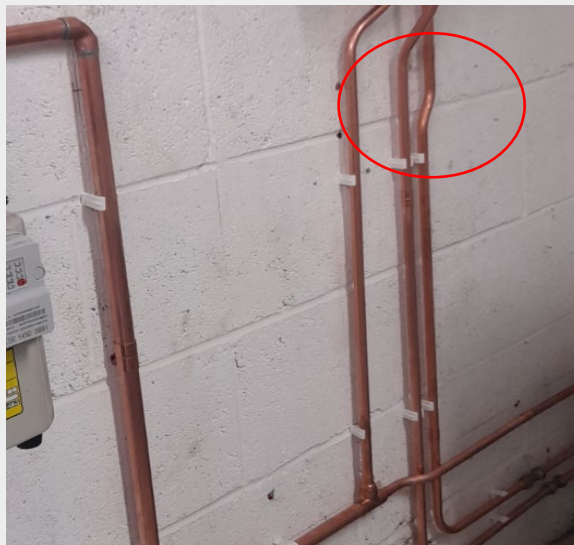
**Photograph 6**

Pipework installed to the required tolerance (+/-2mm). Bends have been completed to a high standard with no signs of throating or rippling.

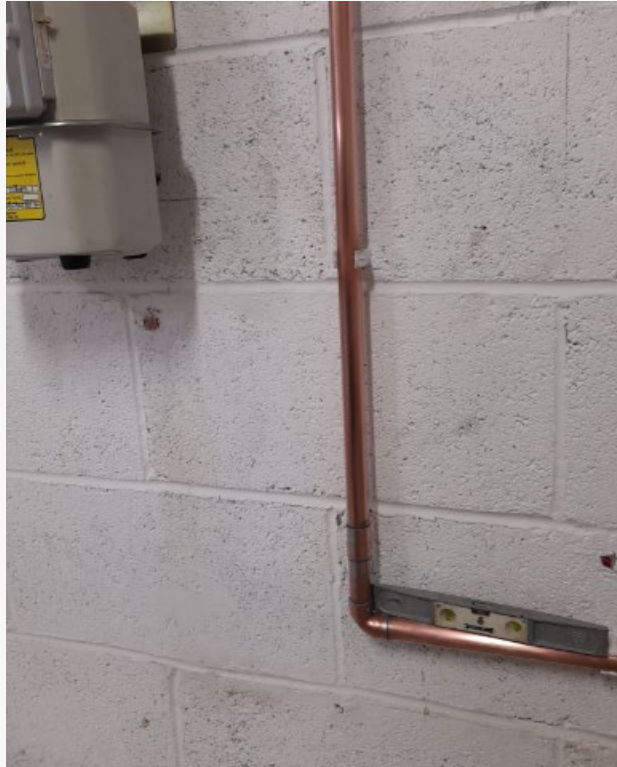
**Photograph 7**

Pipework level

Pipework level and within tolerance. (+/-2mm)

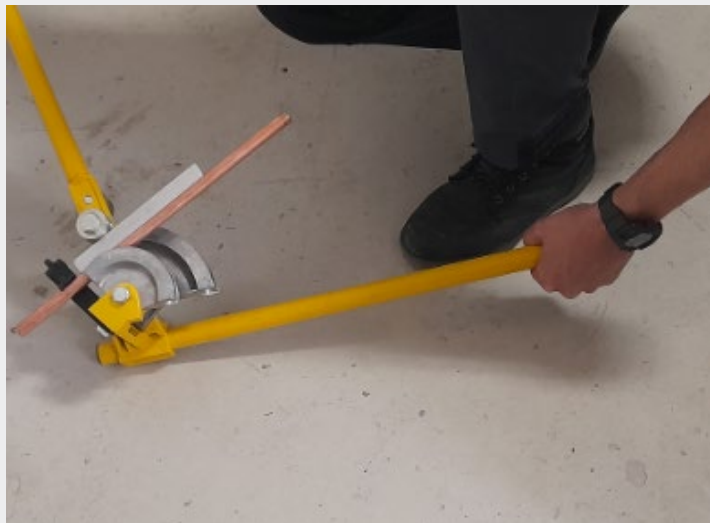
**Photograph 8**

Fabricated bend with appropriate clearance.

Use of tools (bending and cutting equipment) and piping skills.

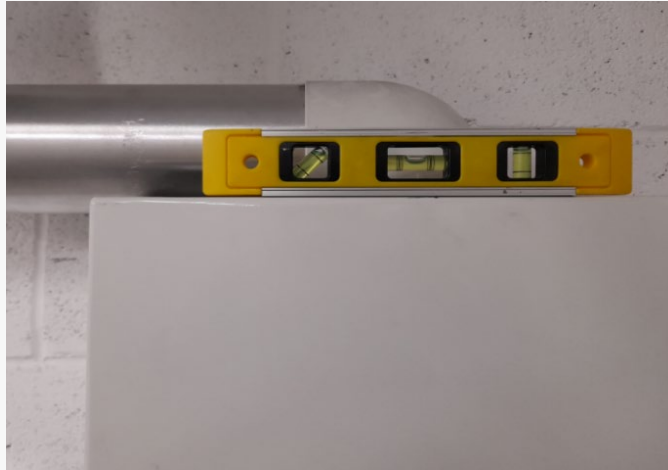
### Photograph 9

Tolerances have been met for the installation of the gas cooker and water heater.

Tolerances of (+/-2mm) have been met for the installation of the WHB.

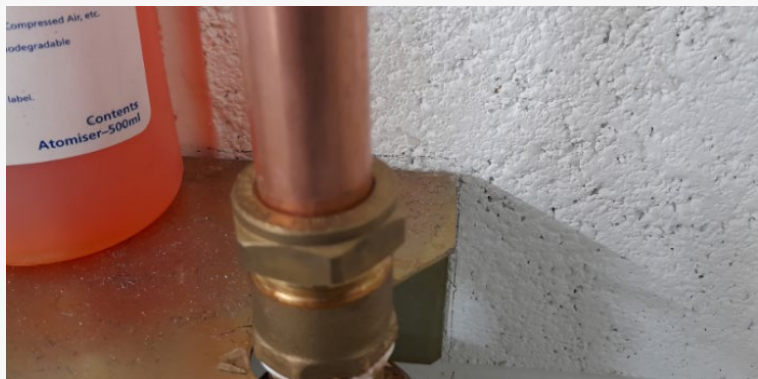
### Photograph 11

Results of tool usage.

Component fitted correctly with no signs of tool marks from installation.

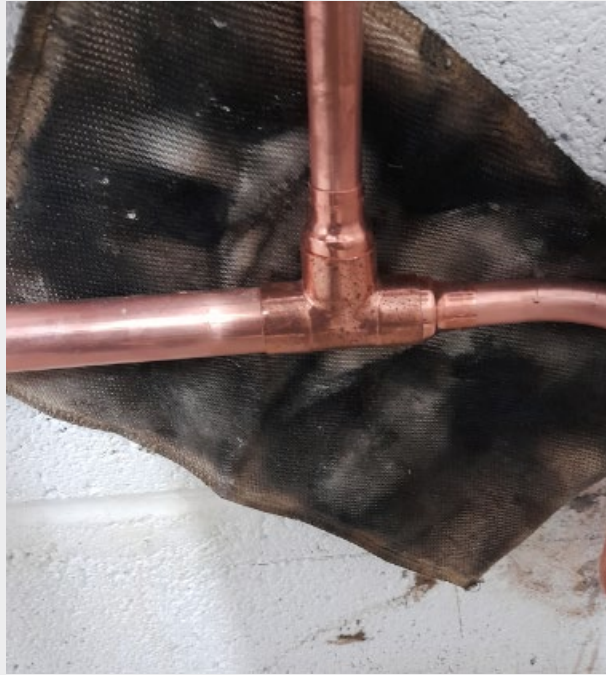
### Photograph 12

Soldering/soldered fittings to show that heat mats have been used and no burn/scorch marks to the wall/or burn marks to the wall to support the assessors making of the jointing process.

Correct use of blow lamp, safe soldering, correct selection of solder, protection of customer property with heat mat centrally positioned. Removal of vulnerable heat sensitive components before soldering commences.

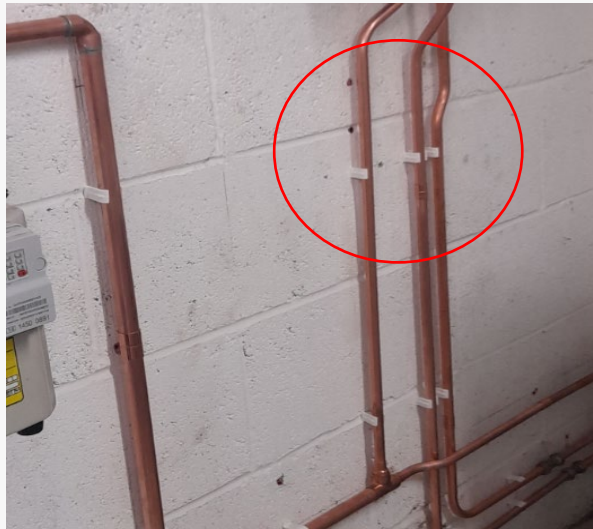
### Photograph 13

Use/type of clips.

Pipework level and adequately clipped with appropriate spacing.

Pipework fabricated without the use of additional fittings.

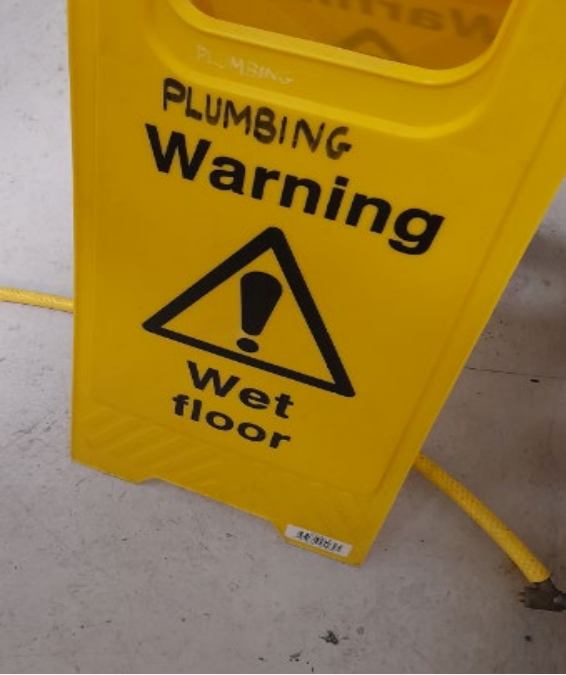
Evidence description	Photo
<p><b>Photograph 14</b></p> <p>Preparation for draining down: correct equipment and drain point used to drain down system pipework for decommissioning activities.</p>

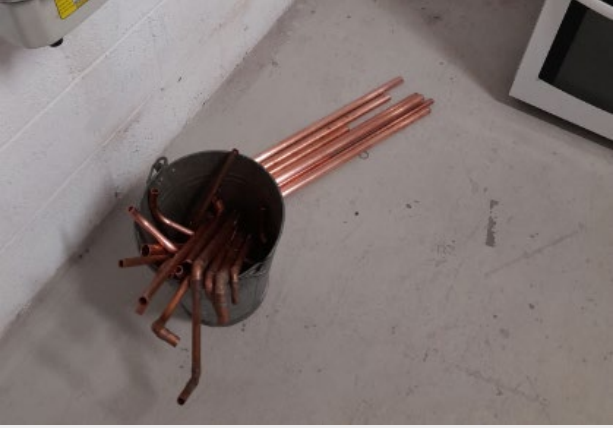
A yellow plastic warning sign stands on a light-colored concrete floor. The sign features the word 'PLUMBING' at the top, a large 'Warning' in the middle, a black triangle with a white exclamation mark below it, and the words 'Wet floor' at the bottom. A yellow hose is visible on the floor behind the sign.
<p><b>Photograph 15</b></p> <p>Decommissioning of pipework and components for the system installation.</p> <p>Pipework decommissioned correctly with consideration of recycling and reuse.</p> <p>Separation of clean/dirty copper.</p>

A black bucket sits on a concrete floor, filled with several long, straight copper pipes. The pipes are arranged in a somewhat haphazard manner, with some protruding from the top of the bucket. The background shows a plain wall and a portion of a white object.

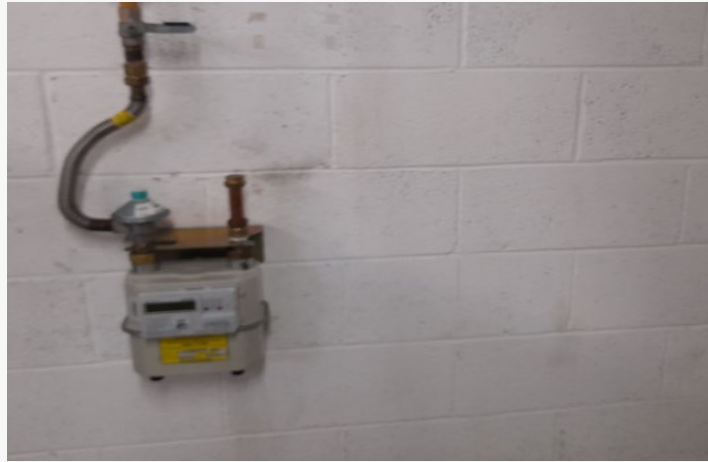
No holes and marks evident following decommissioning of pipework and surface preparation.

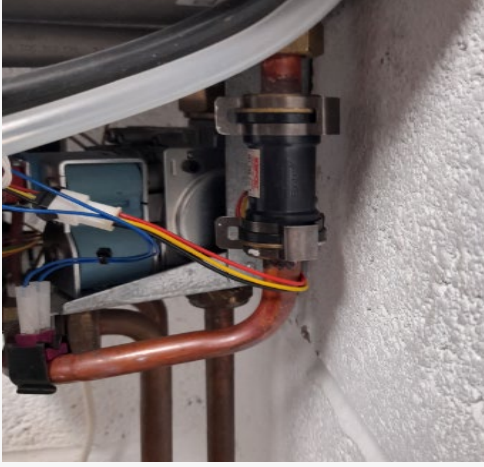
Evidence description	Photo
<p><b>Photograph 17</b></p> <p>Results of tool usage.</p> <p>Component fitted correctly with no signs of tool marks from installation of the replacement component.</p>

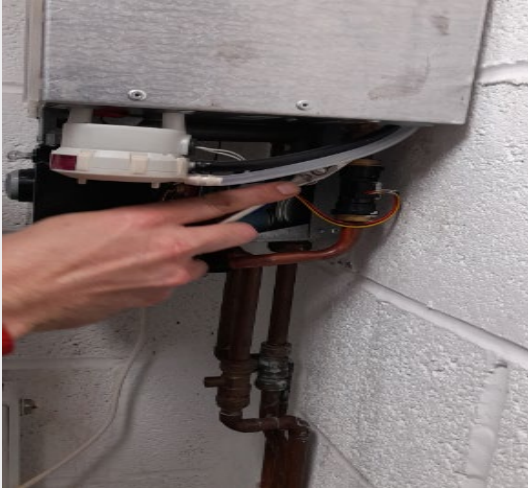
<p><b>Photograph 18</b></p> <p>Sequence of photos which show the replacing and removal of the faulty component, and reinstallation of the new component.</p> <p>Loosening of faulty component with correct tool.</p>

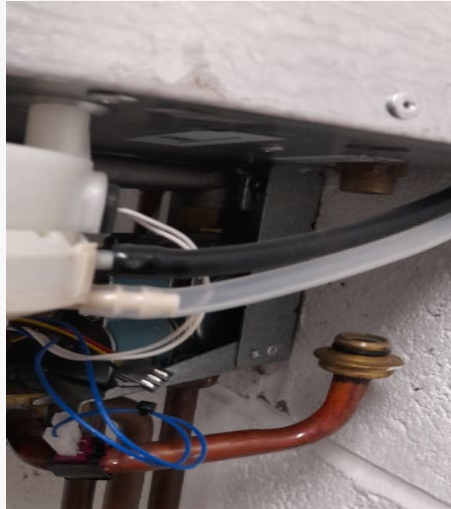
**Photograph 19**

Removal of faulty component.

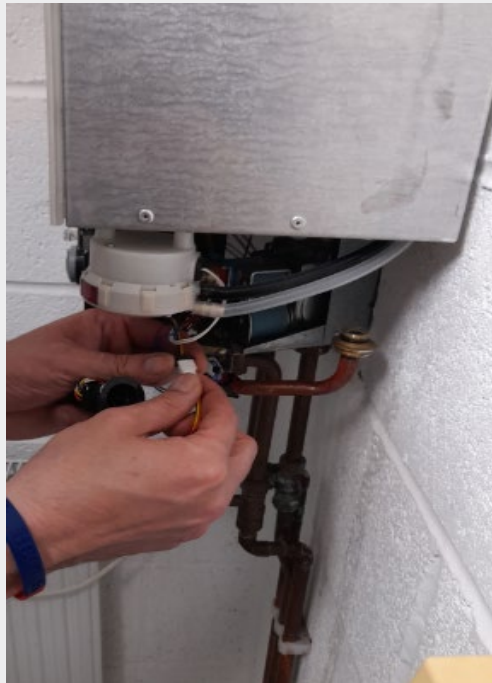
**Photograph 20**

Replacement of component.

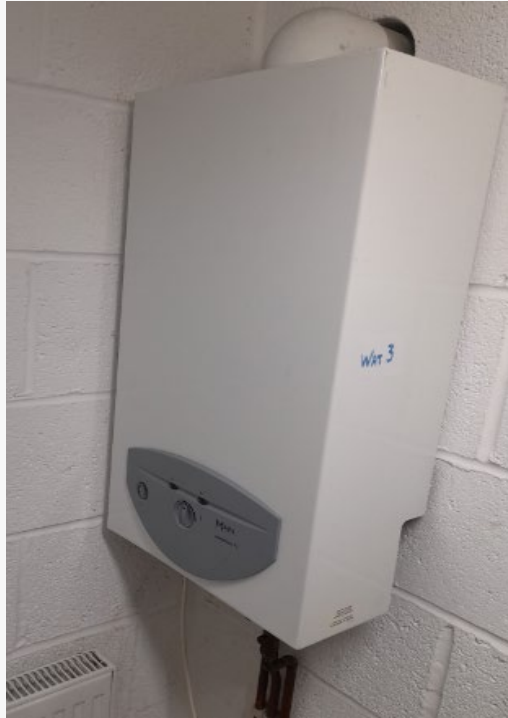
**Photograph 21**

System on completion of all works.

Repair completed and work area left tidy.

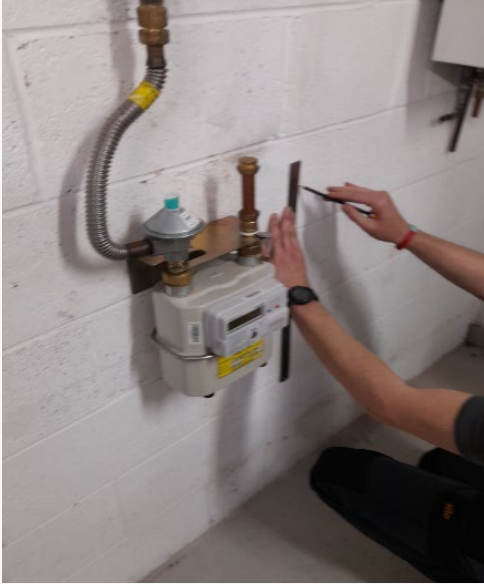
Evidence description	Photo
<p><b>Photograph 1</b></p> <p>Candidate marking out a work area using a straight edge that is not the approved method.</p>

A photograph showing a person kneeling on the floor, using a long, thin straight edge to mark a wall. The wall is white and has a gas meter and associated pipes. The person is holding the straight edge against the wall and appears to be marking it with a pencil or marker.
<p><b>Photograph 2</b></p> <p>Work area shows multiple marks on work surface from marking out due to initial inaccurate measuring and marking out.</p>

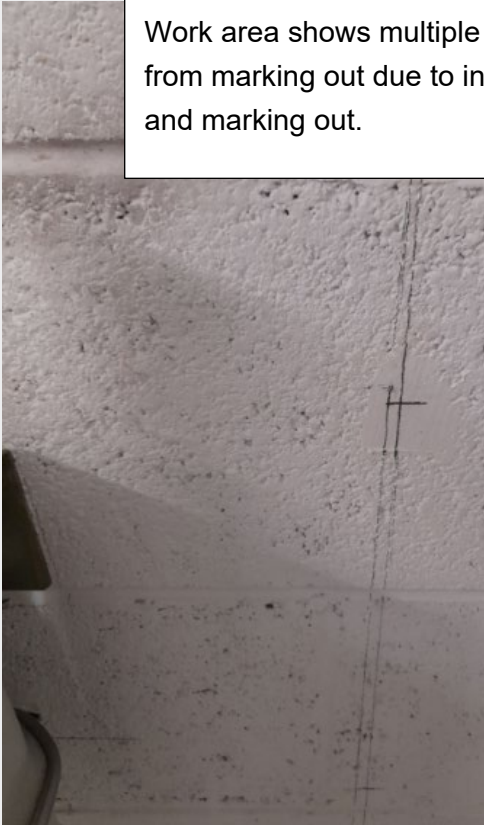
A close-up photograph of a white wall. The wall has several vertical and horizontal marks, including a prominent vertical line and several shorter horizontal lines, indicating multiple attempts at marking out. A text box is overlaid on the image, stating: "Work area shows multiple marks on work surface from marking out due to initial inaccurate measuring and marking out." data-bbox="471 501 931 586"/>

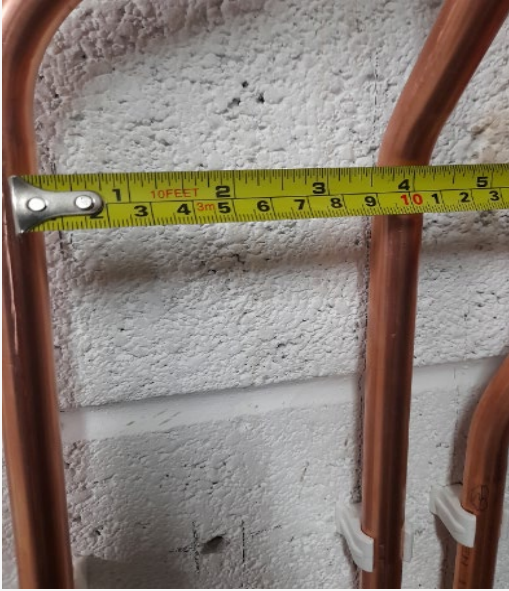
Evidence description	Photo
<p><b>Photograph 3</b></p> <p>Photograph 3 and 4, two photos, one each of each installation showing finished pipework and component positioning which demonstrates the aesthetics of the completed installation. Visible signs of pipework damage that are not straight or horizontal/vertical and bends that are not properly formed. None of which stops the system operating correctly.</p> <p>Tolerances (+/-5mm) have been met during the installation of pipework.</p>

<p>A close-up photograph of copper pipework installed against a white textured wall. A yellow measuring tape is stretched horizontally across the pipes, showing measurements in both feet and centimeters. The pipes are supported by white plastic clips.</p>
<p><b>Photograph 4</b></p> <p>Finished installation of the gas cooker and associated pipework.</p> <p>Overall aesthetics of the installation have been met.</p>

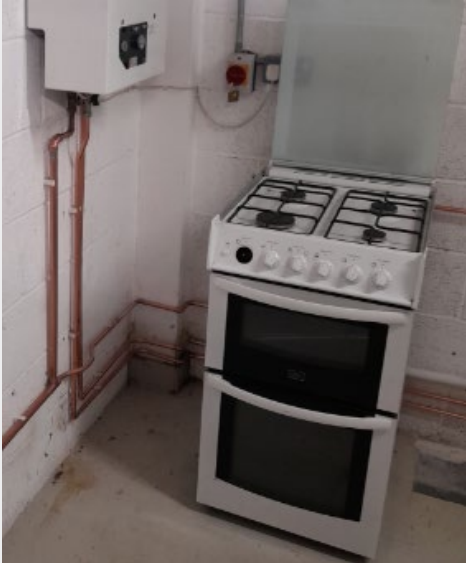
<p>A photograph of a white gas cooker with four burners and an oven, installed in a kitchen. Copper pipework is visible on the wall behind the cooker, connected to a gas control box and a gas valve. The installation is clean and professional.</p>

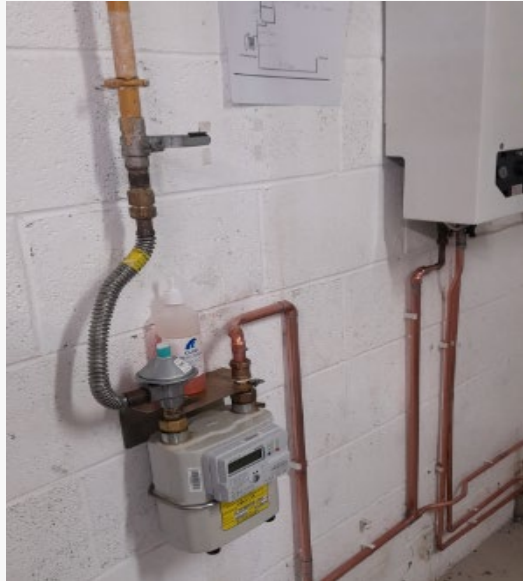
**Photograph 5**

Finished installation of the water heater and associated pipework.

Overall aesthetics of the installation have been met.

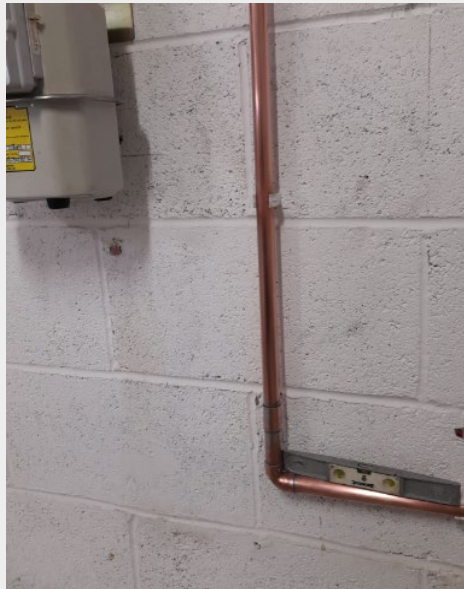
**Photograph 6**

Pipework not level but within tolerance.

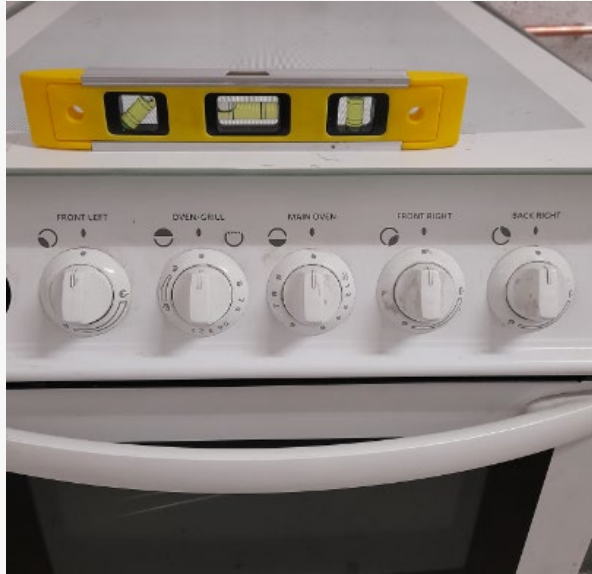
**Photograph 7**

Components correctly installed but not level.

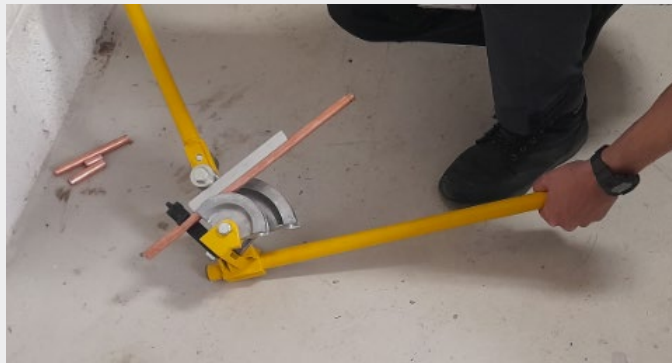
**Photograph 8**

The correct operation/use of pipe bend machine and pipe cutting tools.

Use of tools (bending and cutting equipment) and piping skills. Photos may show pipework cut offs.

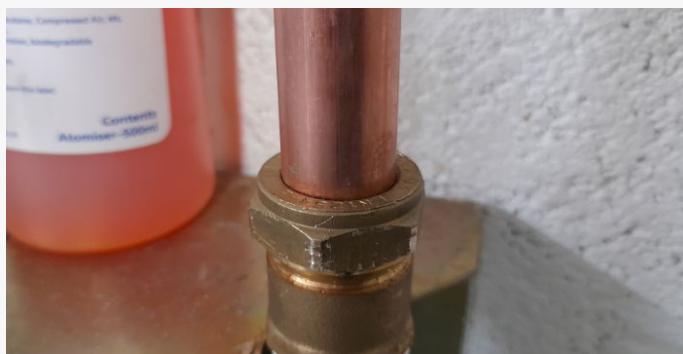
**Photograph 9**

Results of tool usage.

Component fitted correctly with signs of tool marks from installation.

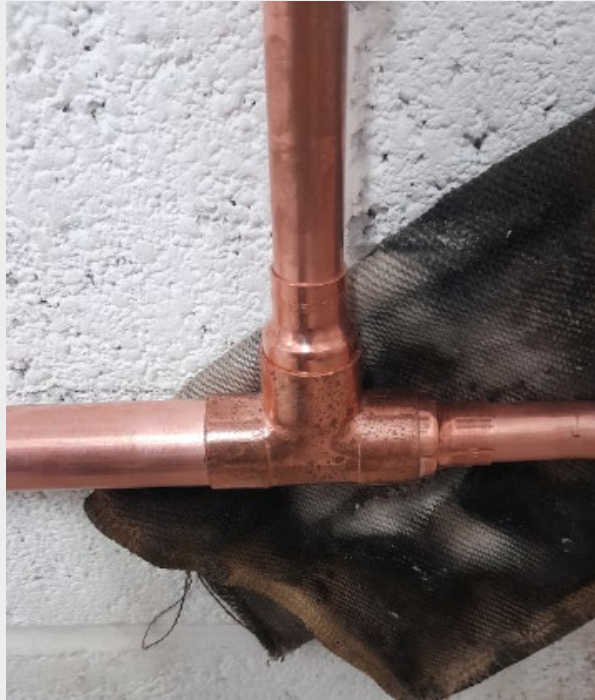
### Photograph 10

Soldering/soldered fittings to show that heat mats have been used and no burn/scorch marks to the wall/or burn marks to the wall to support the assessors making of the jointing process.

Correct use of blow lamp, safe soldering, correct selection of solder and protection of customer property although heat mat not centrally positioned.

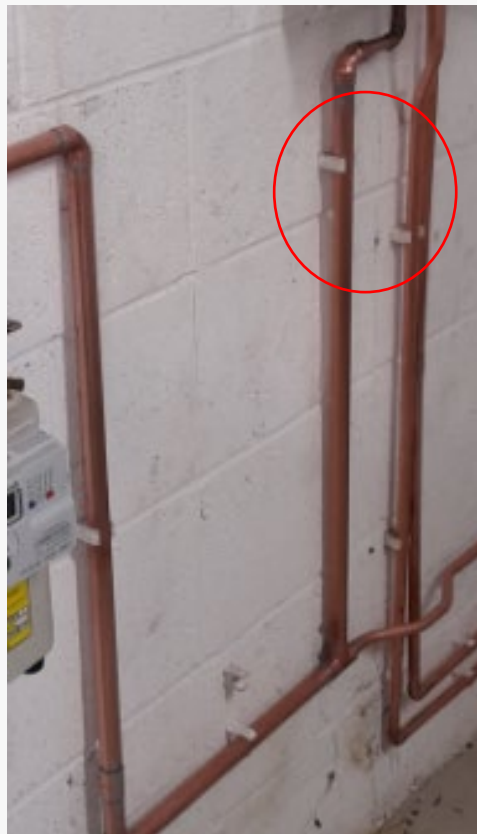
### Photograph 11

Use/type of clips. Photos may show clips that are not equally spaced or installed in line.

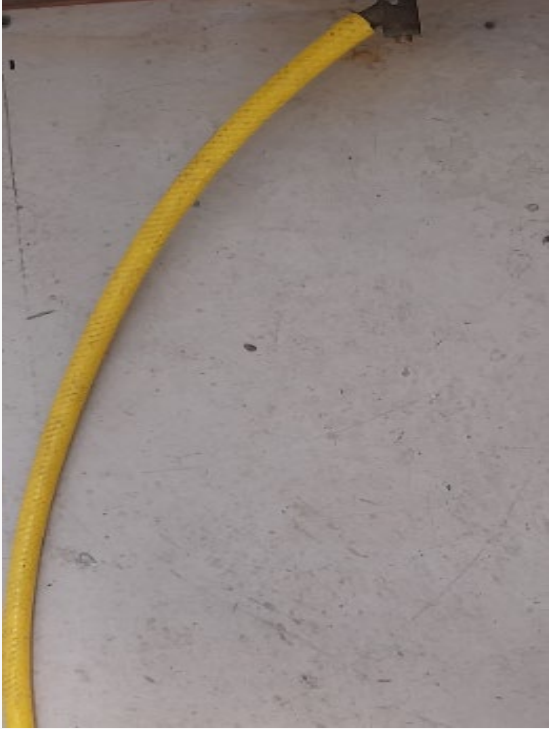
Evidence description	Photo
<p><b>Photograph 14</b></p> <p>Preparation for draining down: correct equipment and drain point used to drain down system pipework for decommissioning activities.</p>

A photograph showing a yellow flexible hose connected to a drain point on a wall. The hose is curved downwards, and the drain point is a metal fitting on the wall.
<p><b>Photograph 15</b></p> <p>Decommissioning of pipework and components for the system installation.</p> <p>Pipework decommissioned correctly with consideration of recycling and reuse.</p> <p>Separation of clean/dirty copper.</p>

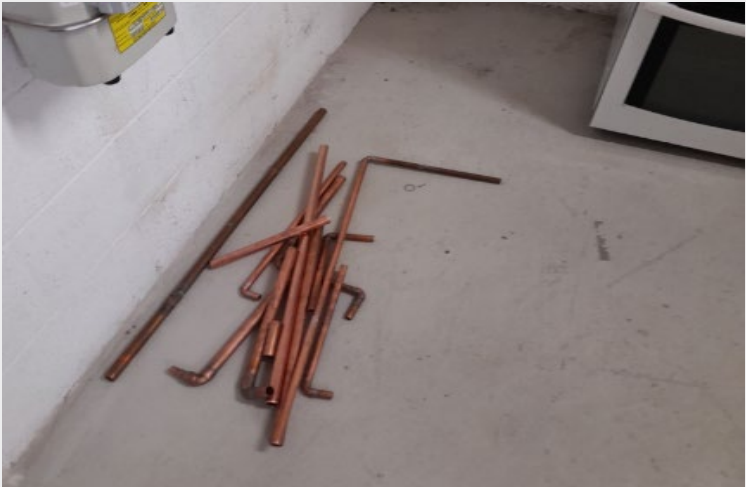
A photograph showing a pile of copper pipes and components on a floor. The pipes are of various lengths and are bundled together. A white electrical outlet is visible on the wall to the left.

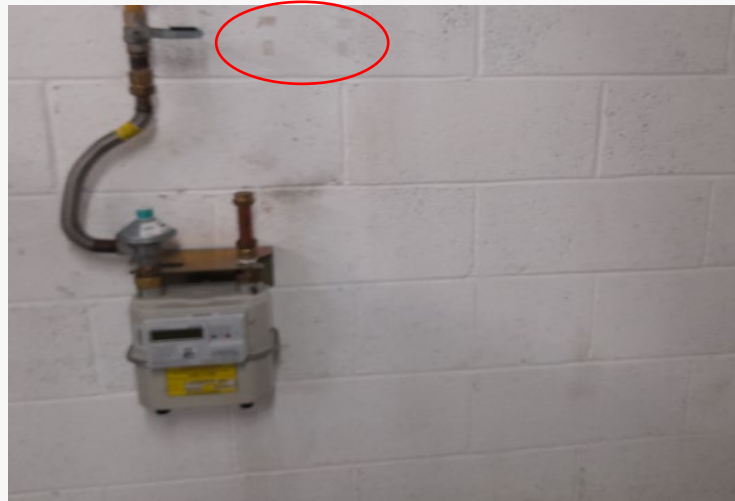
No holes and marks evident following decommissioning of pipework and surface preparation.

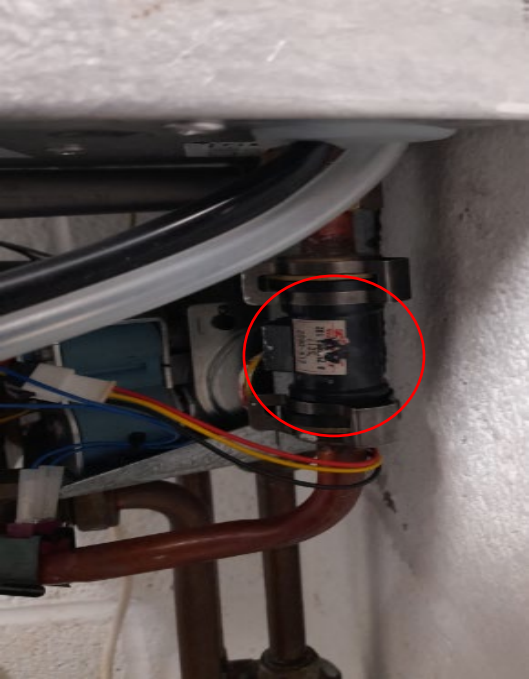
Evidence description	Photo
<p><b>Photograph 15</b></p> <p>Results of tool usage.</p> <p>Component fitted correctly with signs of tool marks from installation of replacement component.</p>

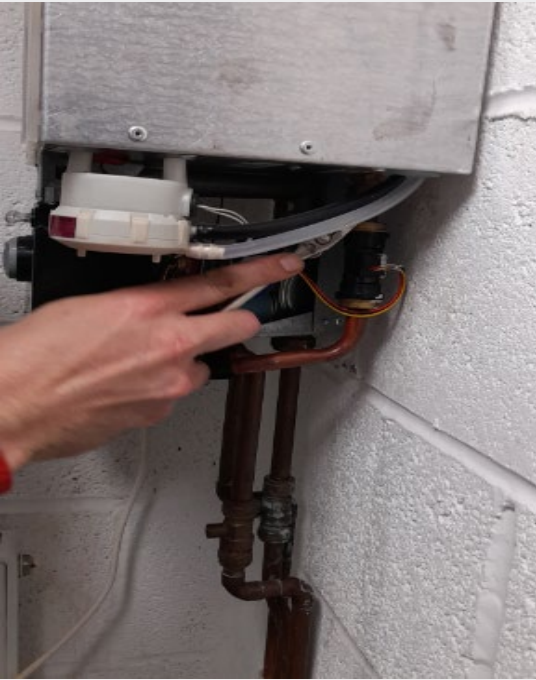
<p><b>Photograph 16</b></p> <p>Sequence of photos which show the replacing and removal of the faulty component, and reinstallation of the new component.</p> <p>Loosening of faulty component using the correct tool.</p>

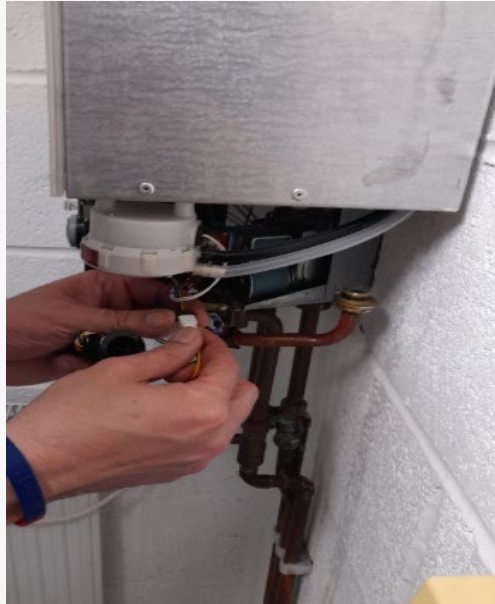
**Photograph 17**

Removal of faulty component.

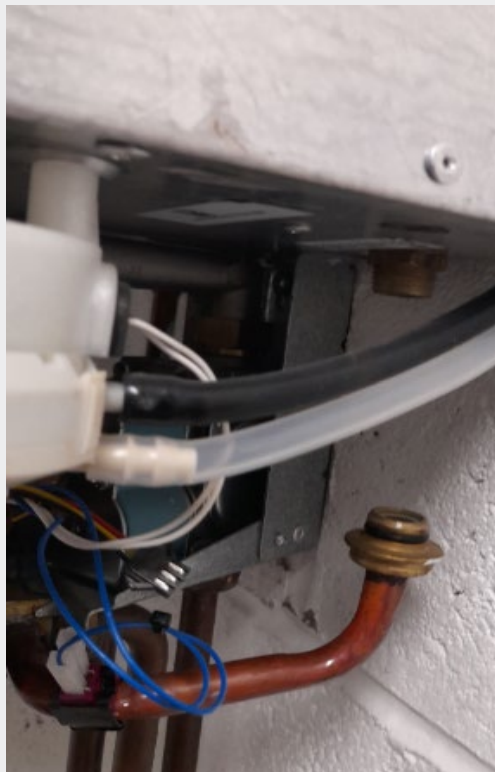
**Photograph 18**

Component removed during repair activity.

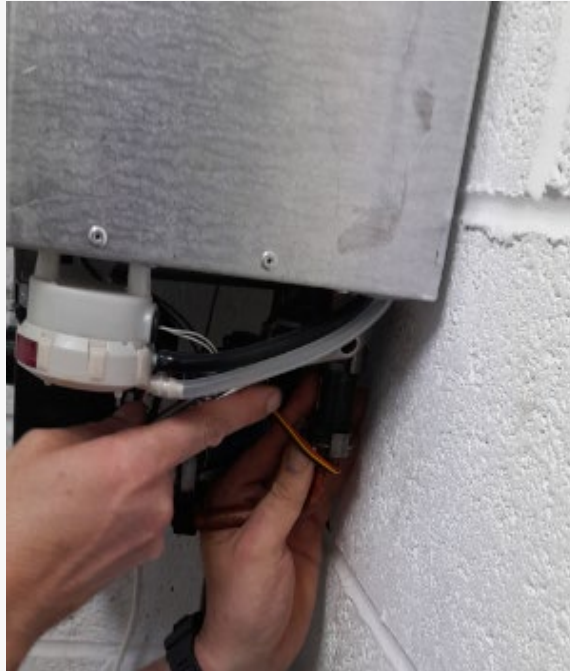
**Photograph 19**

Replacement of component.

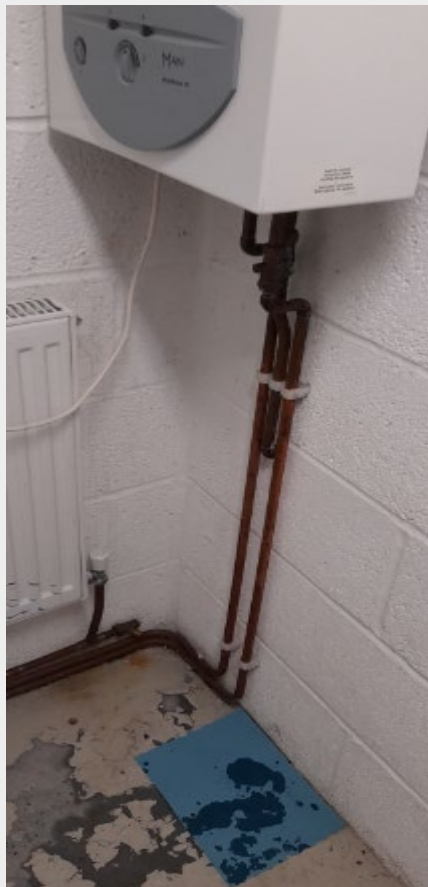
**Photograph 20**

System on completion of all works.

Repair completed with signs of leaks which have been repaired.
