T Level Technical Qualification in Building Services Engineering for Construction – Plumbing Engineering

Centre Standardisation Materials

Candidate A

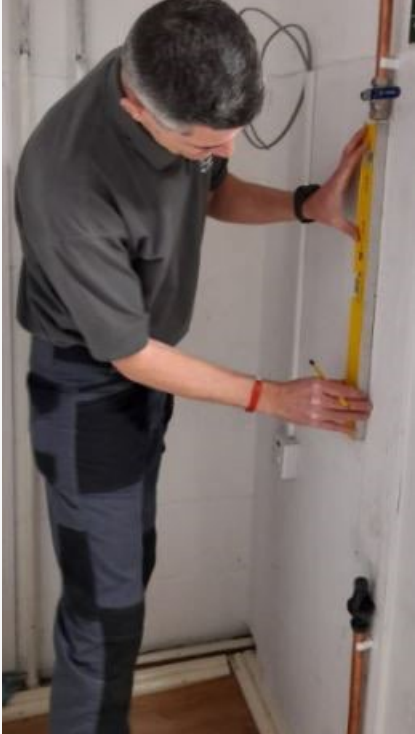
Evidence description	Photo
<p>Photograph 1</p> <p>Candidate marking out a work area using a spirit level to provide a straight and vertical line on the first attempt.</p>

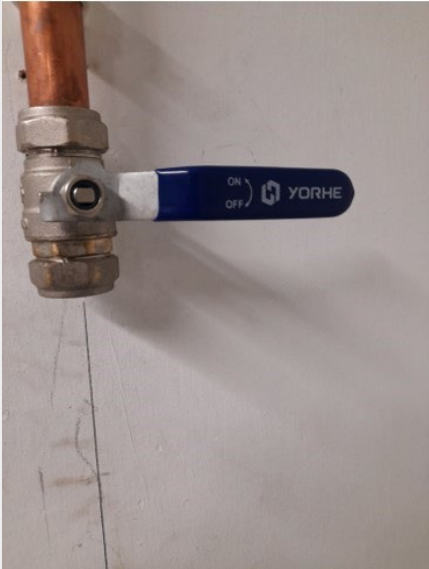
<p>Photograph 2</p> <p>Work area shows accurate and clear marking out on work surface.</p>

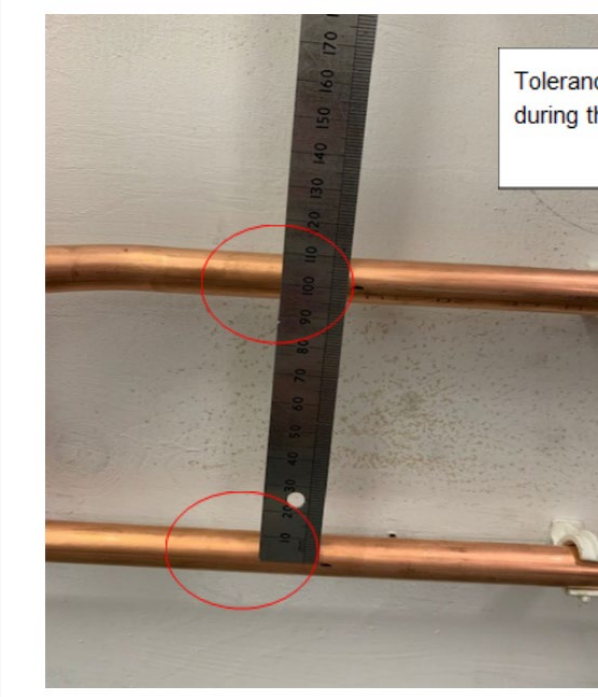
Evidence description	Photo
<p>Photograph 3</p> <p>Tolerance of (+/- 2mm) have been met during the installation of the pipework.</p>

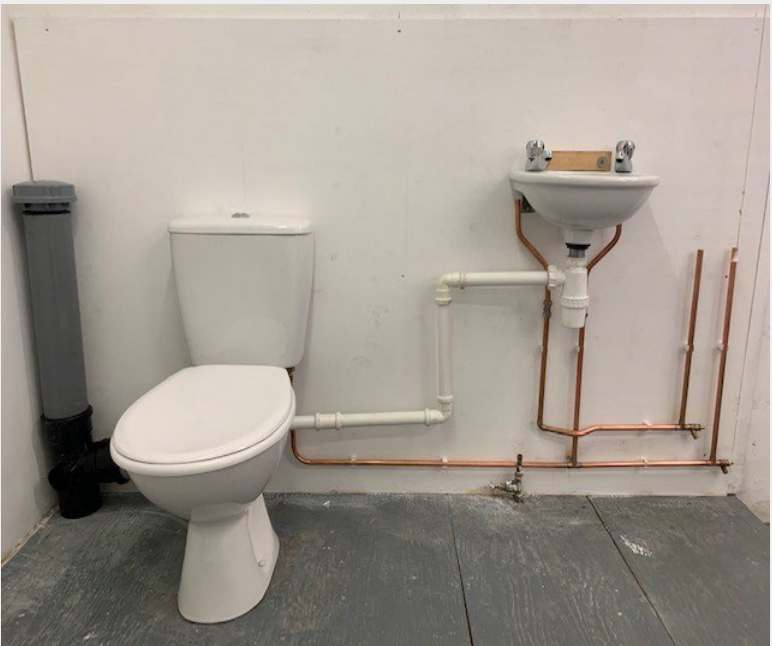
<p>Photograph 4</p> <p>Two photos, one each of each installation showing finished pipework and component positioning which demonstrates the aesthetics of the completed installation.</p> <p>Finished installation of the cloakroom including appliances and pipework to tolerances/standards.</p> <p>Overall aesthetics of the installation have been met.</p>

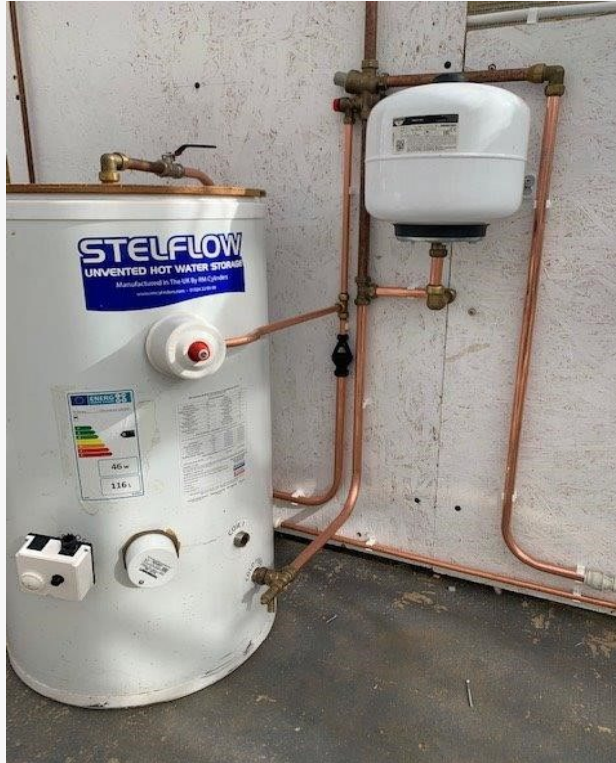
Photograph 5

Copper pipework installation

Finished installation of the unvented hot water cylinder and associated pipework including the installation of both functional and safety controls.

Overall aesthetics of the installation have been met.

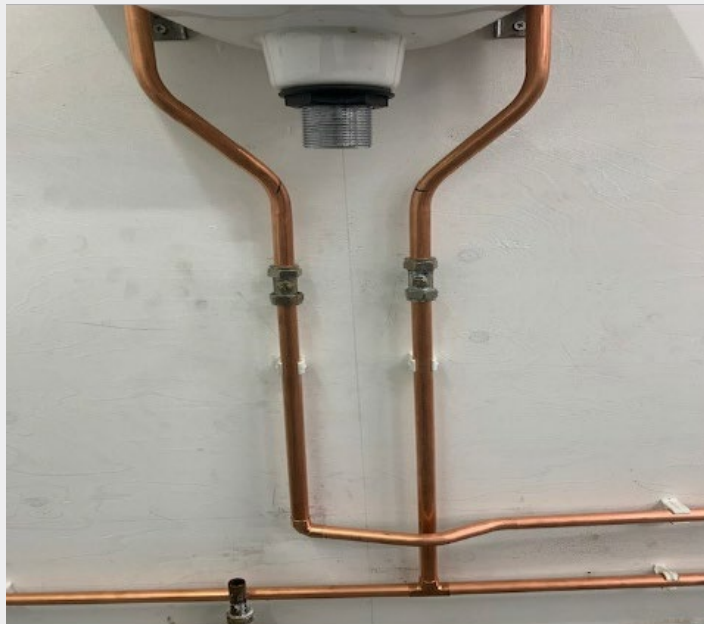
Photograph 6

Pipework installed to the required tolerance ($\pm 2\text{mm}$). Bends have been completed to a high standard with no signs of throating or rippling

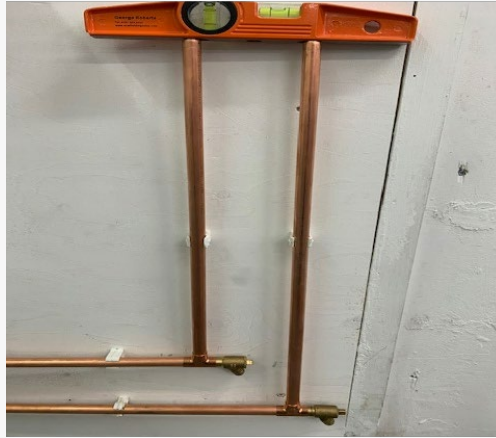
Photograph 7

Pipework level

Pipework level and within tolerance (+/-2mm)

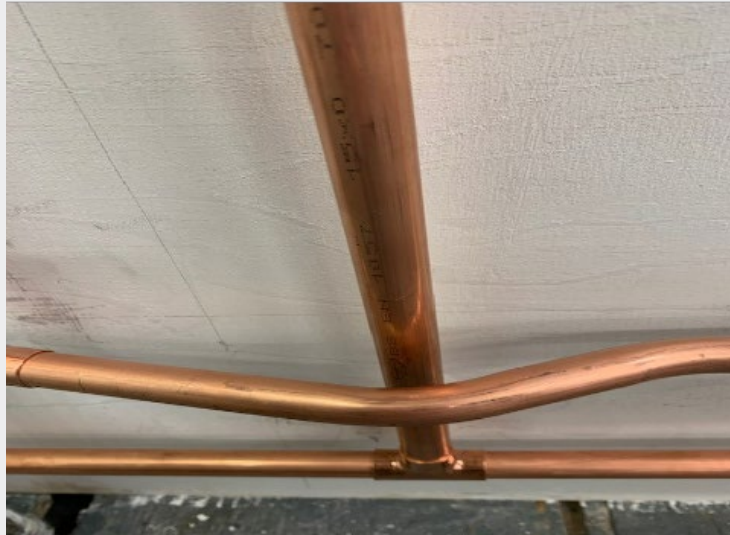
Photograph 8

Use of tools (bending and cutting equipment) and piping skills.

Fabricated Passover with appropriate clearance. no signs of throating or rippling

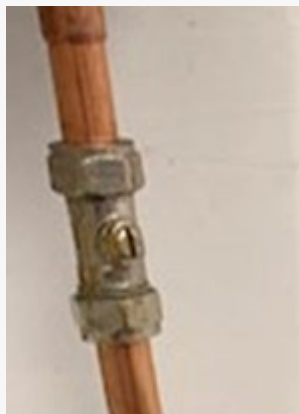
Photograph 9

Results of tool usage

Components fitted correctly with no signs of tool marks from installation.

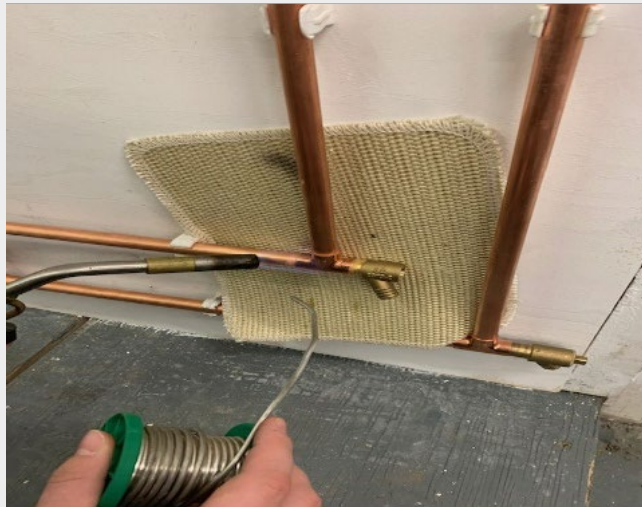
Photograph 10

Soldering/soldered fittings to show that heat mats have been used and no burn/scorch marks to the wall/or burn marks to the wall to support the assessors making of the jointing process

Correct use of blow lamp, safe soldering, correct selection of solder, protection of customer property with heat mat centrally positioned. Removal of venerable heat sensitive components before soldering commences.

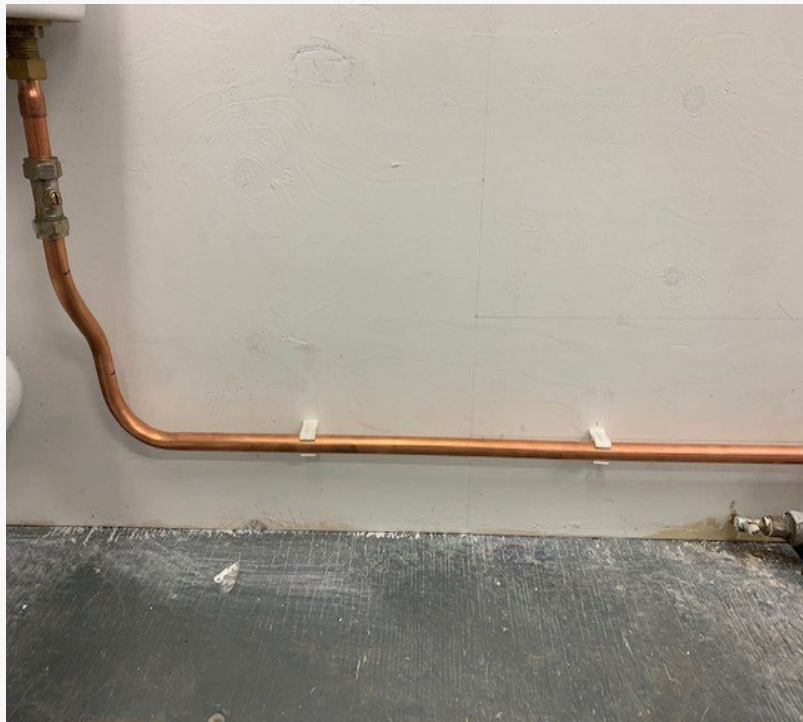
Photograph 11

Use/type of clips

Pipework level and adequately clipped with appropriate spacing. Pipework fabricated without use of additional fittings.

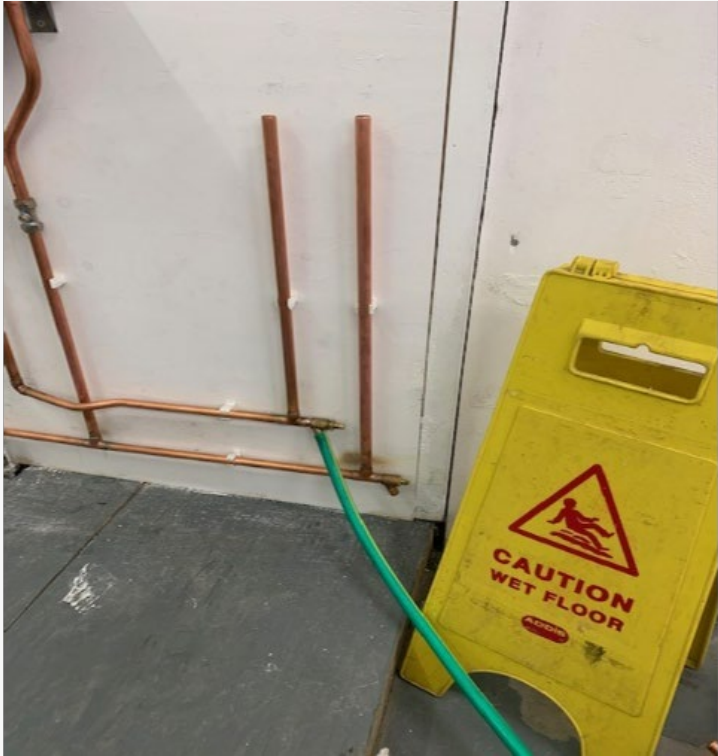
Evidence description	Photo
<p>Photograph 12</p> <p>The system being drained down safely and economically to the correct location.</p> <p>Preparation for draining down: correct equipment and drain point used to drain down system pipework for decommissioning activities.</p> <p>Use of correct signage.</p>

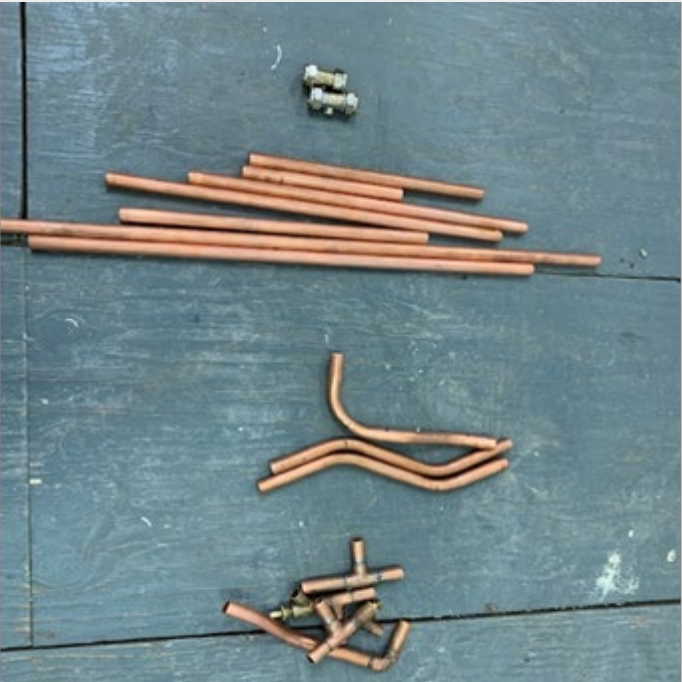
<p>Photograph 13</p> <p>Decommissioning of pipework and components for the system installation.</p> <p>Pipework decommissioned correctly with consideration of recycling and reuse.</p> <p>Separation of clean/dirty copper.</p>

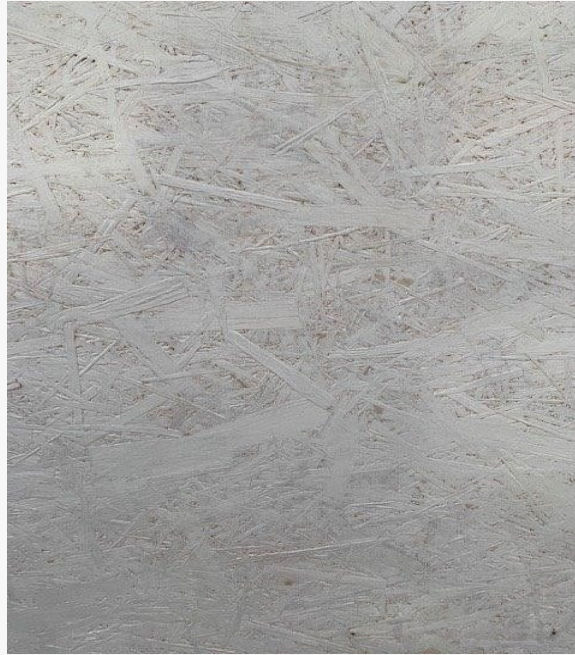
Photograph 14

The finish of the working area after decommissioning following filling and repainting of surfaces.

No holes and marks evident following decommissioning of pipework and surface preparation.

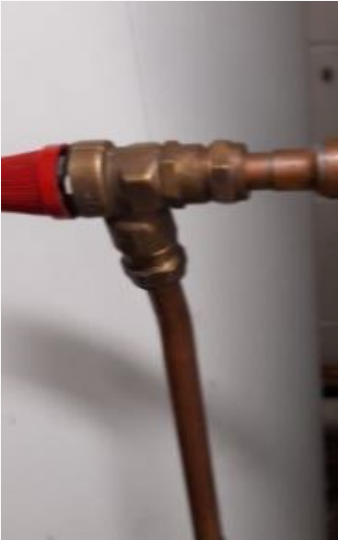
Evidence description	Photo
<p>Photograph 15</p> <p>Results of tool usage.</p> <p>Component fitted correctly with no signs of tool marks from installation of the replacement component.</p>

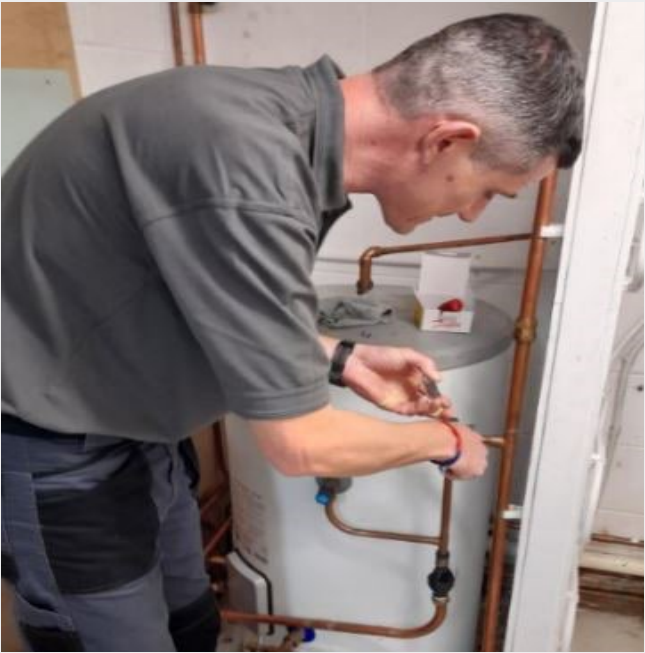
Photograph 17

A photograph of a plumber in a grey shirt and dark trousers working on a white water heater. The plumber is leaning over the water heater, which is surrounded by copper pipes. The plumber is using a tool to work on a component on the side of the water heater. The background shows a white wall and a doorway.

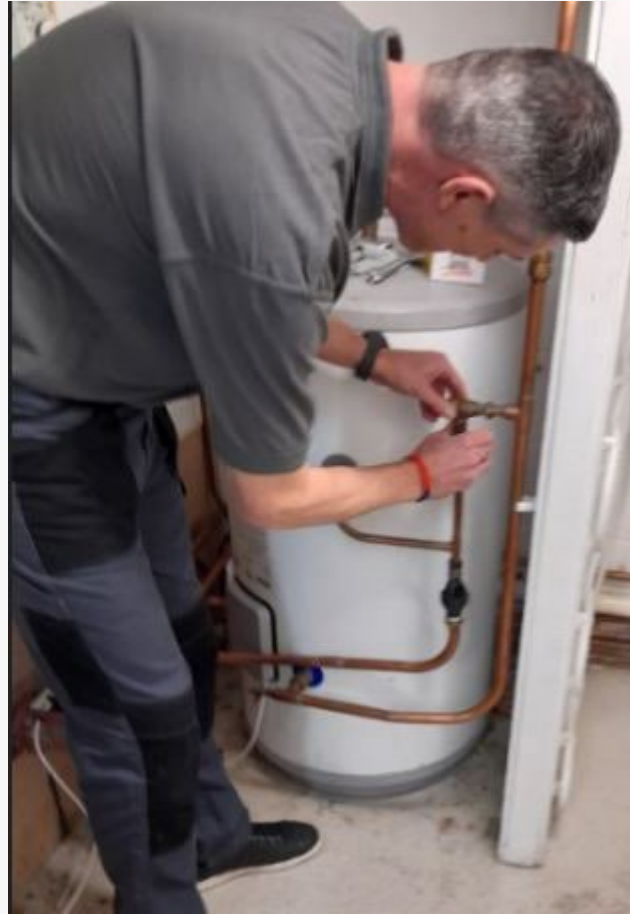
Removal of faulty component.

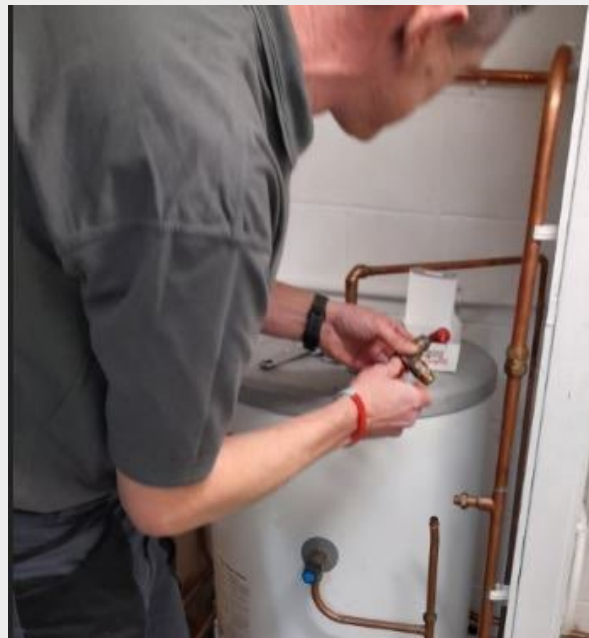
Photograph 18

Replacement of component.

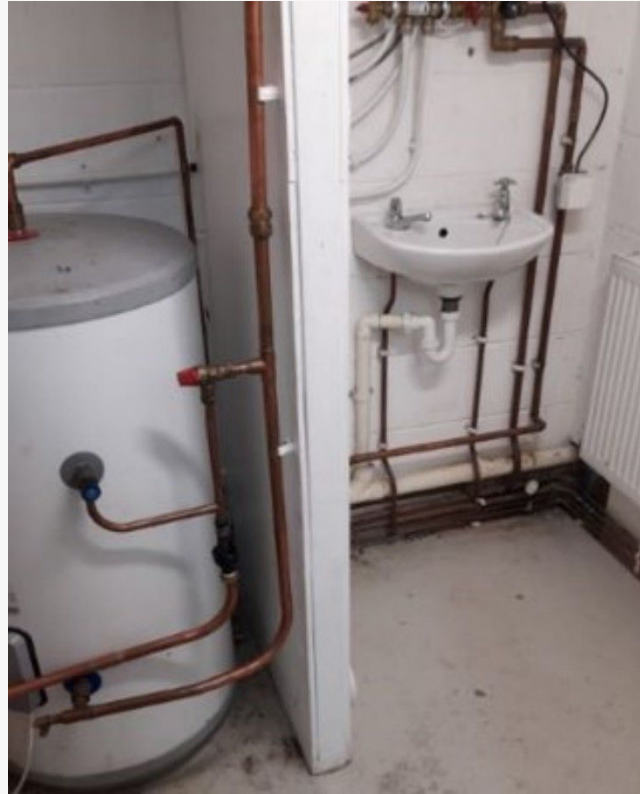
Photograph 19

System on completion of all works.

Repair completed and work area left tidy.

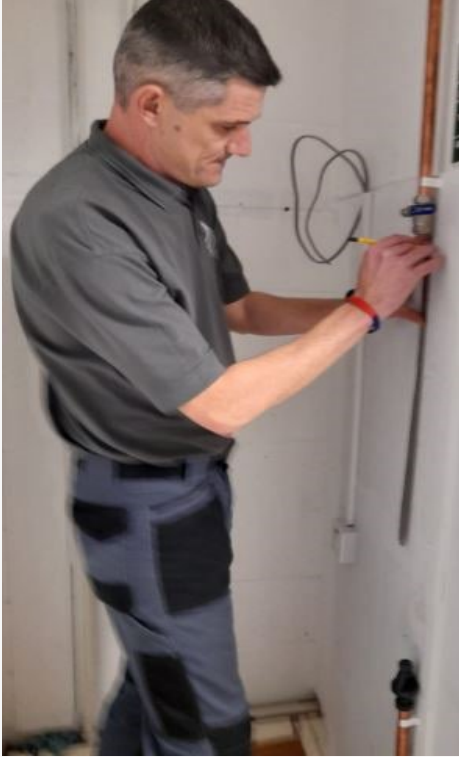
Evidence description	Photo
<p>Photograph 1</p> <p>Candidate marking out a work area using a straight edge that is not the approved method.</p>

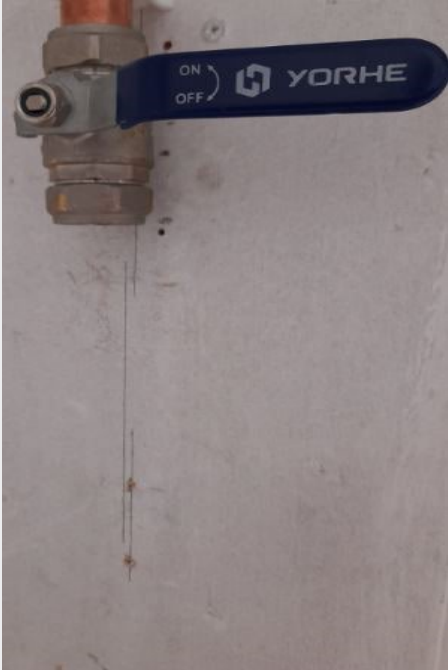
<p>Photograph 2</p> <p>Work area shows multiple marks on work surface from marking out due to initial inaccurate measuring and marking out.</p>

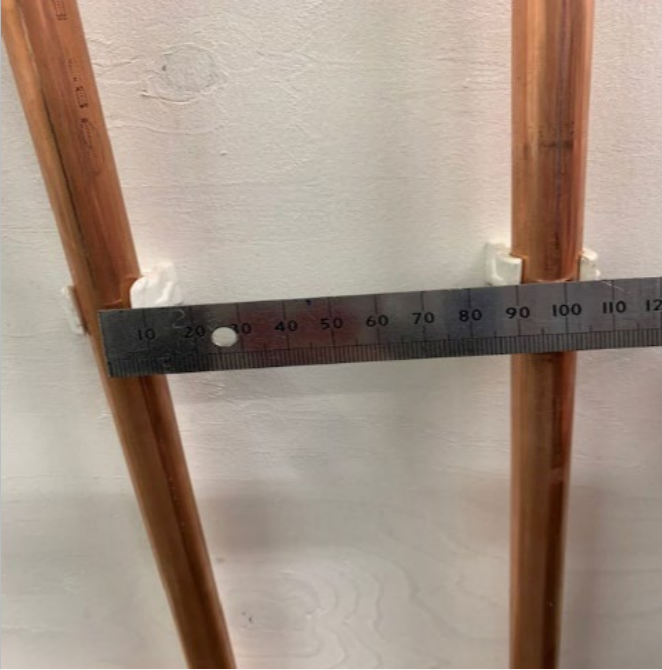
Evidence description	Photo
<p>Photograph 3</p> <p>Tolerance of (+/- 5mm) have been met during the installation of the pipework.</p>

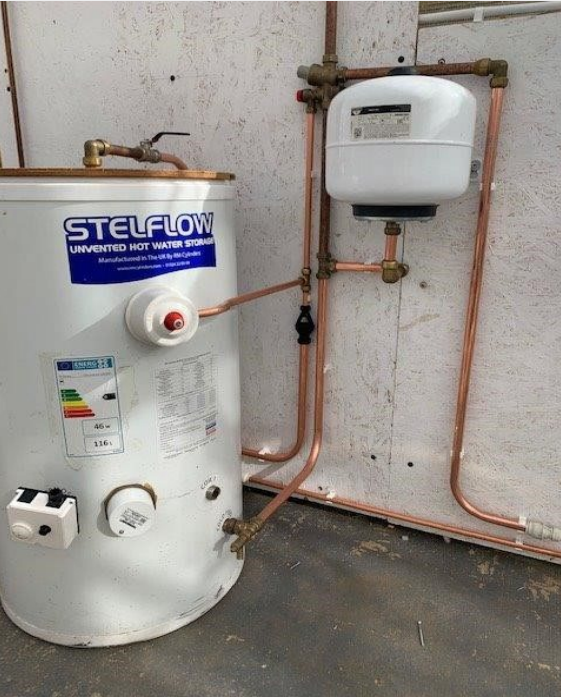
<p>Photograph 4</p> <p>Two photos, one each of each installation showing finished pipework and component positioning which demonstrates the aesthetics of the completed installation. Visible signs of pipework damage that are not straight or horizontal/vertical and bends that are not properly formed. None of which stops the system operating correctly.</p> <p>Finished installation of the unvented hot water cylinder and associated pipework including the installation of</p>

both functional and safety controls.

Overall aesthetics of the installation have been met.

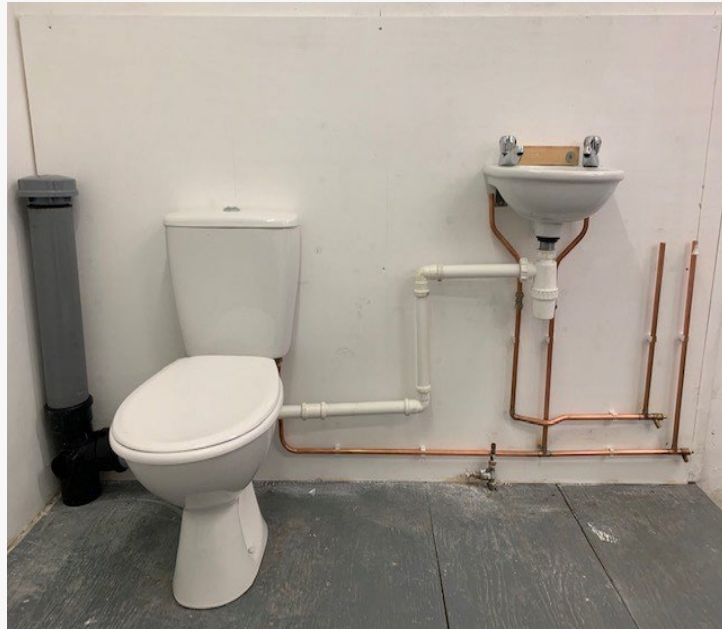
Finished installation of the cloakroom including appliances and pipework to tolerances/standards.

Overall aesthetics of the installation have been met.

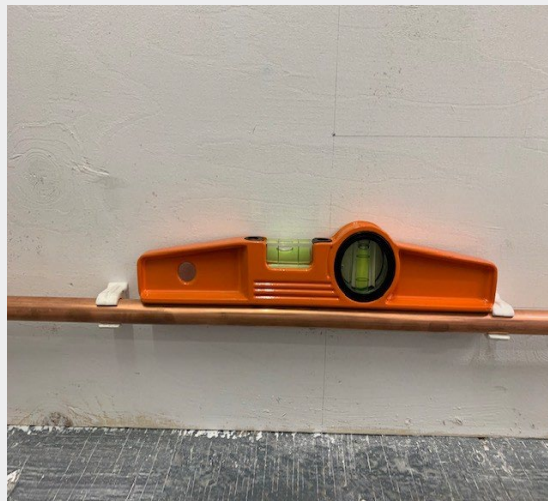
Photograph 6

Pipework not level but within tolerance.

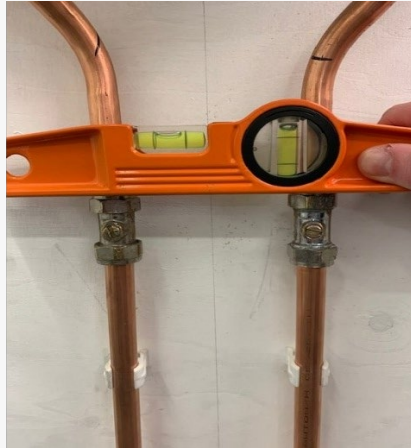
Photograph 7

Components correctly installed but not level

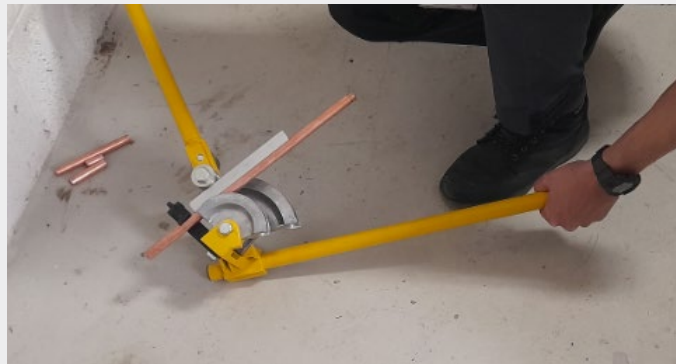
Photograph 8

Use of tools (bending and cutting equipment) and piping skills. Photos may show pipework cut offs.

The correct operation/use of pipe bend machine and pipe cutting tools.

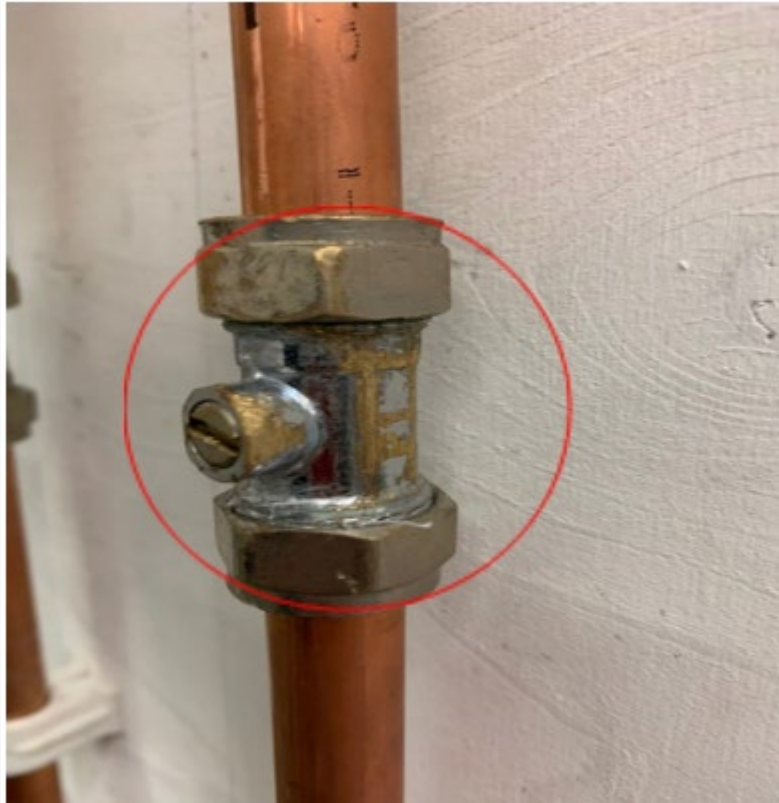
Photograph 9

Results of tool usage

Component fitted correctly with signs of tool marks from installation.

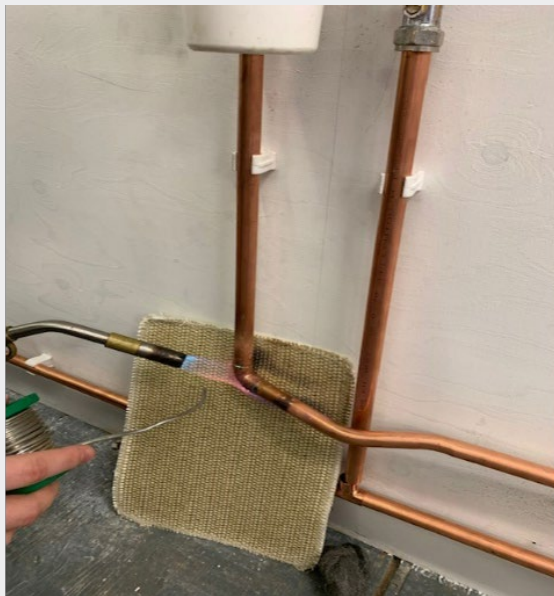
Photograph 10

Correct use of blow lamp, safe soldering, correct selection of solder, protection of customer property although heat mat not correctly positioned.

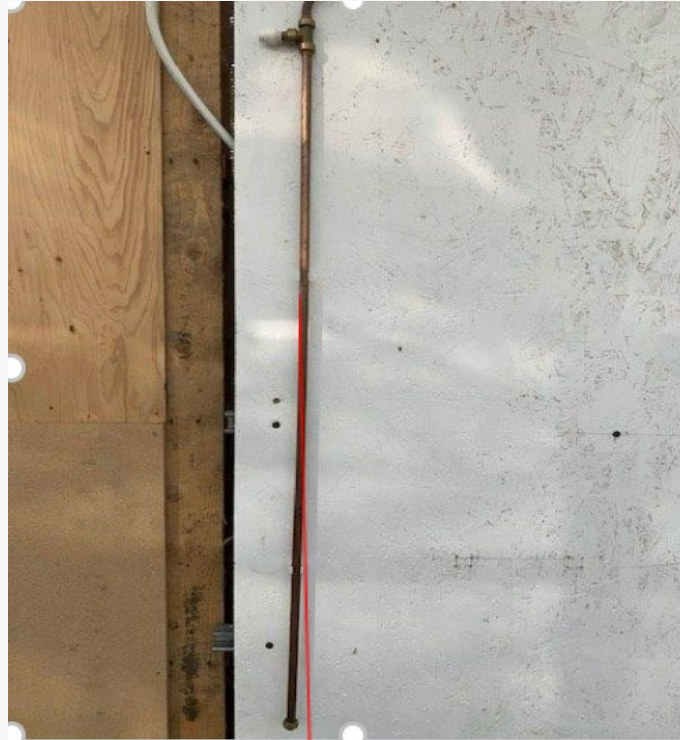
Photograph 11

Use/type of clips. Photos may show clips that are not equally spaced or installed in line.

Incorrect clipped pipe not plumb

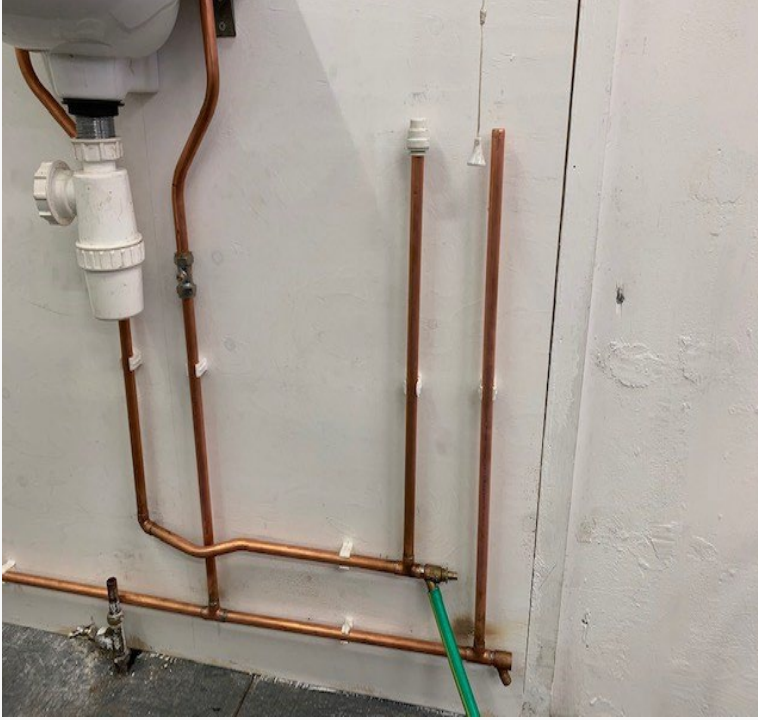
Evidence description	Photo
<p>Photograph 12</p> <p>The system being drained down safely and economically to the correct location.</p> <p>Preparation for draining down: correct equipment and drain point used to drain down system pipework for decommissioning activities.</p>

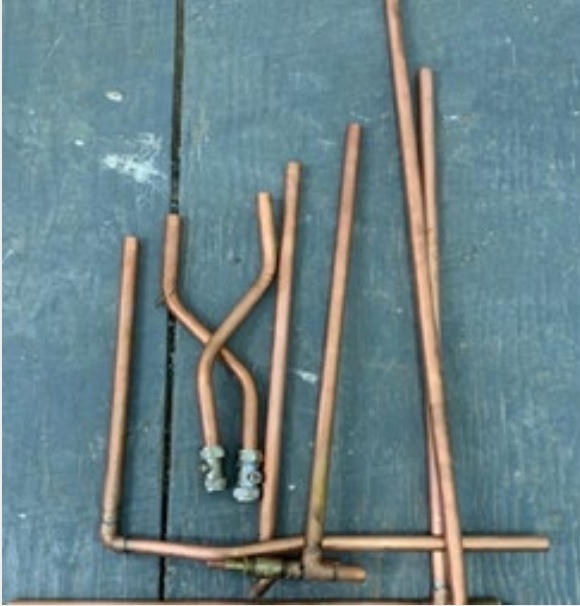
<p>Photograph 13</p> <p>Decommissioning of pipework and components for the system installation.</p> <p>Pipework decommissioned correctly with minimal consideration of recycling.</p> <p>No separation of different materials.</p> <p>No separation of clean/dirty copper.</p>

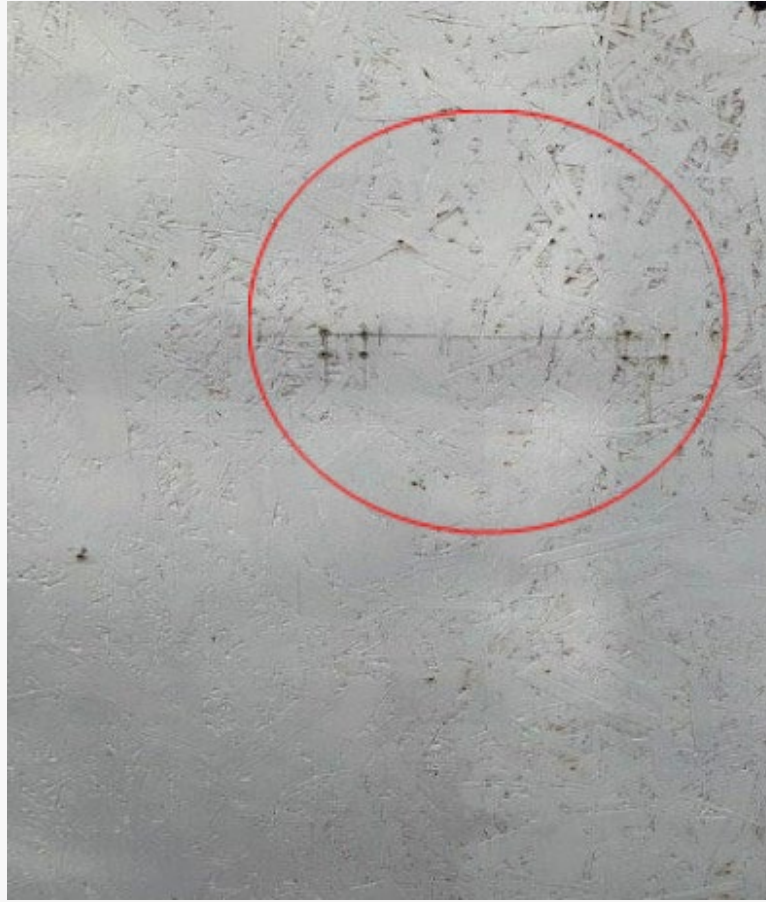
Photograph 14

Some holes and marks still evident from complete decommissioning of pipework.

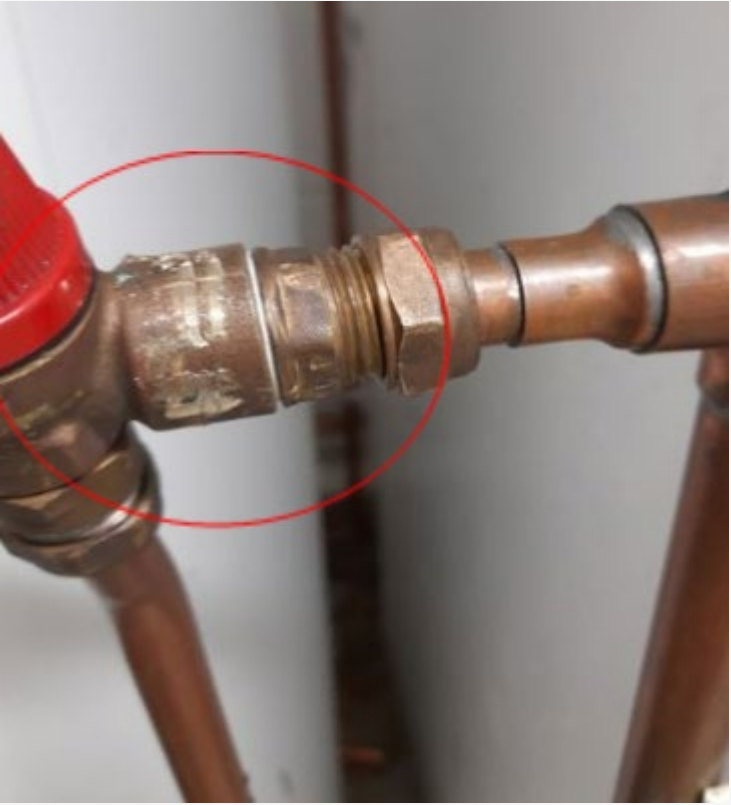
Evidence description	Photo
<p>Photograph 15</p> <p>Results of tool usage.</p> <p>Component fitted correctly with signs of tool marks from installation of replacement component.</p>

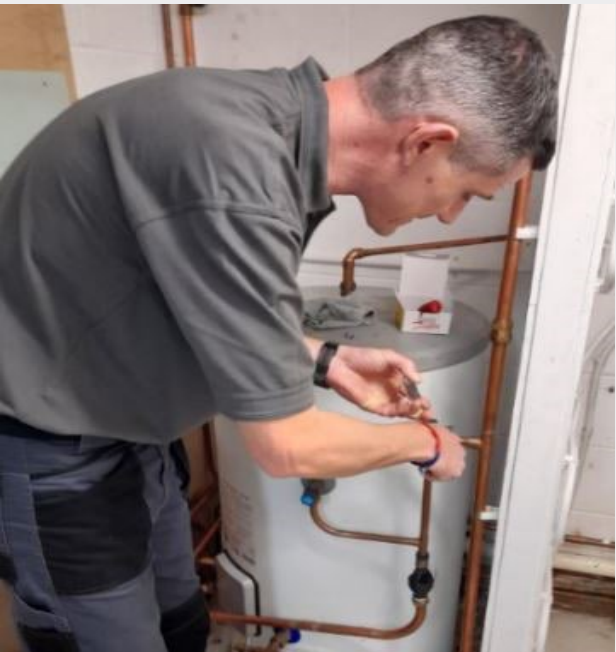
Photograph 17

A photograph of a plumber in a grey shirt and dark trousers working on a white water heater. He is using a tool to loosen a component on the copper piping. The background shows a white wall and a window.

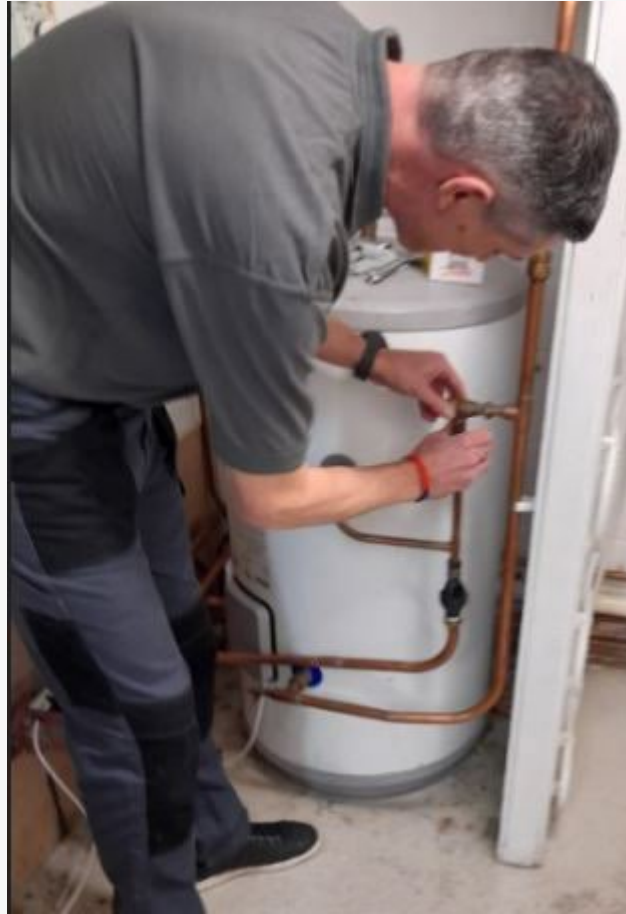
Removal of faulty component.

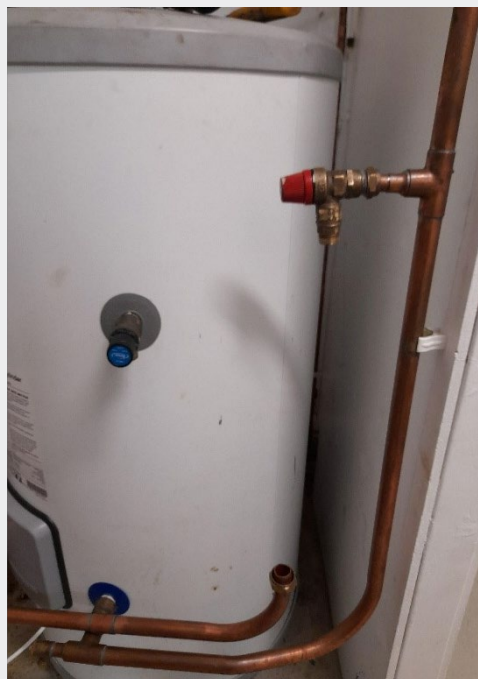
Photograph 18

Excess pipework removed during repair activity.

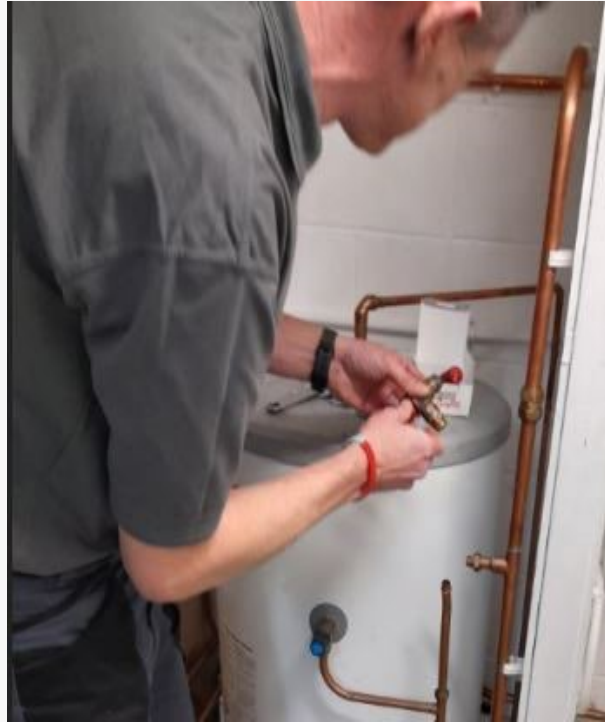
Photograph 19

Replacement of component

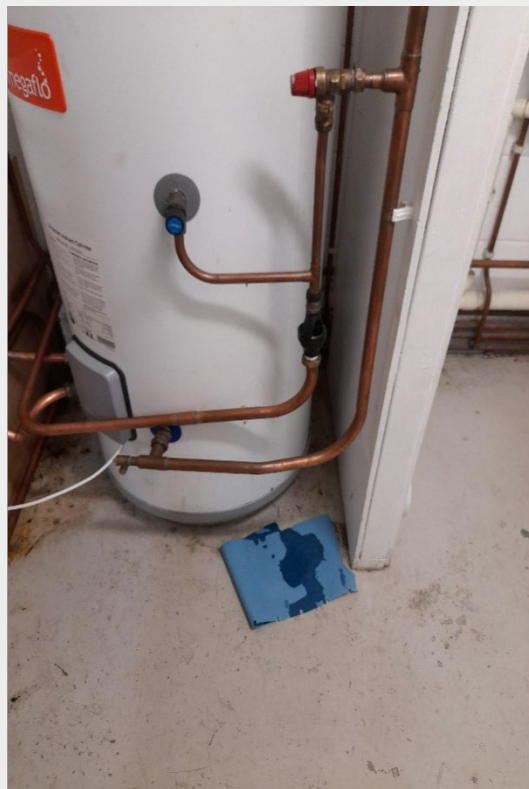
Photograph 20

System on completion of all works.

Repair completed with signs of leaks which have been repaired.
