T Level Technical Qualification in Construction

Painting and Decorating

Guide exemplification material

Threshold competence – Sample 2021

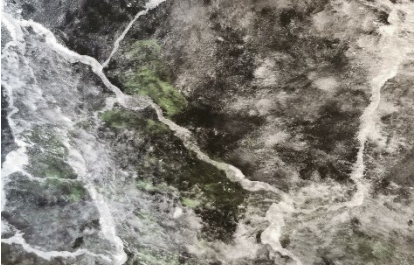
<p>Fireplace back panel finished with Vert de Mer marble effect</p>

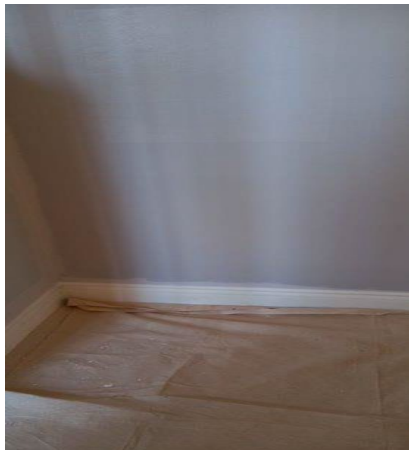
Photograph 1 showing main living room area protected correctly (dustsheets used).
Photograph 2 showing small omission around door opening

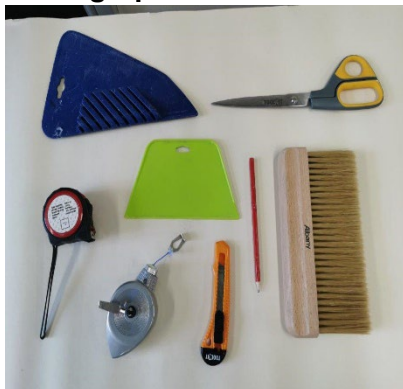
Photograph 3 showing correct tools selected and prepared for the application of lining paper to the fireplace wall

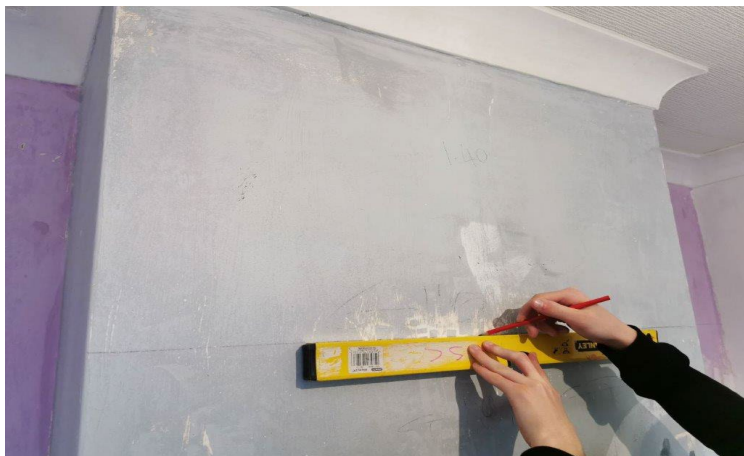
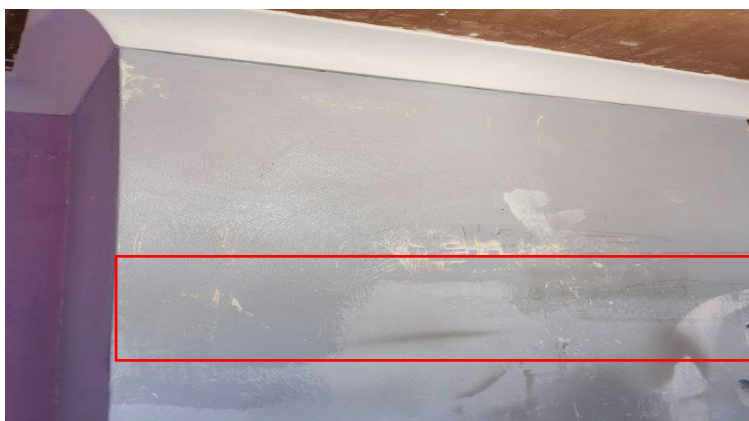
Photograph 4

Photographs 4 – 5 showing measuring and sizing of first length of lining paper

Photographs 4 - 5 showing correct technique used for marking out and measuring fireplace wall for first length of lining paper (measuring , sizing and marking out accurate).

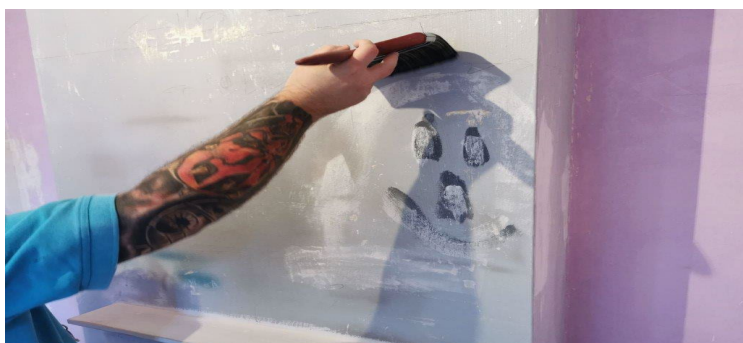
Photograph 6 pasting adhesive to surface

Photograph 6 shows paste applied directly to wall surface to ensure good adhesion

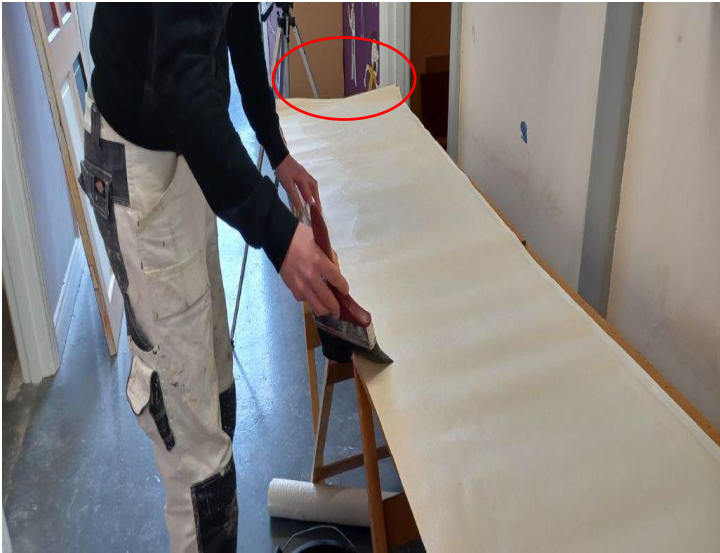
Photograph 7 shows candidate pasting first length of lining paper

Photograph 7 shows paste applied to the lining paper correctly and evenly bar one small omission (miss in pasting) at end of the length.

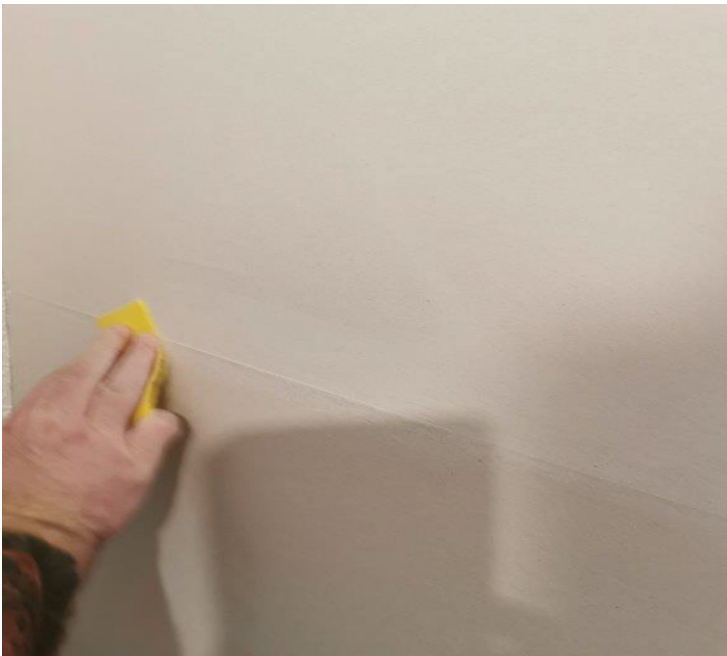
Photograph 8 showing slight overhang of completed lining paper

Photograph 8 shows completed lining paper but as a result of a slight overhang, the candidate has had to rectify the error by abrading the overhang before commencing the patterned wallpaper.

Photograph 10 shows completed lining paper, front and side recesses to a good standard after candidate rectifications (as detailed in photographs 8 and 9).

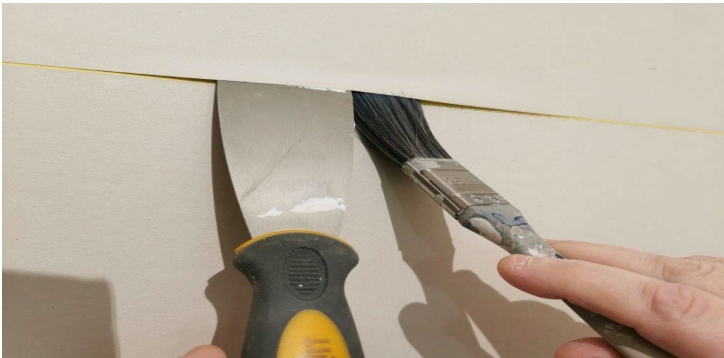
Photograph 9 shows dry edge requiring rectification

Photograph 9 shows dry edge that the candidate rectifies by re-pasting prior to completion of lining paper.

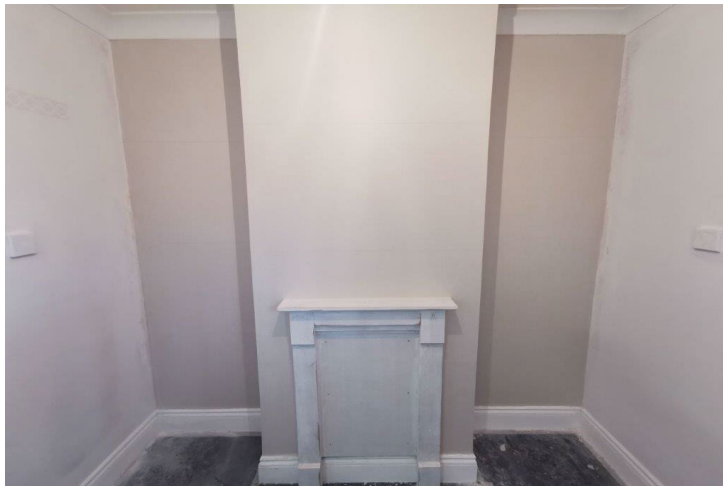
Photograph 10 - showing completed lining paper on fireplace wall

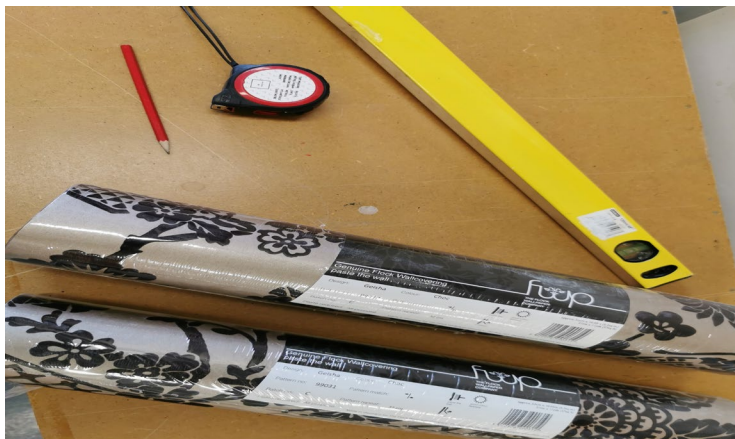
Photograph 11 shows batch numbers checked before commencing measurements, cuts, trim and matching.

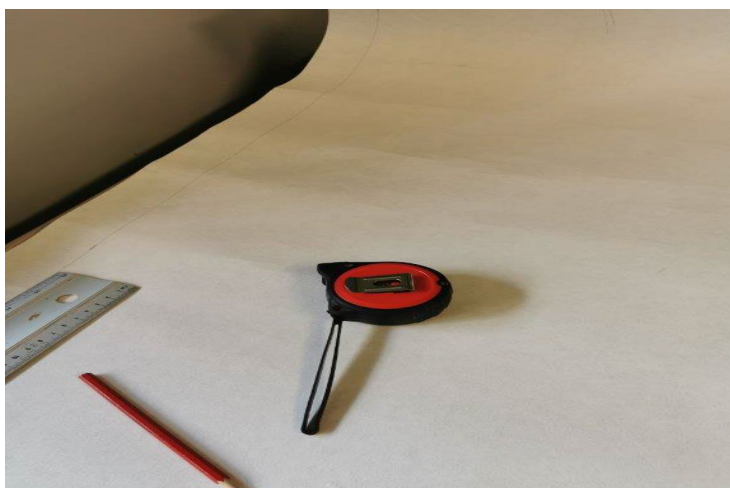
Photograph 12 shows candidate beginning measurements for cuts and trims to wallpaper

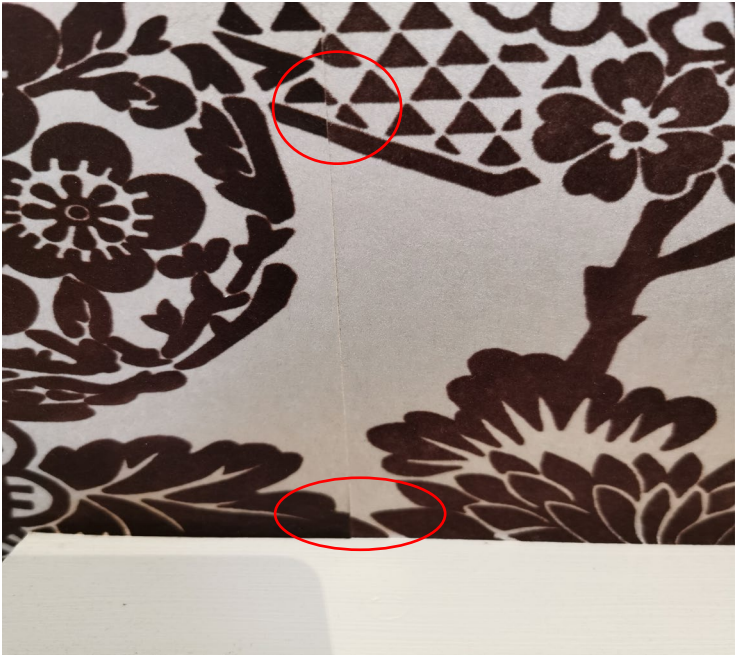
Photograph 13 showing matching/pattern misalignment on wall

Photograph 13 shows slight error in matching (minor misaligned motif) on fireplace wall – adjunct to skirting board

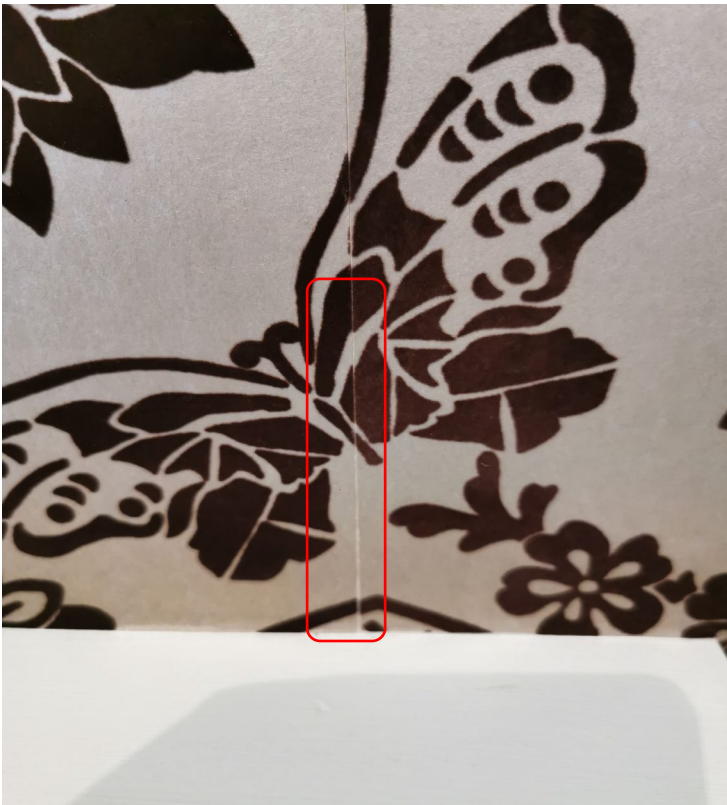
Photograph 14 showing slight gap in one length

Photograph 14 shows slight open joint (gap) at the bottom of one length

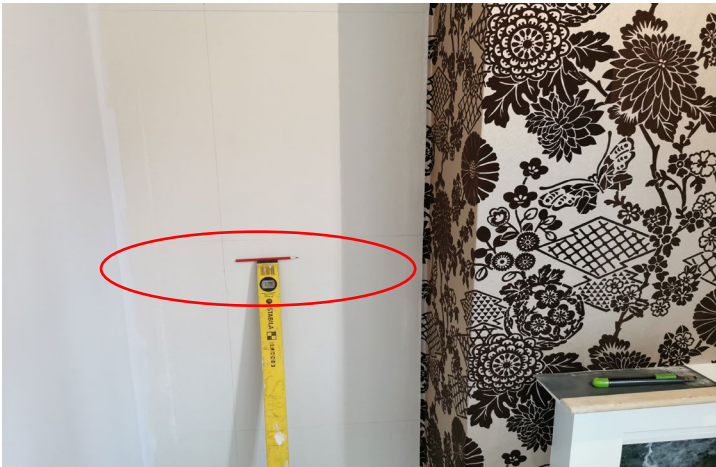
Photograph 15 shows the correct setting out one internal angle

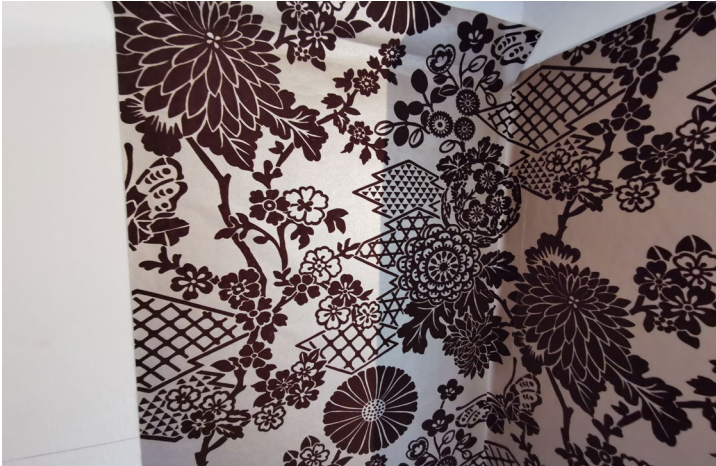
Photograph 16 shows internal angle hung correctly before being trimmed

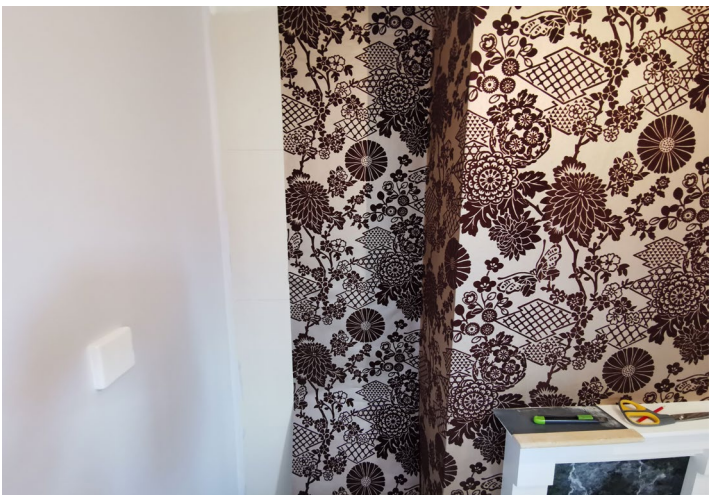
Photograph 17 shows trimming taking place on internal angles

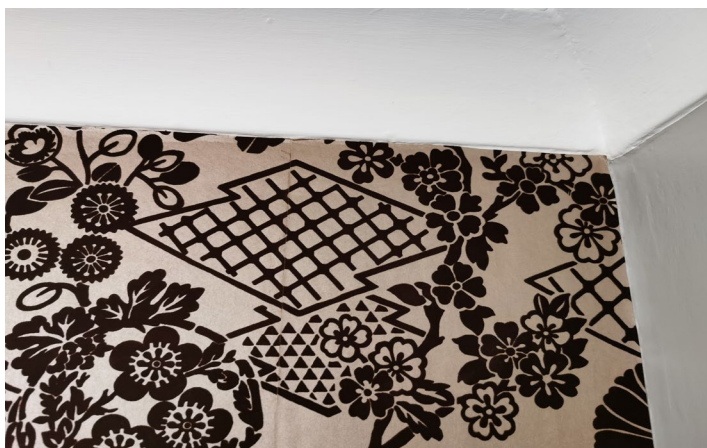
Photograph 18 shows slight trim/cutting error at ceiling level (not even or flush across the length)

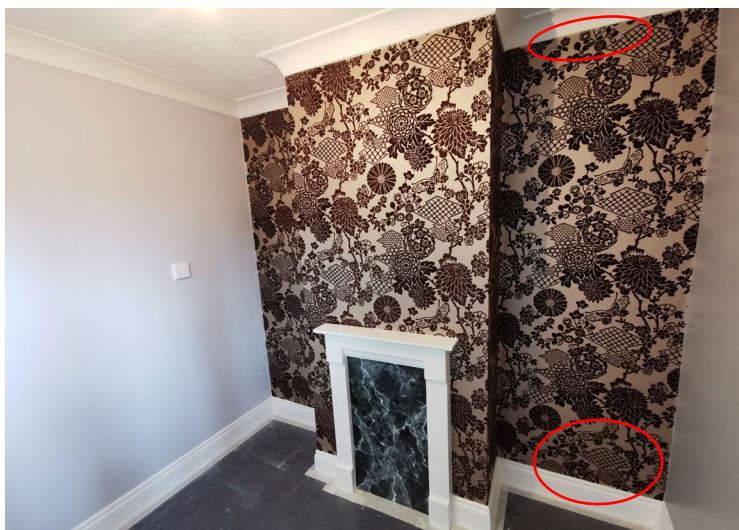
Photographs 19 showing finished wallpaper with detail on drop pattern

Photograph 19 shows completed fireplace with drop pattern with slight errors/defects (as detailed in previous photographs). Overall aesthetics not affected by small errors and it is finished to a good standard in keeping with the design specification

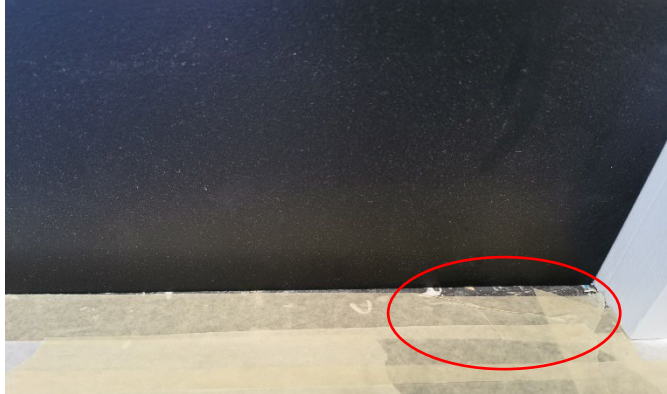
Photograph 20 showing protection of surrounding areas

Photograph 20 shows protection of surrounding area and floors complete bar one small tape omission

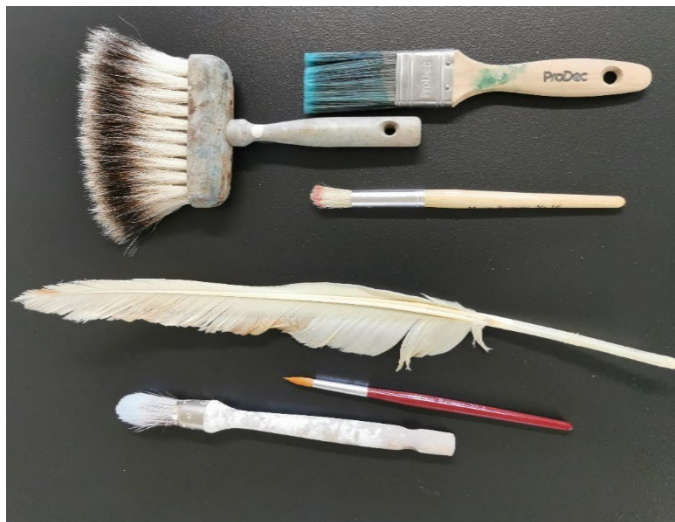
Photographic 21 shows the preparation stages/tools selection

Photograph 21 shows correct tools selected (after small omission) resulting in candidate returning to stores for hog hair brush

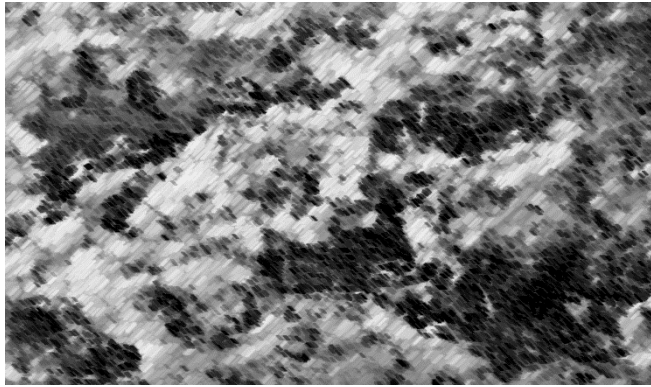
Photograph 22 shows first application correctly applied although glaze slightly dark

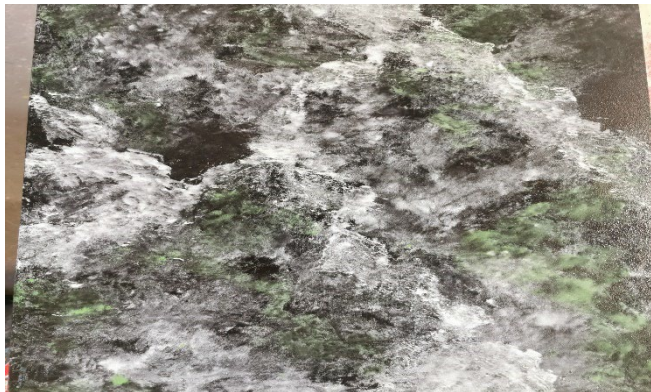
Photograph 23 shows second application applied correctly after some amendments to ensure even finish

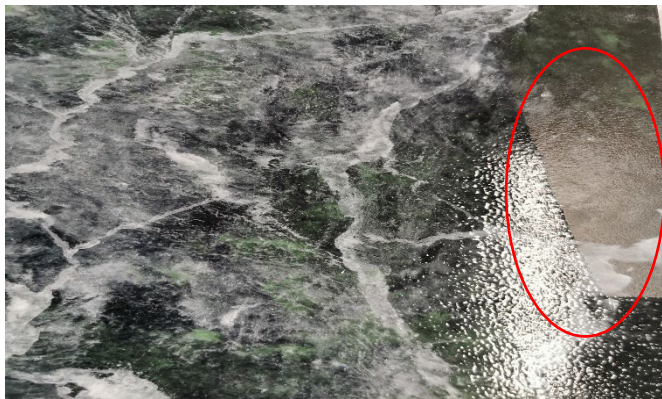
Photograph 24 shows correct application of protective glaze, but with a small omission (left uncorrected by candidate on completion)

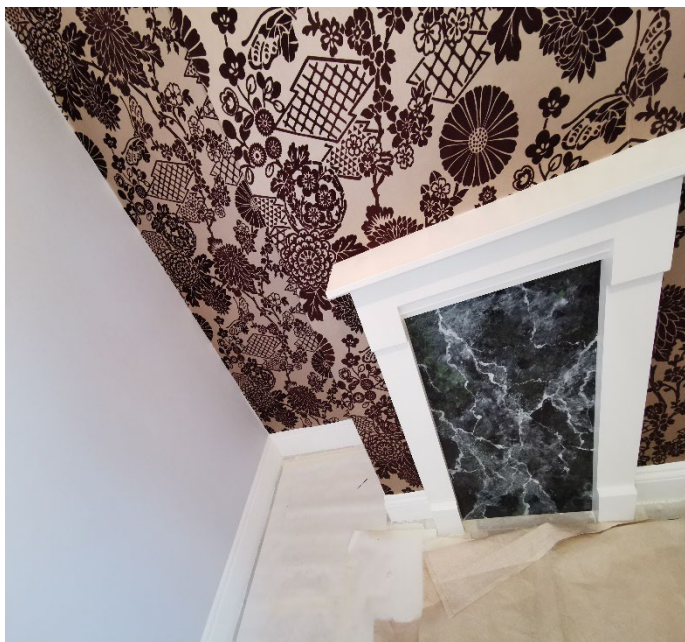
Photograph 25 – showing completed fireplace with “Vert de Mer” marble effect

Photograph 25 shows completed fireplace with “Vert de Mer” effects. Despite small imperfections, the effect was to a good standard and overall reflected of the specification

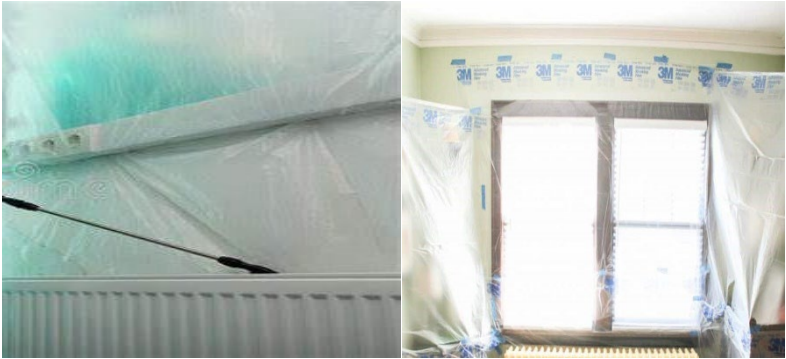
Photograph 26 showing evidence of the protection of surrounding area

Photograph 26 shows adequate protection of surrounding area

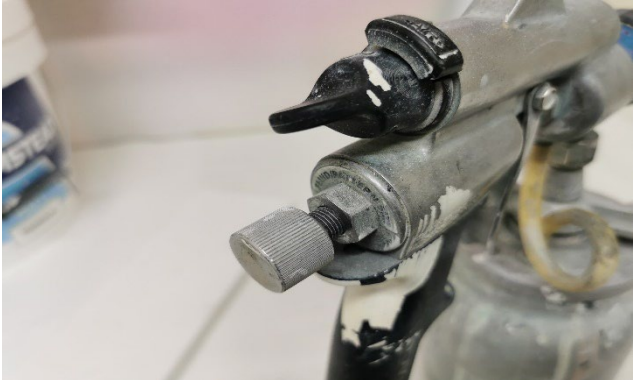
Photograph 27 shows equipment set up correct

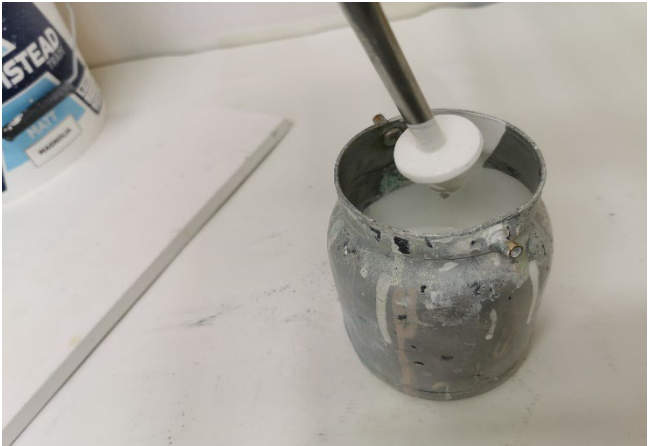
Photograph 28 shows first paint attempt mix (viscosity incorrect)

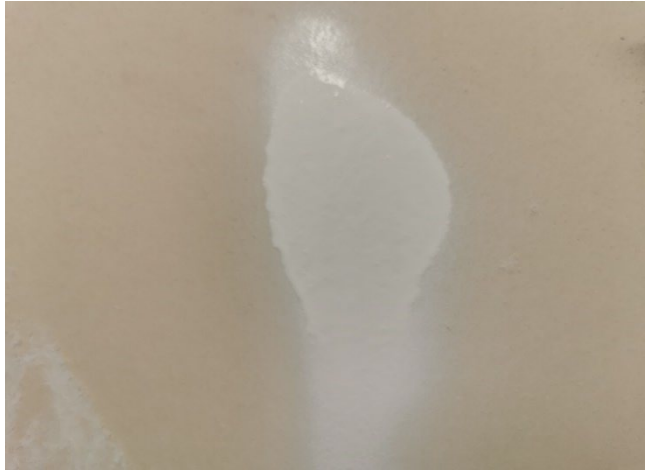
Photograph 29 shows candidate test paint mix (viscosity too thick) candidate notices issues and rectifies (as shown in photographs 30 and 31)

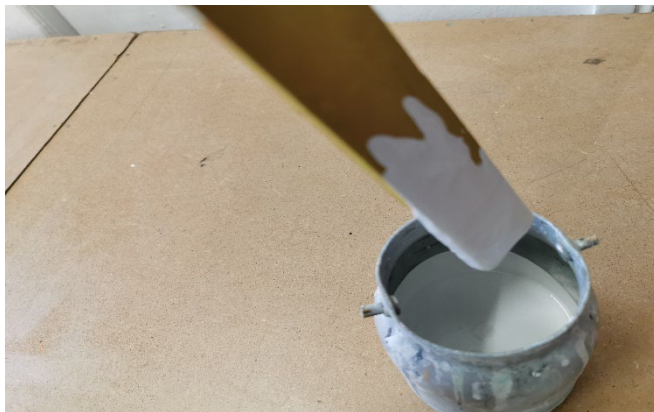
Photograph 30 shows candidate adjusting viscosity of paint

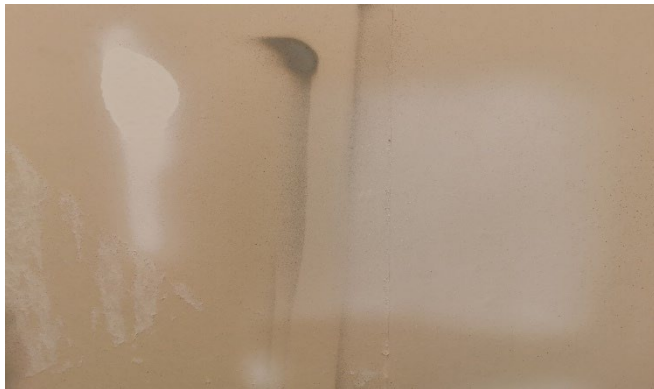
Photograph 31 shows candidate testing paint again before application after adjustment. Paint viscosity correct after second attempt

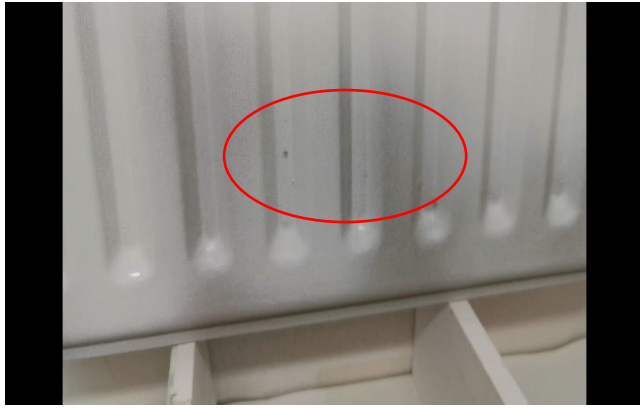
Photograph 32 shows the candidate applying first application correctly bar a minor miss when arching the gun slightly

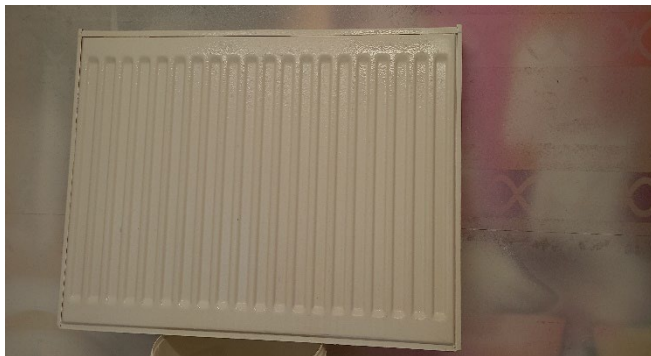
Photograph 33 shows the finished radiator with initial application miss corrected on second application. Finish to a good standard and meets scheme requirements

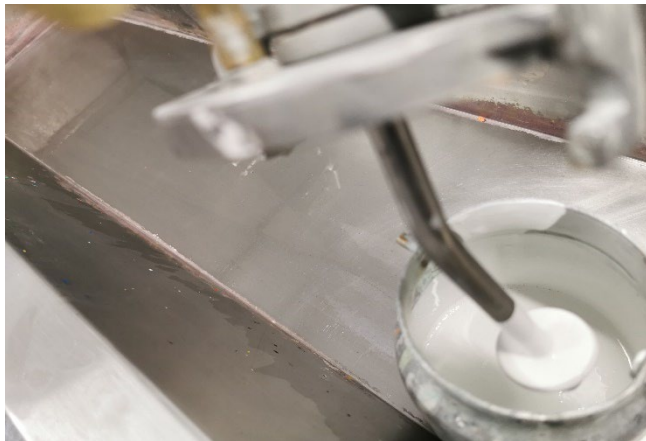
Photograph 34 shows adequate cleaning of HVLP spray tool

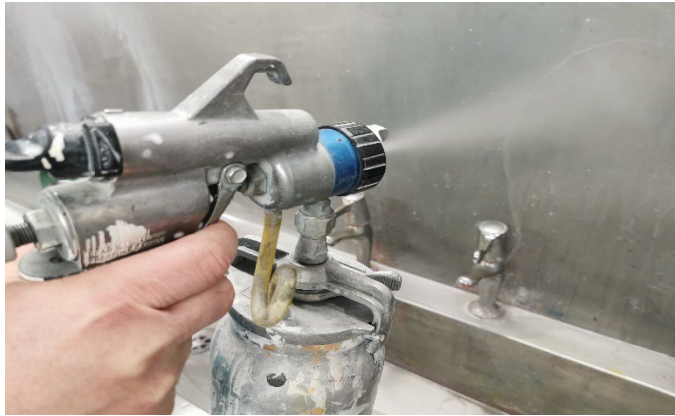
Photograph 35 shows correct clean and flush of HVLP spray tool

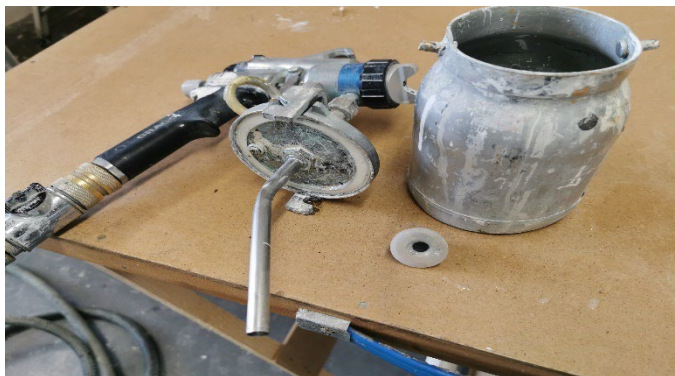
Photograph 36 shows the correct clean and break down of HVLP spray tool ready for storage
