# **T Level Technical Qualification in Engineering and Manufacturing – Maintenance, Installation and Repair**

## **8712-315 Light & Electric Vehicle**

### **Grade standard exemplification material**

### **Distinction - summer 2024**

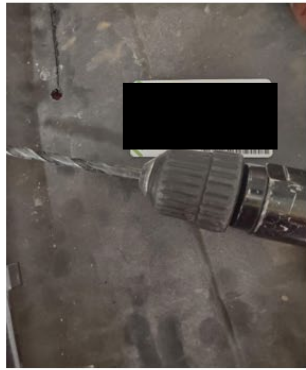
Hole drilled into end of crack.

Drill two holes into both ends of the crack to stop it from cracking even more.

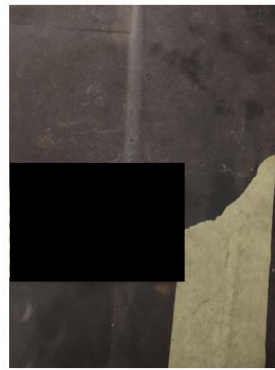
Taped backside of crack

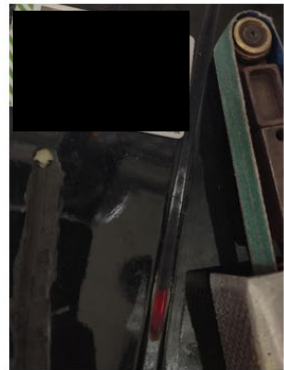
Belt sanded to create v groove.

Then you scuff the crack using sandpaper to make the edges smoother to give it a smoother finish at the end.

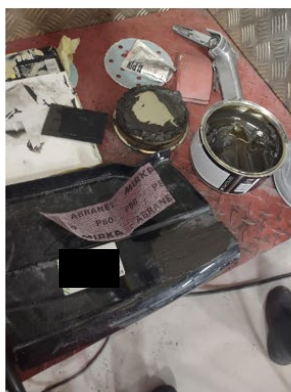
Sanded and filled with filler and hardener mixer.

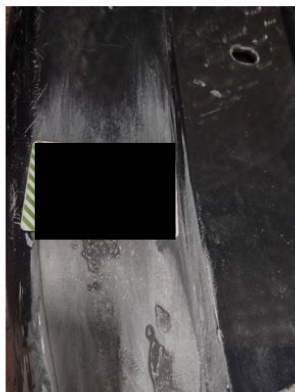
Final product after sanded down with p240 grit

Candidate ensured the chosen method of repair was suitable for the repair and this was completed to manufacturer standard to ensure a lasting repair. The surface was thoroughly prepared and ready for paint once finished.

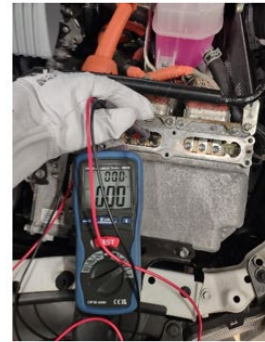
Testing inverter for voltage

I used an 8mm socket and ratchet to remove the 2 bolts that held down the glass fuse in the inverter, I also tested that for resistance as this fuse could also be blown, not allowing the ready light to illuminate. However, the fuse had no resistance within it, therefore it wasn't broken.
