**T Level Technical Qualification in
Engineering and Manufacturing –
Maintenance, Installation and Repair**

8712-315 Light & Electric Vehicle

Grade standard exemplification material

Pass - summer 2024

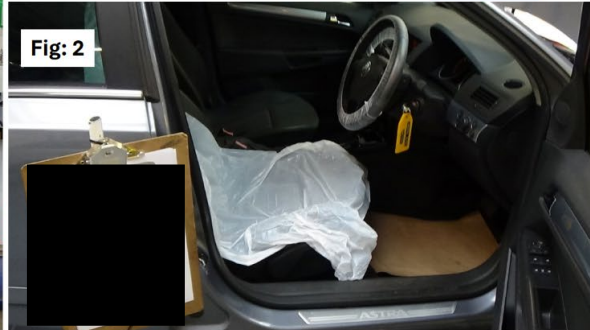
Fig 1 and 2 photographic evidence, shows the vehicle 1 is prepared using VPE before work commences. The use of magnetic wing covers, disposable floor mats, seat covers and steering wheel cover.

VPE has been fitted and positioned but seat cover could have been more accurately secured.

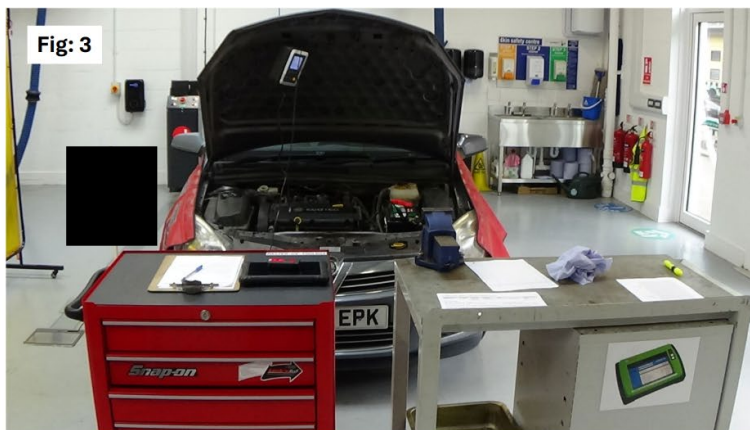
Fig 3 photographic evidence, shows that the student has prepared the work area in readiness to start the task.

All tools are available to use with some other equipment available the scan tool. The battery maintainer is connection ready for fault diagnosis.

Documentation ready.

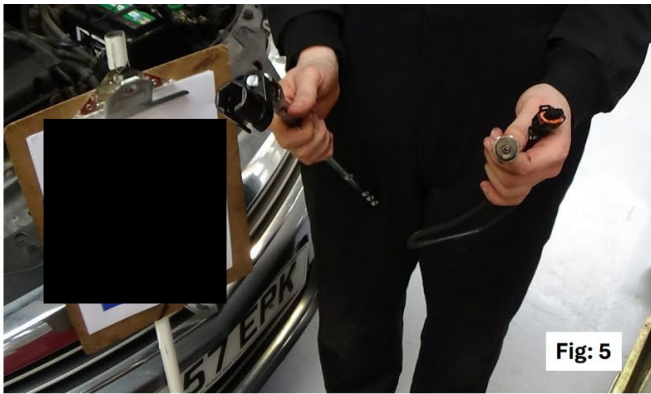
Fig: 5

Fig 5 photographic evidence, shows the candidate holding the faulty Os2 sensor requiring replacement.

O2 sensor broken

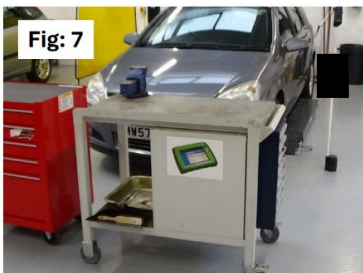
Fig: 7

Fig 7 photographic evidence shows the candidates work area re-instated on completion of the task.

Tools and work bench correctly cleared and tidy.

Vehicle operating correctly, no EML light displayed.

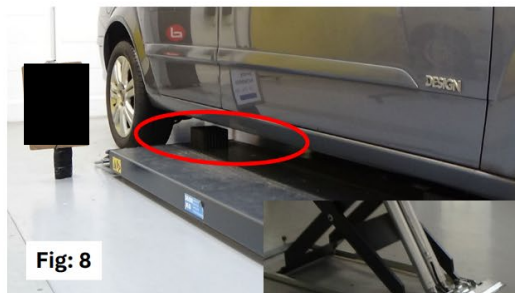
Fig: 8

Fig 8 photographic evidence shows the ramp blocks were also left under the vehicle.

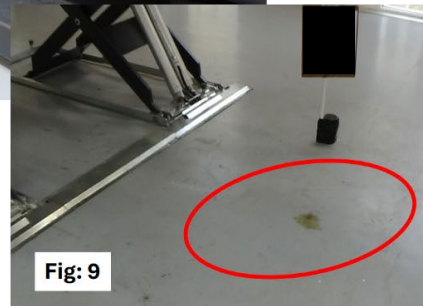
Fig: 9

Fig 9 shows that although the candidates attempted to clean the floor but there was still remanence of oil on the floor.

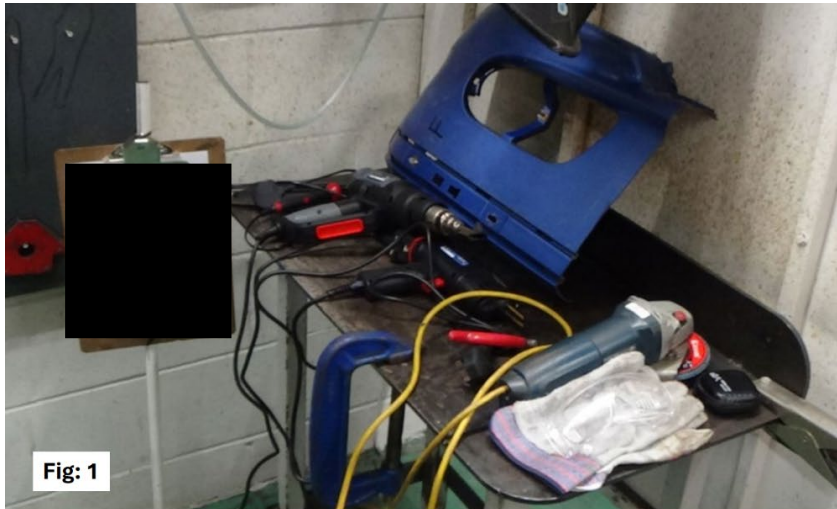
Fig 1 photographic evidence, shows that the candidate has set up the work area. The student has laid out all tools and equipment required to be used within the task.

All PPE has been set out and boots and overalls were worn.

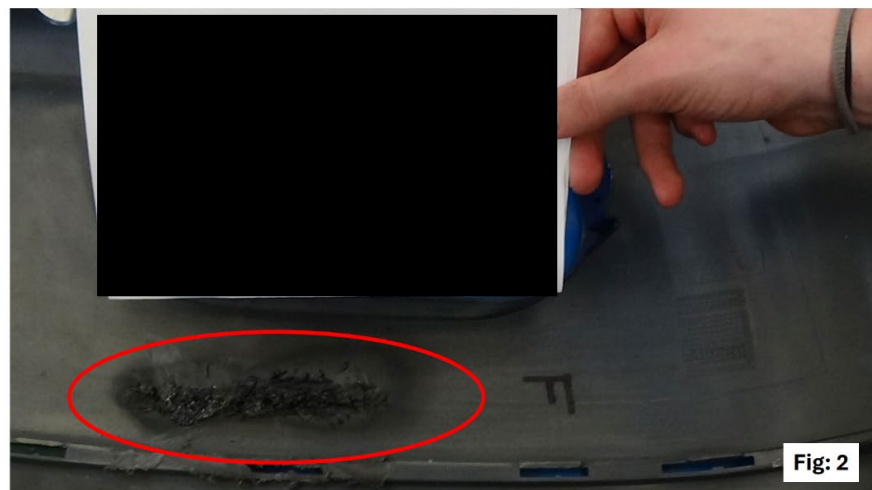
Fig 2 photographic evidence, demonstrates the candidates completed work piece shown from the underside which the repair was carried out to.

This show the joint and a completed repair and join.

The candidate applied too much heat and penetrated too deep causing some distortion to the front of the work piece which will require some additional work. The candidate provided a good join and an adequate amount of build-up on the back of the work piece to support the repair.

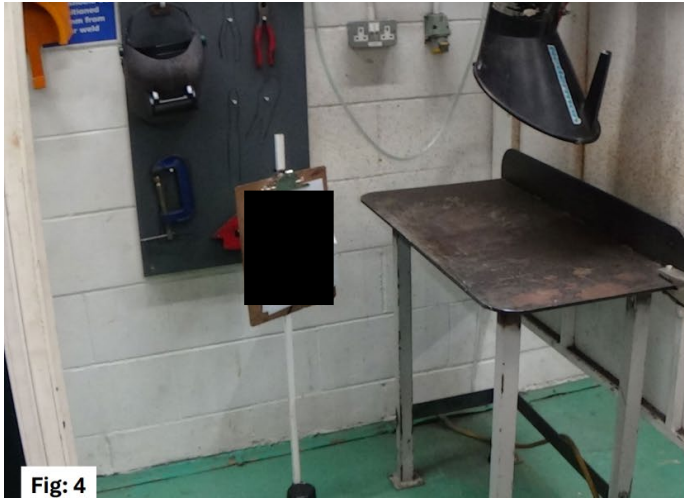
Fig: 4

Fig 4 photographic evidence, show the candidates has re-installed the work area.

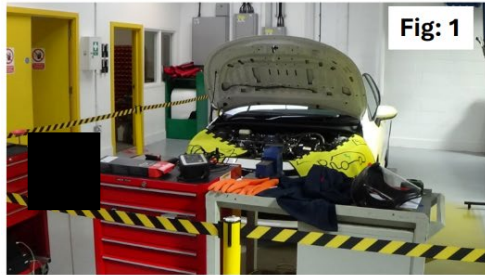
Fig 1 photographic evidence, shows that the student has completely prepared the work area in readiness to start the task.

All protection barriers fitted to HV work area before commencing work.

Area is correctly cordoned off to restrict access to area. HV PPE has been set out ready to use.

Tools are available to use with the battery maintainer.

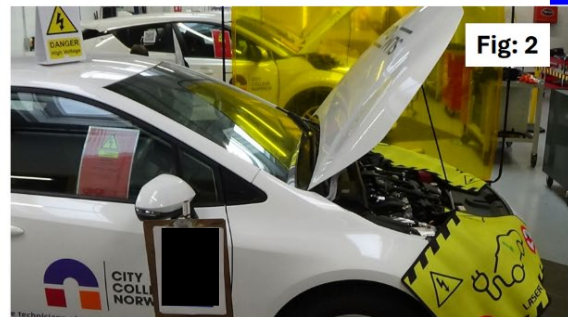
Fig 2 photographic evidence, shows that the student has, *High voltage warning signage fitted to the vehicle windows and roof.*

A signature of candidate on the relevant document card placed on the dash, to assign responsibility for the work carried out on the HV system.

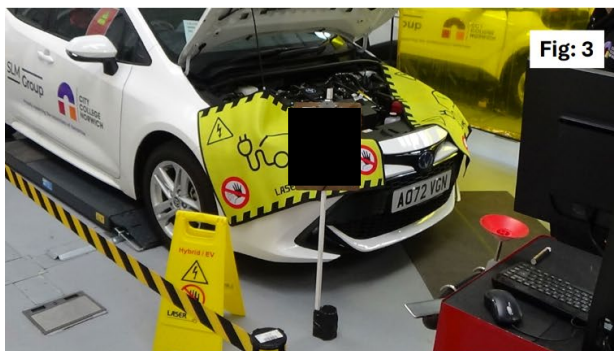
Fig 3 photographic evidence, shows vehicle 2 has insulated VPE wing covers fitted.

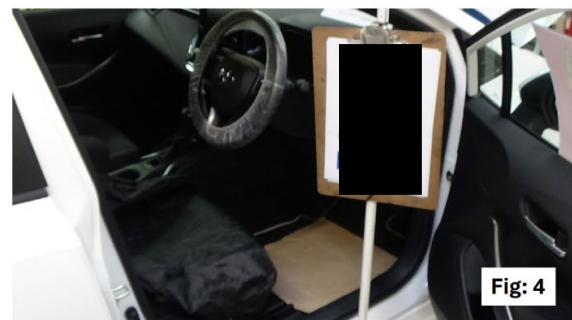
Fig 4 photographic evidence, clearly shows the interior of vehicle 2 is correctly prepare using VPE before work commences. The use of disposable floor mats, steering wheel and re-useable seat covers. All VPE is accurately positioned.

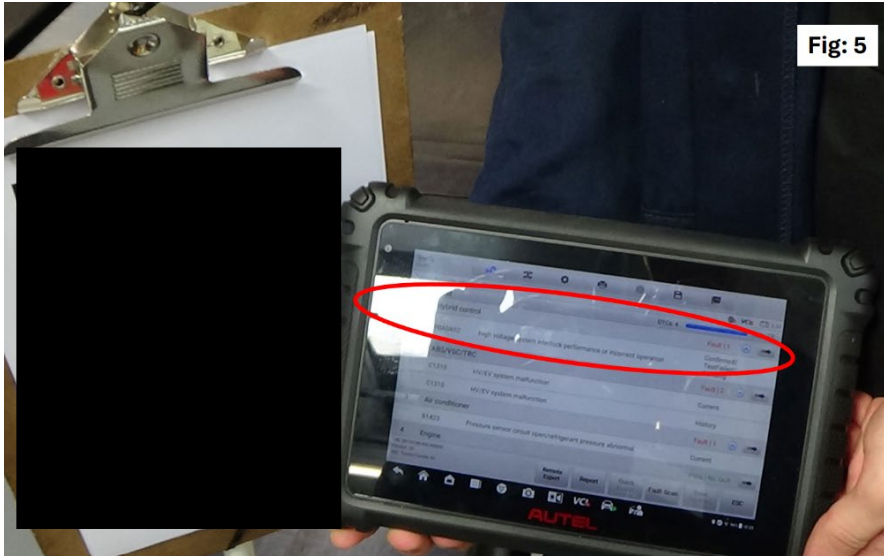
Fig: 5

Fig 5 photographic evidence, displays the candidate's use of the scan tool to extract a diagnostic trouble code.

The vehicle was fitted with a battery maintainer and the candidate used the Autel scan tool to extract DTC from the vehicle, noted on paperwork. At this stage the candidate carried out no more diagnostics and proceeded to perform a VHC. I would like to have seen some basic diagnostic checks carried out before the VHC, research the DTC using E3 Technical for example. This would have shown better sequencing of the task.

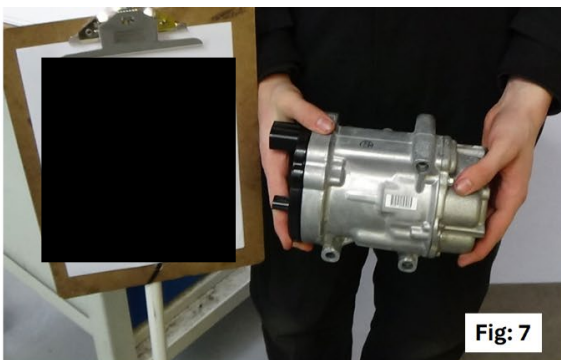
Fig: 7

Fig 7 photographic evidence, shows the candidate holding the faulty HV AC compressor before replacing with a new unit.

On performing the repair to the HV AC compressor the process that the candidate followed a logical process showing high level of hand skills. HV AC compressor was correctly mounted, and pipes located and secured correctly. There was a basic use of technical information although no use of a calibrated torque wrench to tighten bolts were observed.

The faulty HV AC compressor was replaced and reconnected to the HV system before re-energising the high voltage. All components removed to access the HV AC compressor were refitted correctly.

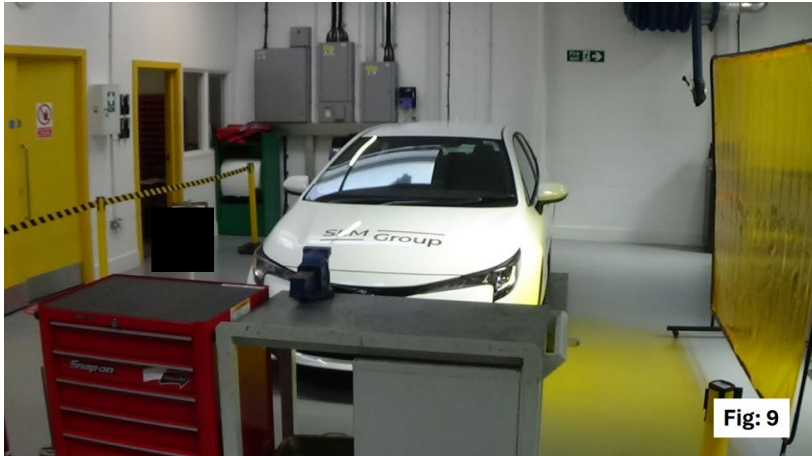
Fig 9 photographic evidence shows the candidates work area re-instated on completion of the task.

Vehicle return to correct operation.
Ready light displayed.
