**T Level Technical Qualification in  
Maintenance, Installation and  
Repair for Engineering and  
Manufacturing (8712-35)**

**Light and Electric Vehicles (315)**

**Guide standard exemplification  
material**

**Distinction – Sample 2022**

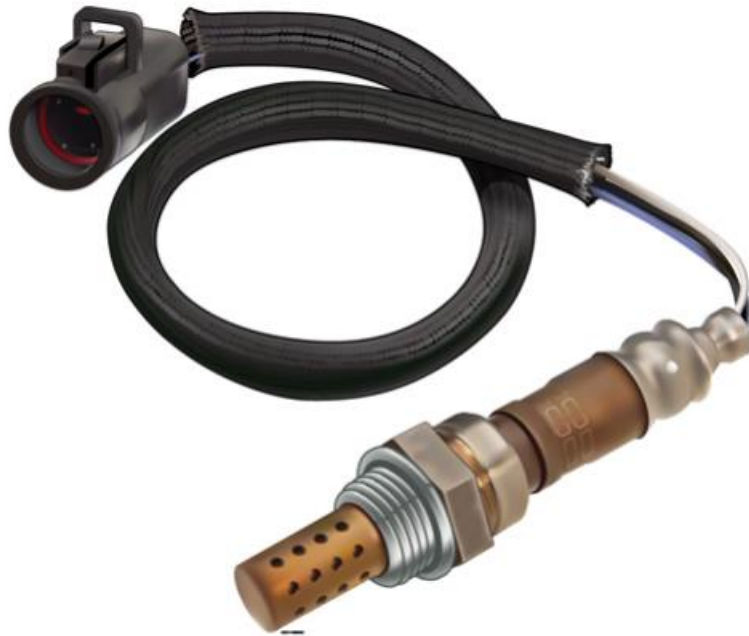
## Heated oxygen sensor (HO2S)

Opel/Vauxhall Astra-K  
LE2/D14XFT/1.4 (B16)

Note: General component image for illustration only

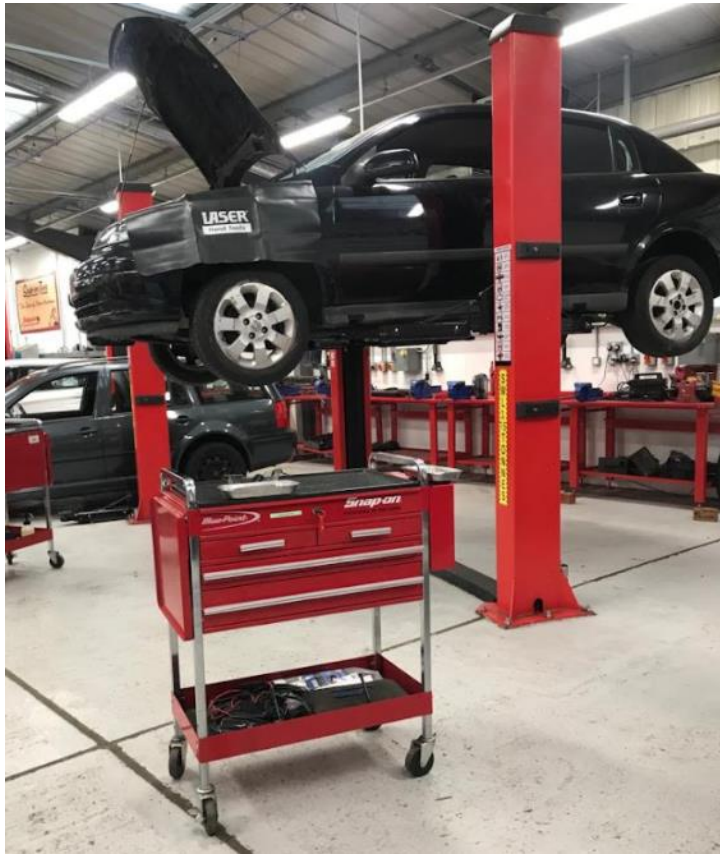
**Photograph 1:** Photographic evidence shows the tools, equipment and all relevant technical documentation placed in the working area, within reach and methodical order of use.

- Photographic evidence showing the prepared work area for vehicle 1 service and maintenance - Illustrated in Task 2a photographic evidence section below (photograph 1)
- Photographic evidence showing the prepared and fitted VPE – Illustrated in Task 2a photographic evidence section below (photographs 2 and 3)
- Photographic evidence showing the set up and position of DTI to take brake run out readings – Illustrated in Task 2a photographic evidence section below (photograph 4)
- Photographic evidence showing the re-instated work area – Illustrated in Task 2a photographic evidence section below (photograph 5)

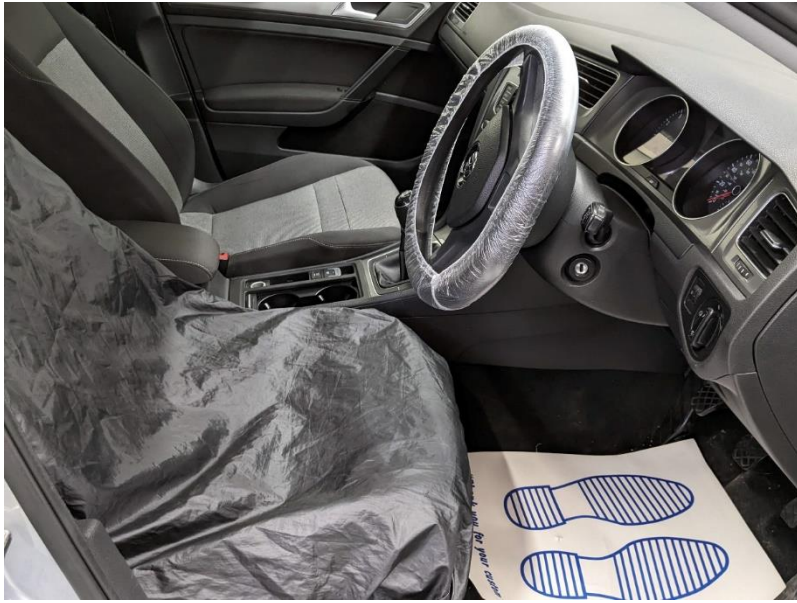
**Photographs 2 and 3:** Photographic evidence shows the prepared and accurately fitted VPE on Vehicle 1.

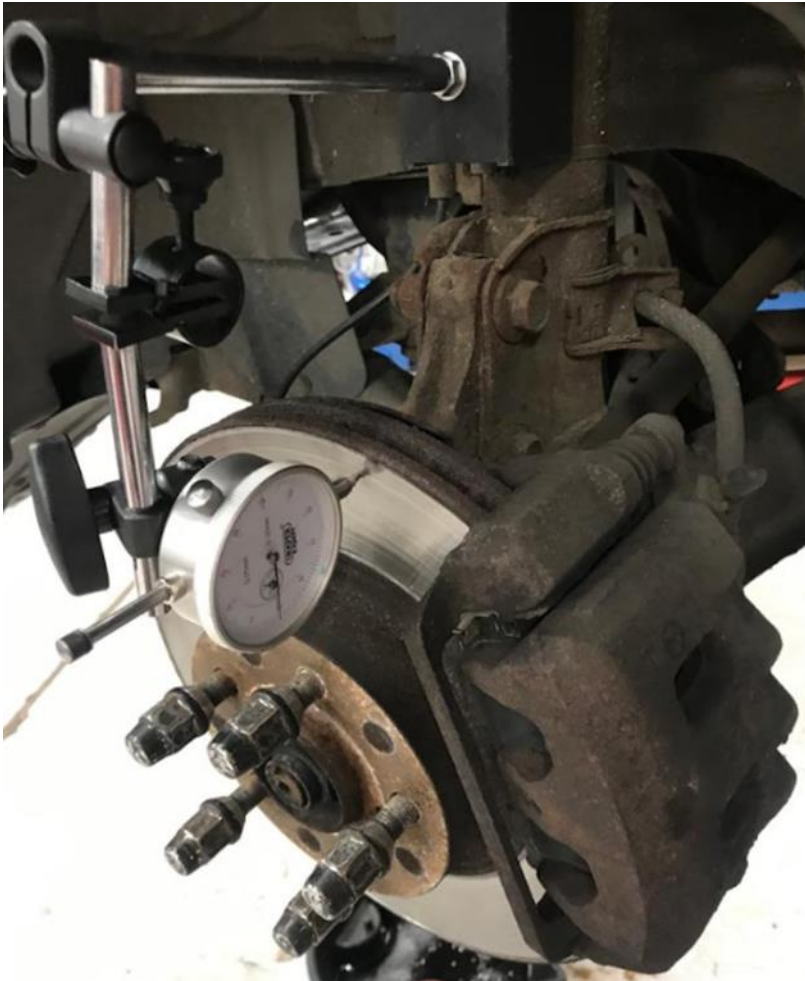
**Photograph 4:** Photographic evidence shows the set up and accurately positioned DTI gauge to take brake run out readings, arm connected to the suspension correctly and gauge fitted to take accurate readings.

I carefully half lowered the vehicle to inspect the wheels, tyres, brakes and suspension. Upon inspection I found the NSF brake disc to be warped. I used a DTI gauge to measure this, and it was out of tolerance (0.04mm is acceptable). I gained a reading of 0.8mm - this is not acceptable. I notified the workshop technician and asked for new pads and discs. I dismantled the calliper removing the pads (4mm thick), then removed the calliper carrier. Next, I removed the retaining screw with an impact driver with a hex bit. I removed both front discs, cleaned up the face of the hub, lubricated with a thin layer of copper grease. I wiped off the mech oil on the discs and double checked the part (comparing old with new) for fitment and then fitted the brake discs. I refitted the retaining screw followed by the calliper carrier, torquing up the bolts to the correct setting (150 Nm), followed by the calliper. The piston was required to be pushed back into the calliper. I raised the vehicle, refitted the sump plug and removed the oil drainer. I fully lowered the vehicle and opened the bonnet. I removed the brake fluid cap and surrounded it with rag. At this point I removed the oil filler cap and dipstick too. I fully raised the vehicle and using a piston wind back tool – pushed the piston back into the calliper. I was now able to fit the pads (using grease on the contact points). I refitted the calliper to the carrier (28Nm) tightening to the correct torque. I now checked the wheels and tyres, all was fine, the tyres required a little pressure and were pumped up to the correct value of 32psi all-round using an air tool. Wheels were refitted to vehicle (nuts tightened but not torqued).

The candidate has completed the service schedule accurately, adding annotations to areas for further detail and where faults were found outside of the planned routine maintenance, and the testing data results that confirmed these. The candidate was also able to interpret and apply manufacturer's parameters and tolerance through their fault finding, service and maintenance. For example, the technical data states disc runout to be 0.04mm and the reading gained was 0.8mm.

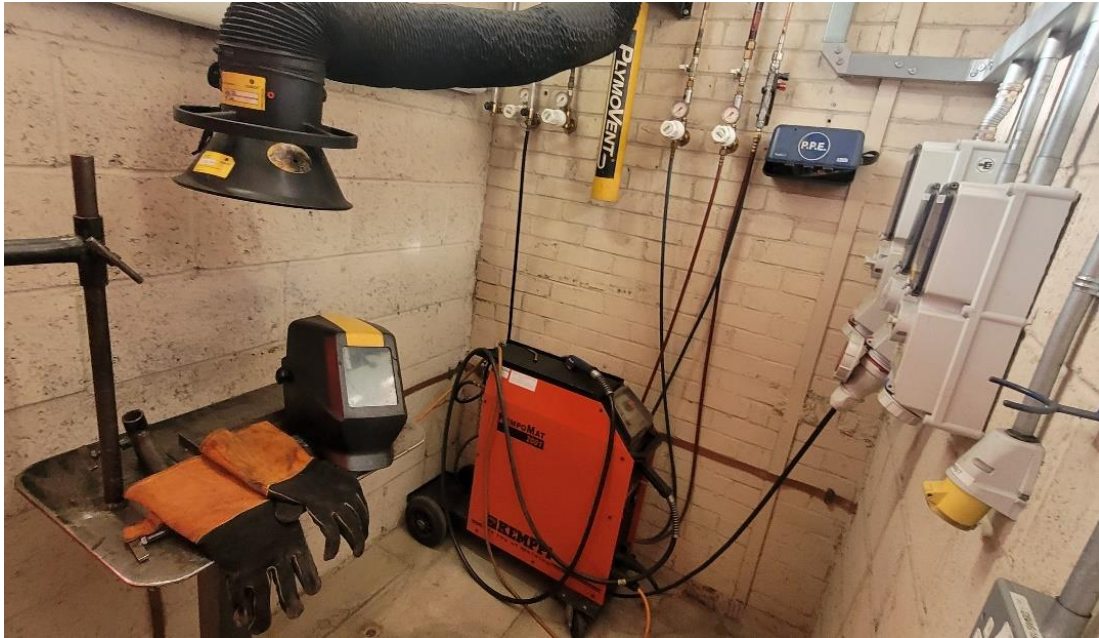
**Photograph 1:** Photographic evidence shows the correct tools and equipment placed in their working area within reach, but at a safe distance, and within a methodical order of use.

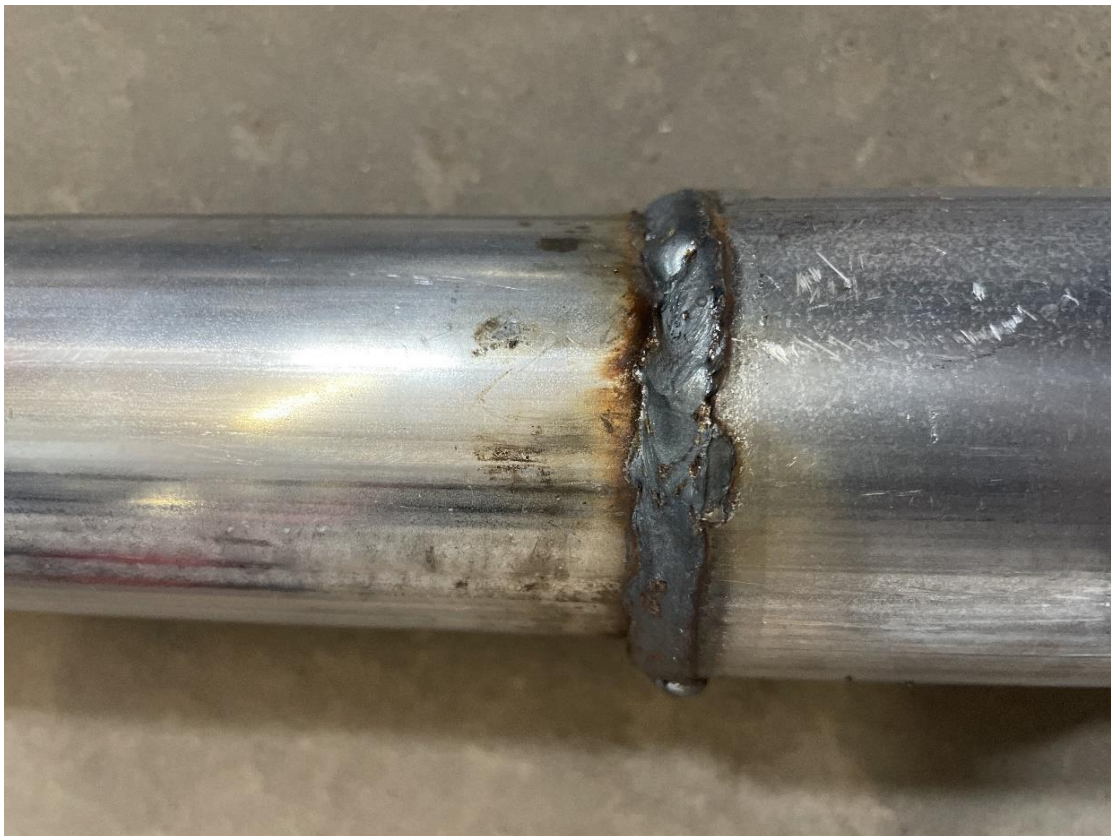
**Photograph 2:** Photographic evidence shows the clean welded joint between the exhaust pipe and extender.

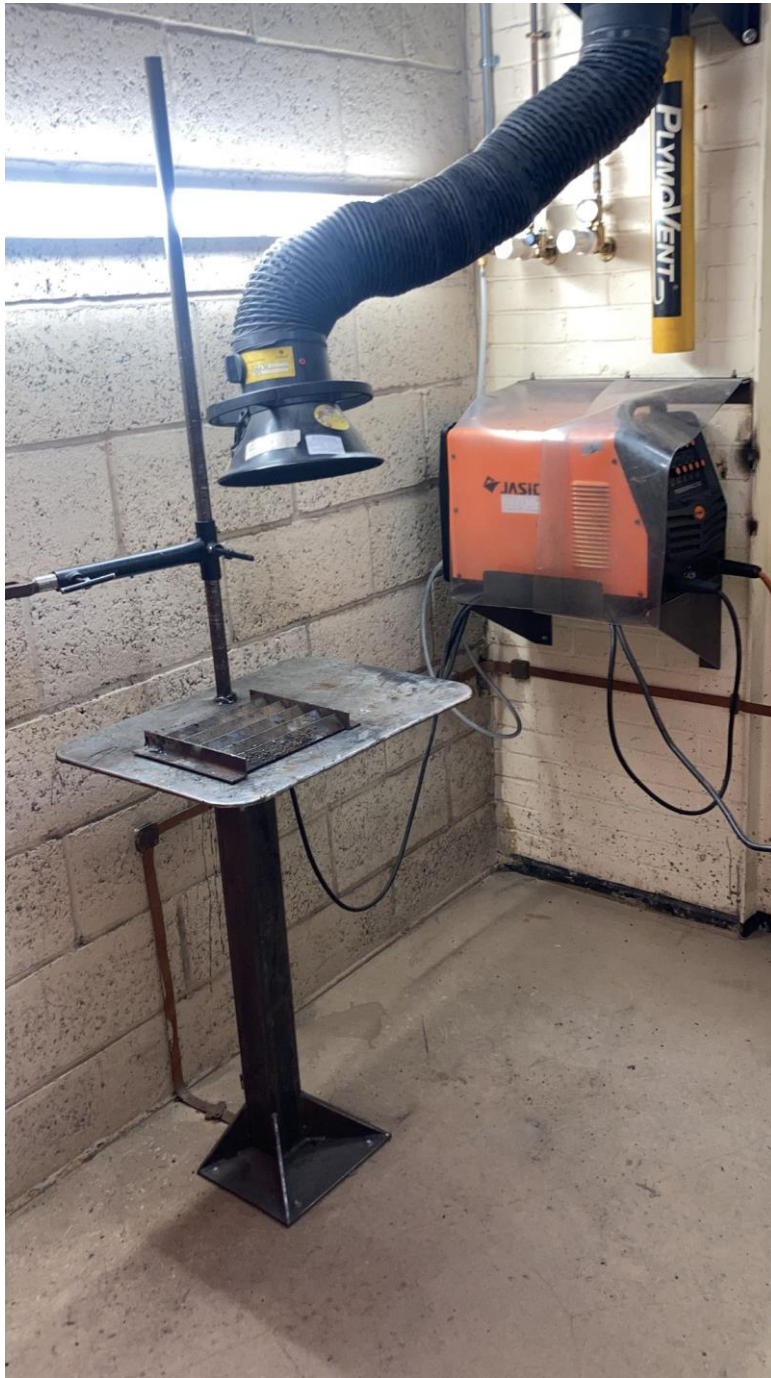
**Photograph 3:** Photographic evidence shows the re-instated working area thoroughly cleaned and tidied.

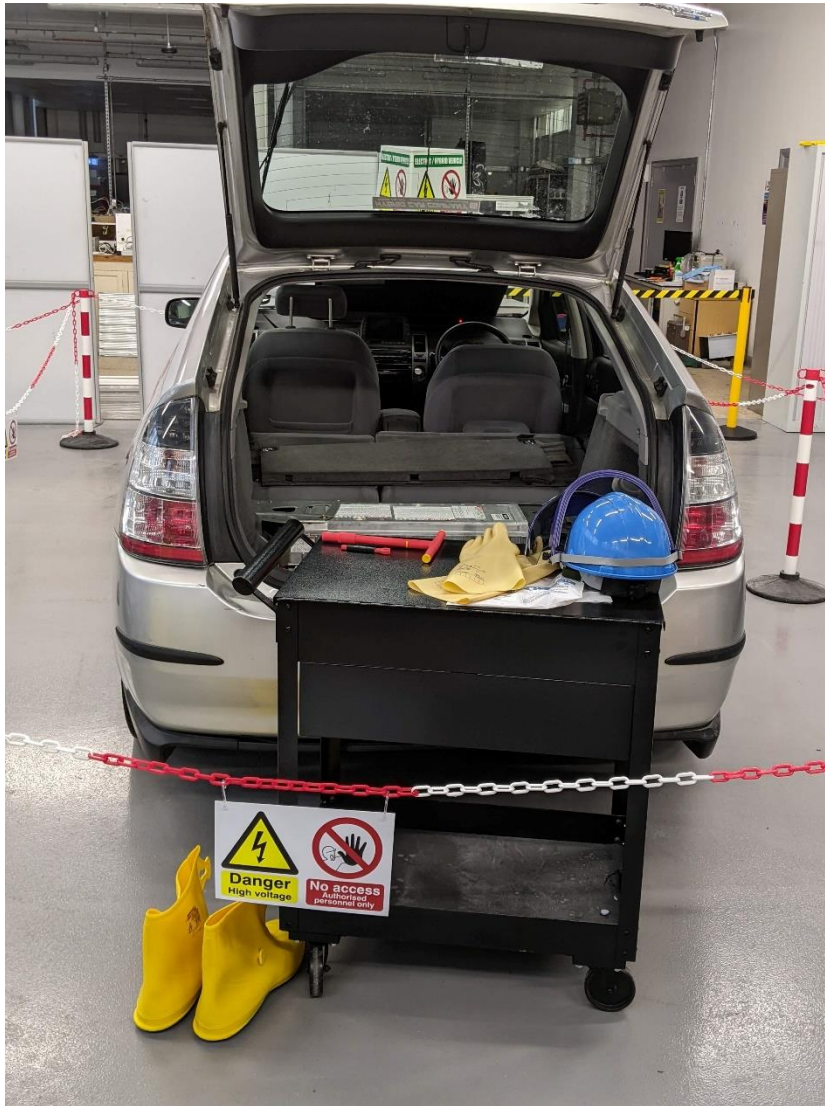
**Photograph 3:** Photographic evidence shows the high voltage battery exposed and candidate has prepared the vehicle and area for work and mitigating risk.

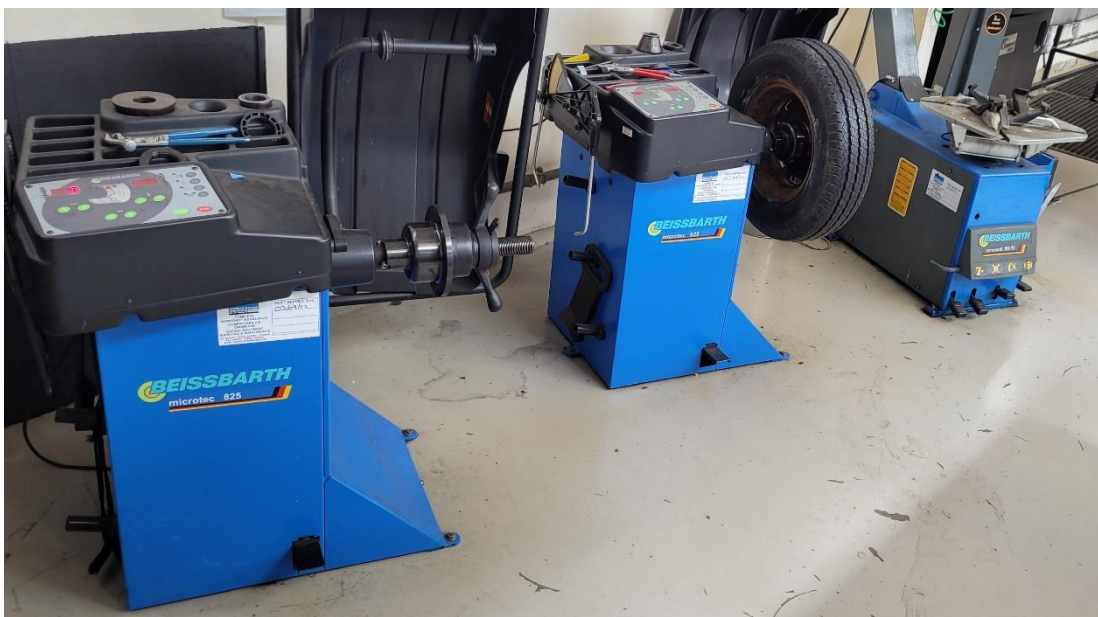
**Photograph 4:** Photographic evidence shows the re-instated wheel balancer working area cleaned and tidy.
