**T Level Technical Qualification in
Maintenance, Installation and
Repair for Engineering and
Manufacturing (8712-35)**

Light and Electric Vehicles (315)

**Guide standard exemplification
material**

**Threshold competence – Sample
2022**

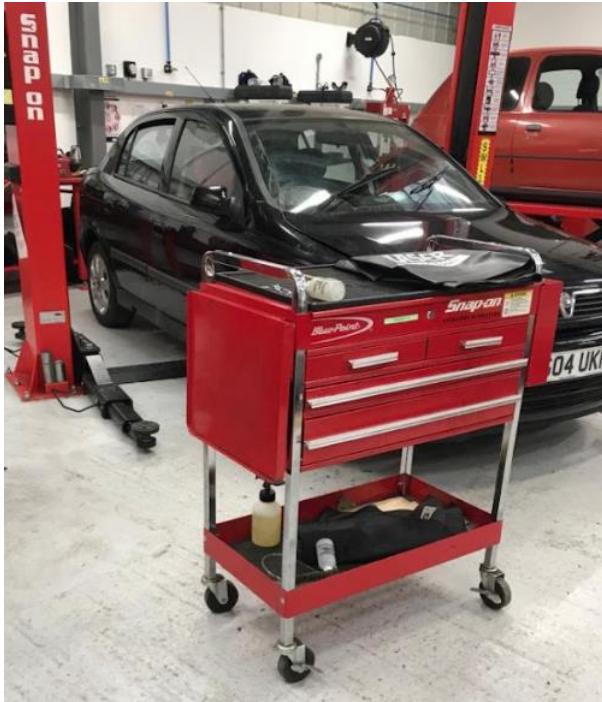
Photograph 1: Photographic evidence shows the prepared work area. Tools and equipment have been placed in the work area but have not been positioned in a fully logical sequence. Technical documentation is to hand but has been placed underneath the not yet fitted wing cover.

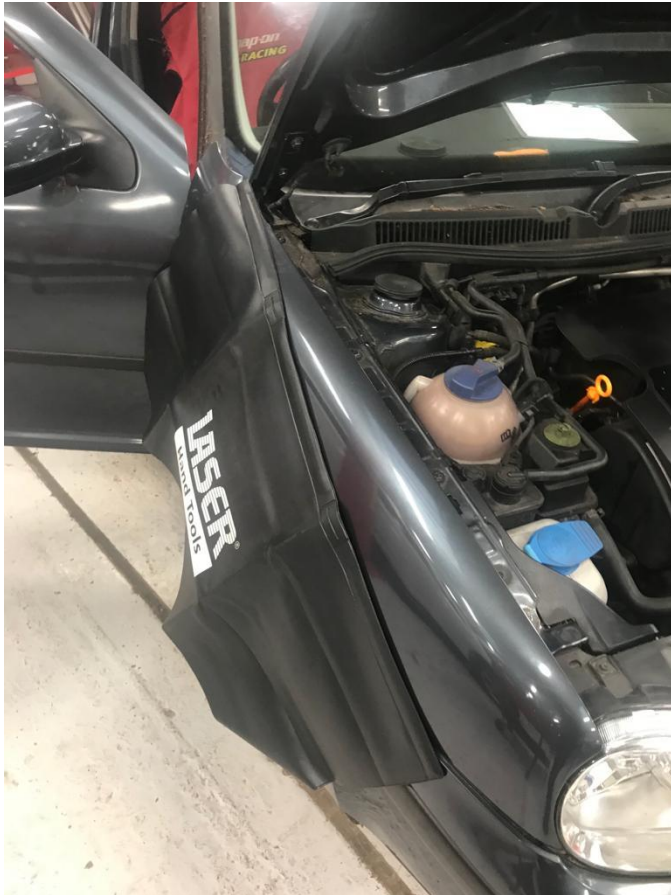
Photograph 2: Photographic evidence shows the prepared but not fully accurately fitted VPE on Vehicle 1, the wing cover is noted as sliding off.

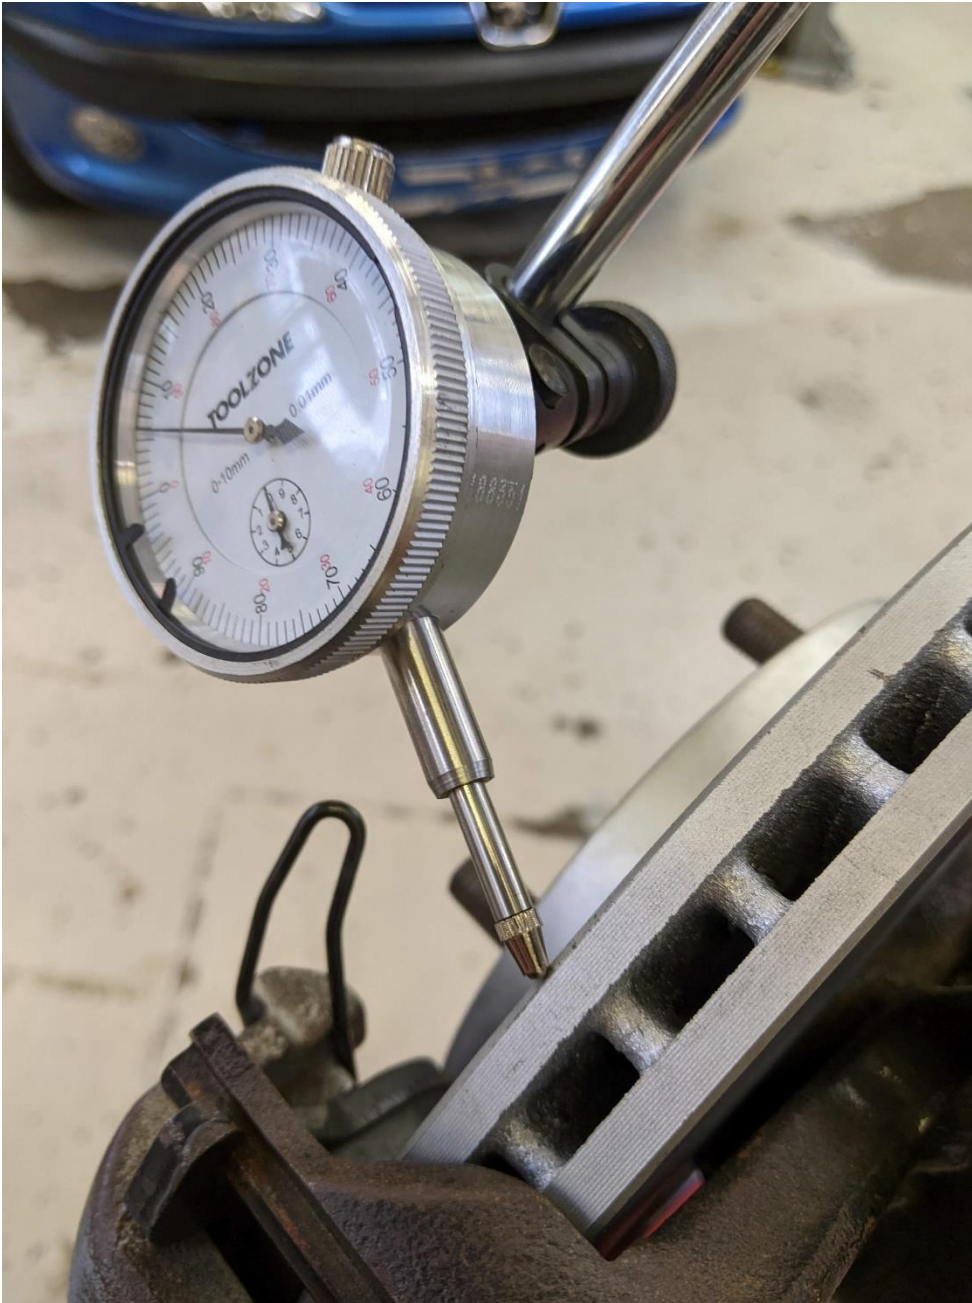
Photograph 3: Photographic evidence shows the initial set up and positioned DTI gauge to take brake run out readings, gauge has been set up to touch the outer edge of the disc which will give an inaccurate reading. This was subsequently corrected when the candidate realised the mistake and realigned.

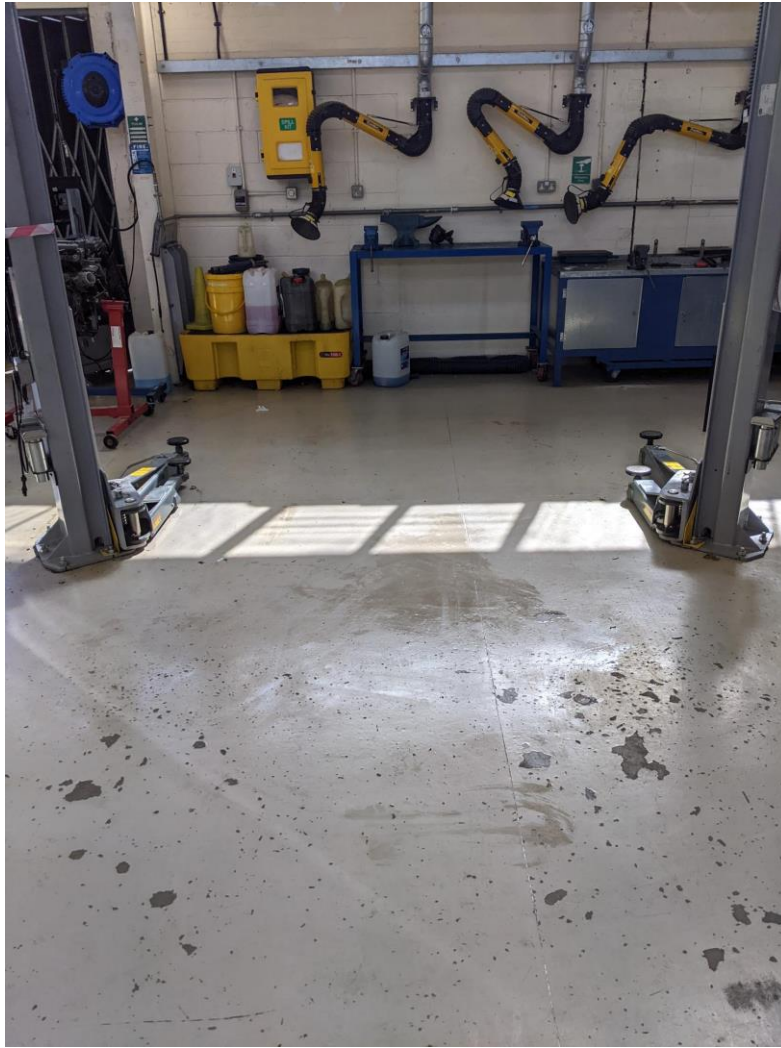
Photograph 4: Photographic evidence shows the two pillar working area reinstated correctly. The area has been cleaned, including an attempt to mop up a spillage – however the floor is still slippery so should include a slippery floor sign.

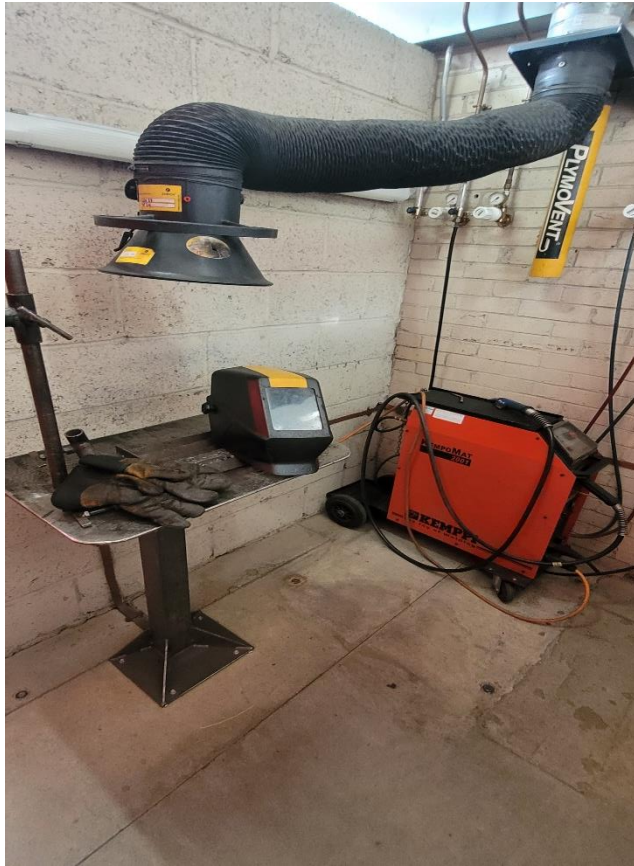
Photograph 1: Photographic evidence showing the prepared welding area, using heat proof gloves instead of long-sleeved welding gauntlets.

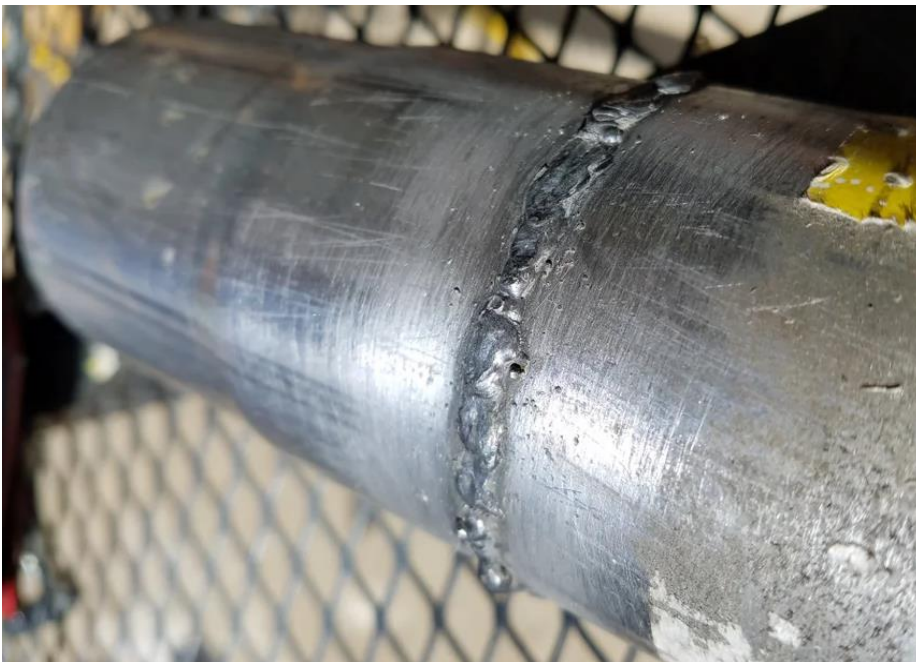
Photograph 2: Photographic evidence shows the welded joint between the exhaust pipe and extender, showing the level of quality finish with bubbles and a difference in weld thickness throughout the joint.

The candidate was able to demonstrate welding techniques showing adequate hand skills and correct use of tools and equipment, ensuring the weld was completed to a basic standard. For example, producing basic penetrated joints with some consideration for accuracy and finish, allowing the run to cool before the next run. To develop the response further, the candidate could ensure to clean the welded joint to provide a more thorough finish. For example, the candidate did not clean the welding surfaces, before, during or after if this was followed it would have provided the candidate with a more efficient finish. The candidate followed and met basic health and safety requirements throughout the task ensuring to separate waste into the correct bins. To further develop their response, the candidate should have ensured all tools and equipment were fully returned to correct storage, leaving the working area safe and tidy.

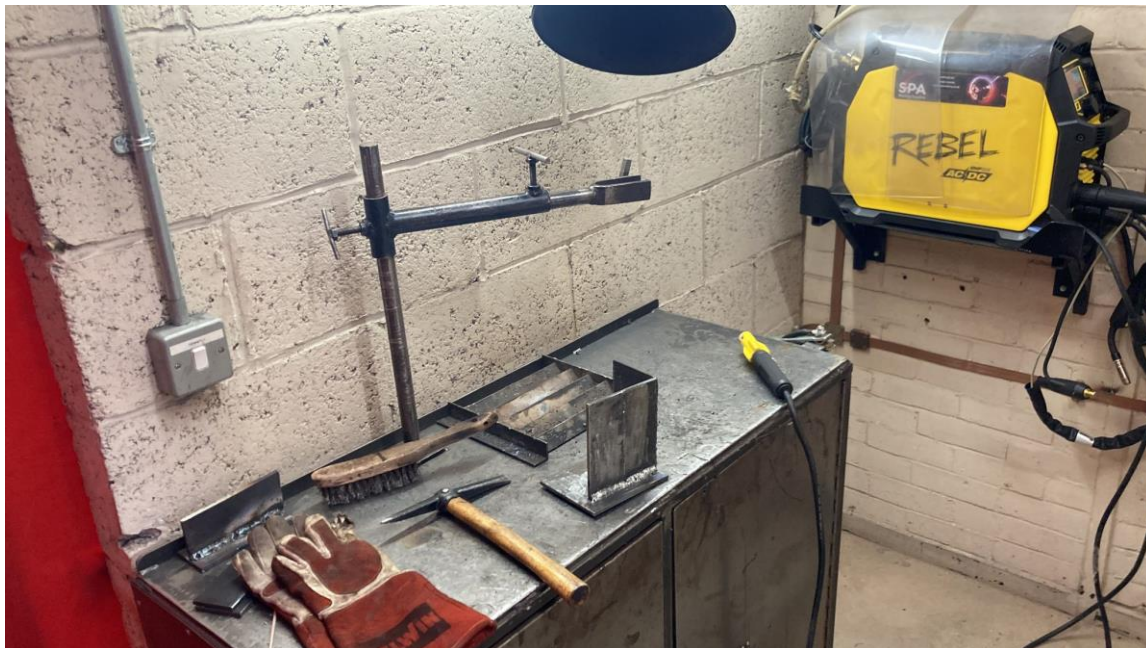
Photograph 3: Photographic evidence showing welding bay which has been cleaned to remove weld debris, but tools and equipment have not been fully returned to appropriate storage.

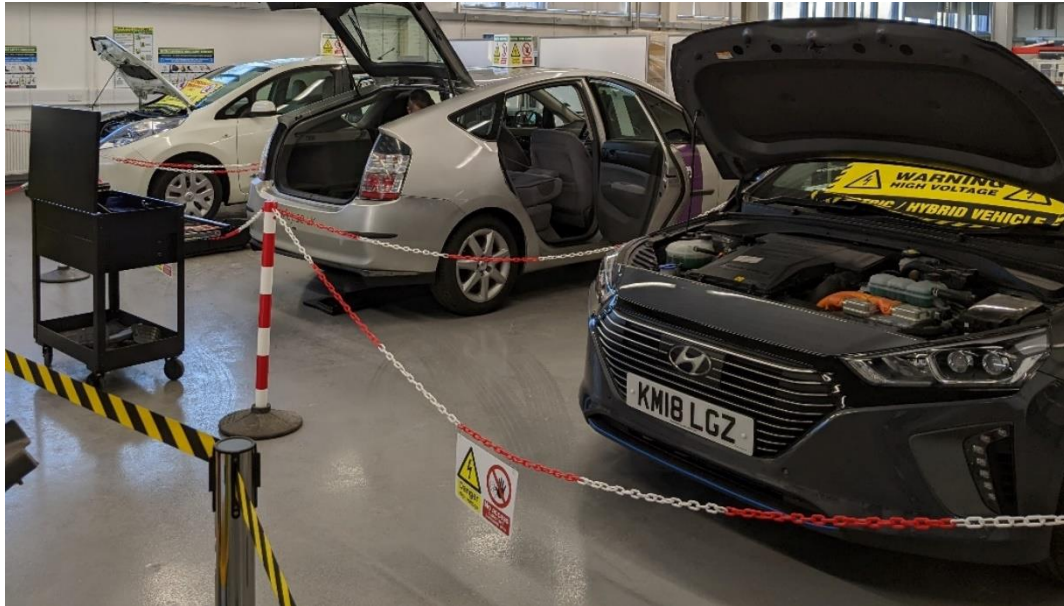
Photograph 1: Photographic evidence shows that the work area has been prepared with consideration of the task to be undertaken. Warning signs have been placed on the windscreen to reflect this is a hybrid vehicle, and a barrier has been erected for safety purposes. Tools, equipment and technical documentation have been collected and placed in a toolbox but this has been positioned away from the vehicle in a way that is not most effective for the work to be carried out, with some tools also placed underneath the toolbox and not positioned logically within the toolbox in the order needed.

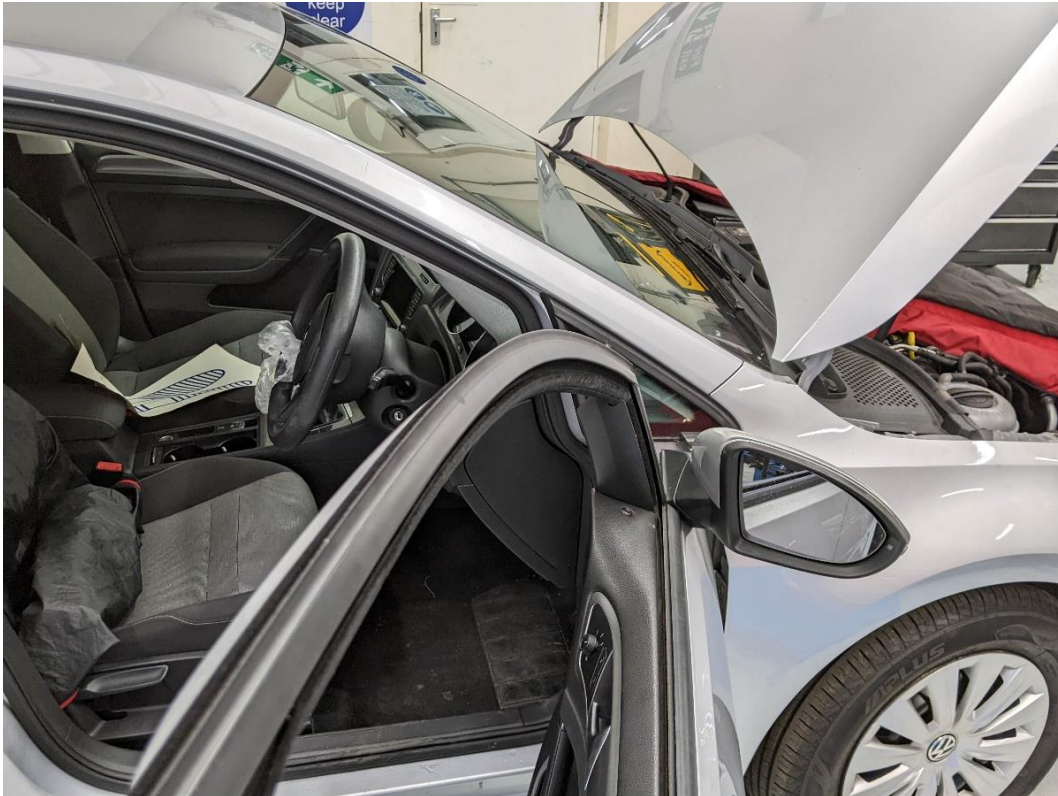
Photograph 2: Photographic evidence shows the prepared and not fully accurately fitted VPE. Steering wheel cover has mostly come off, the foot well protection is on the passenger seat rather than the driver's side floor and the seat cover has also partially come off from the seat. Wing cover has moved to under the bonnet instead of the wing.

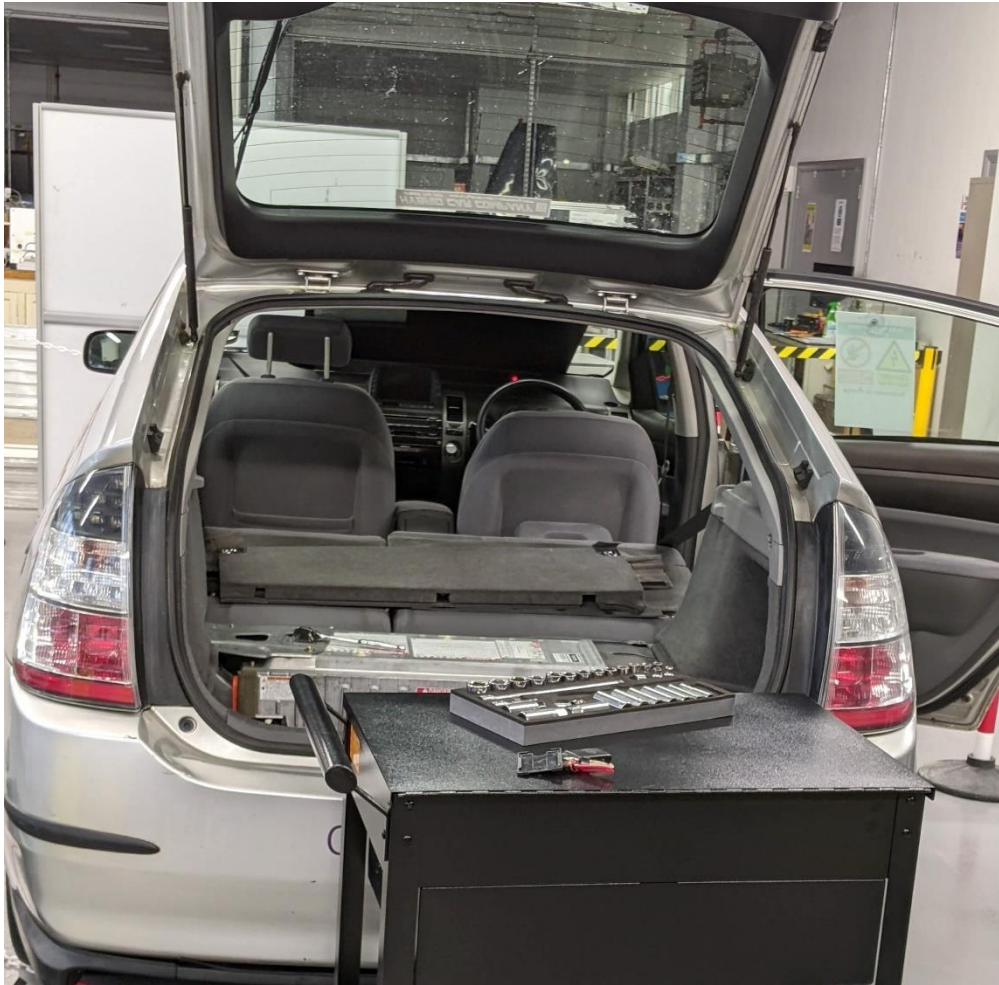
Photograph 3: Photographic evidence shows the high voltage battery correctly exposed with tools prepared but placed improperly.

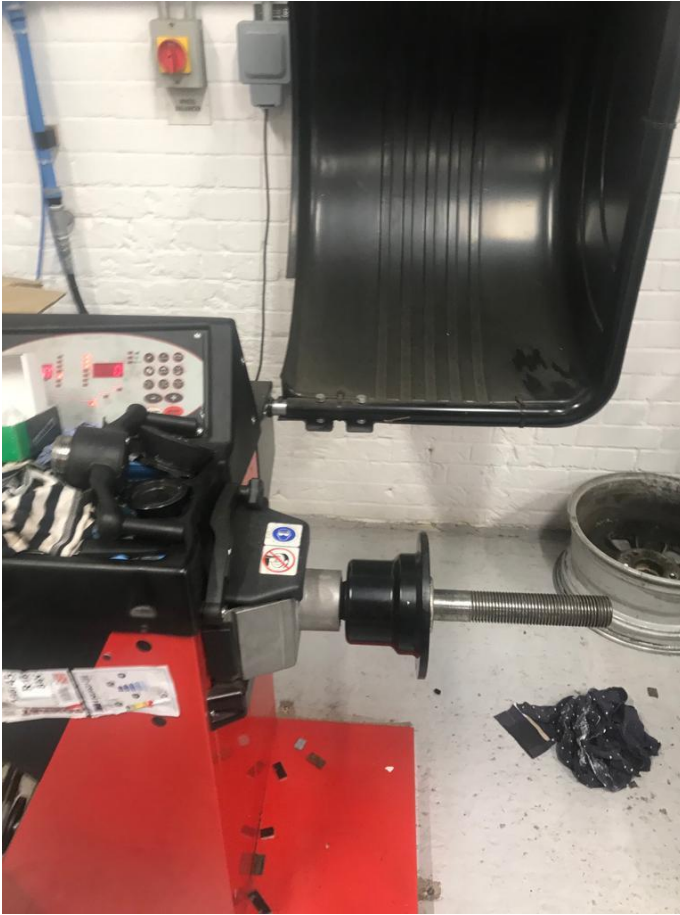
Photograph 4: Photographic evidence shows the re-instated wheel balancing work area, but not fully tidy.
