T Level Technical Qualification in Engineering, Manufacturing, Process and Control (8713-32)

Machining and Toolmaking Technologies (332)

Guide Standard Exemplification Material Threshold Competence - Sample

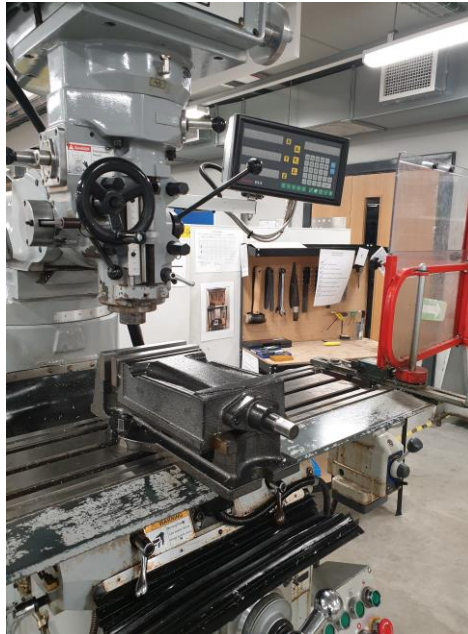
Photograph 1 – showing the prepared mill work area.

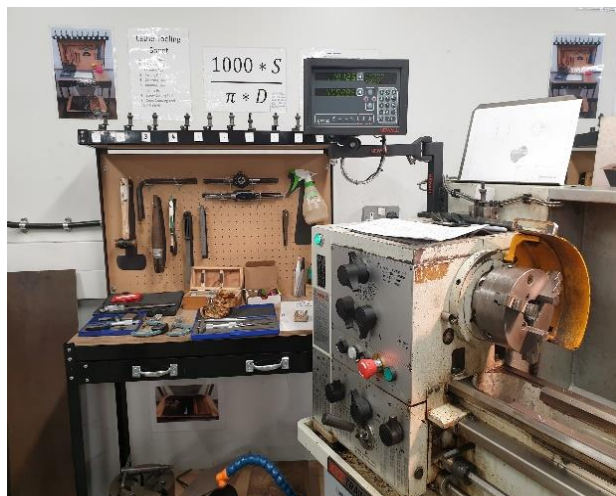
Photograph 2 – showing the lathe area, clear of debris and all tools and equipment are correctly stored on the shadow board next to the machining area.

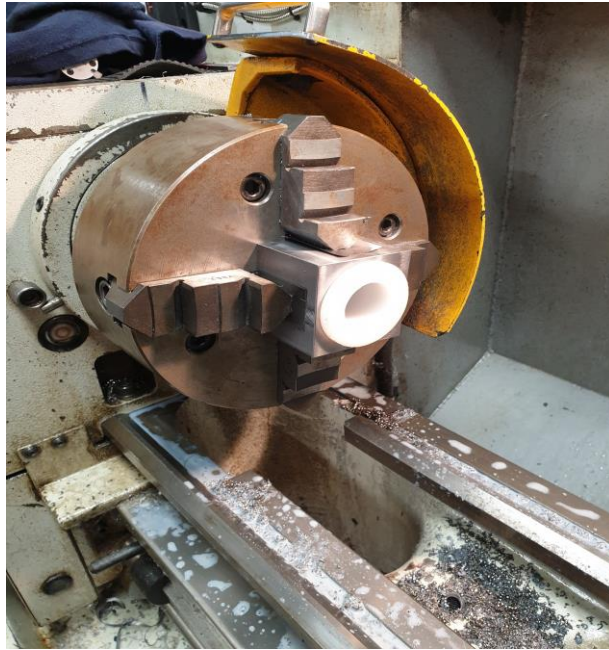
Photograph 9 – showing the bored out bearing housing, some additional adjustment was required until the nylon top hat was a push fit.

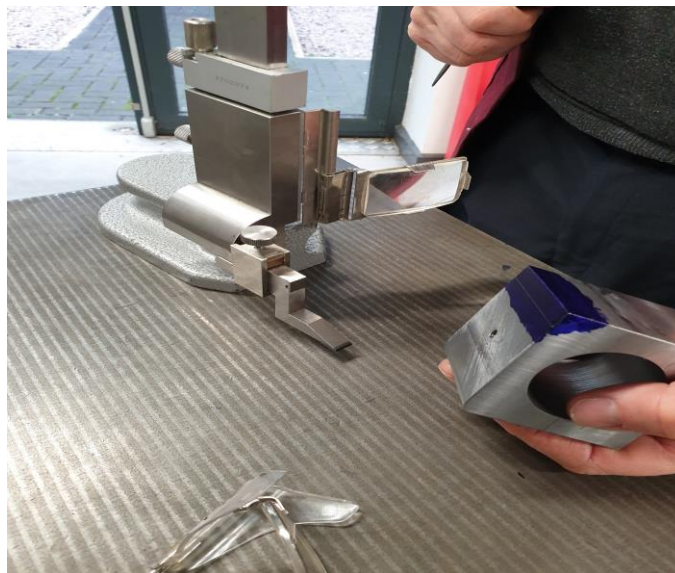
Photograph 10 - showing 8mm chamfer blued and marked with the vernier height gauge.

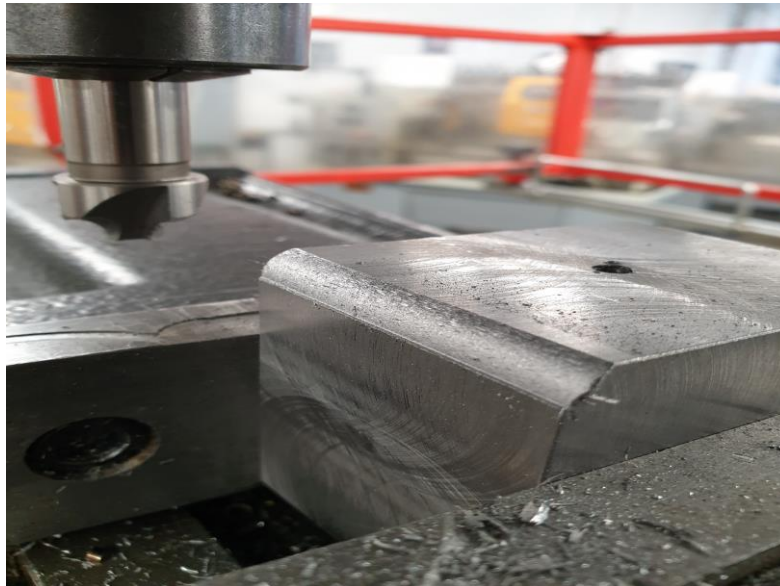
Photograph 11 – showing the chamfer machined using a 45-degree setting piece and a carbide tipped 16mm end mill. The R10 has cut in too deeply on the X axis. This means the form is too far in the block and has created a step.

They gave brief summaries of the activities undertaken and only mentioned some of the issues they encountered. The candidate did not fully explain the reasons for all the surface defects and did not attribute them to a process or state any remedial action. The candidate did not make reference to the defect created when creating the chamfer on the bearing housing.

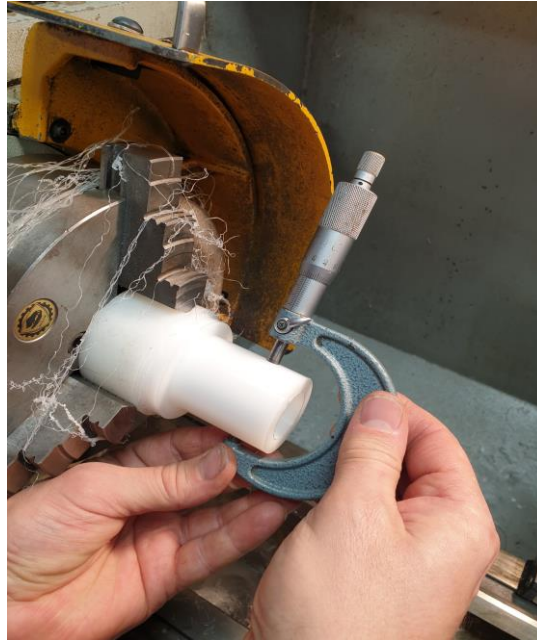
Photograph 13 – showing the candidate checking the external bore with a micrometer. The candidate ensured the excess swarf was cleared from the moving parts most of the time. The swarf was collected in a different bin to the metal swarf.

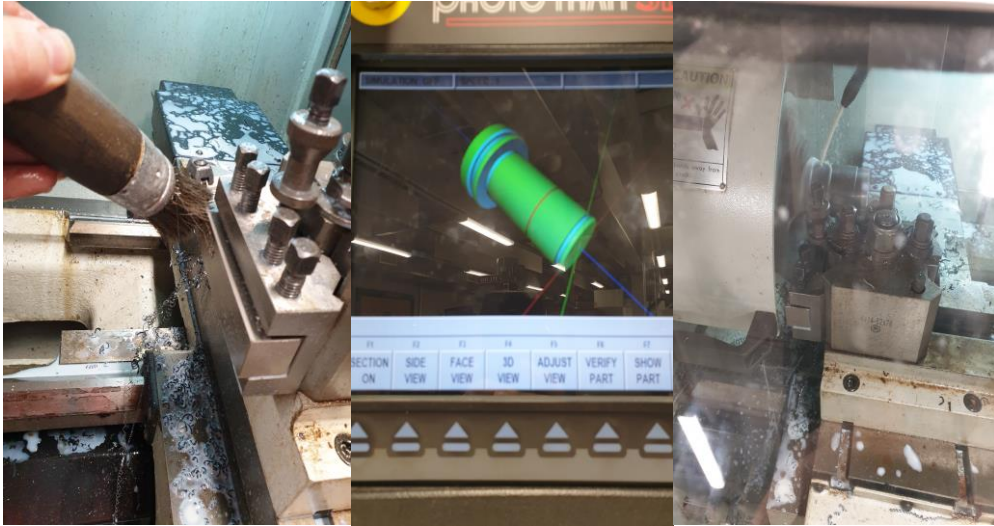
Photographs 15, 16 and 17 – showing the use of the CNC lathe including a tip change.

The tool tip had wear and was changed, the bar was chucked into the right distance from the chuck. The program simulation was run to see the general outlook of the part. The program was then run but in tracking mode to start with to prove first pass. The part was then changed to CNC mode. Coolant was turned on and part run with the 4 tools being changed at the right time.
