T Level Technical Qualification in Engineering, Manufacturing, Processing and Control (8713-34)

Fabrication and Welding Technologies (334)

**Guide standard exemplification
material**

**Threshold competence – Sample
2022**

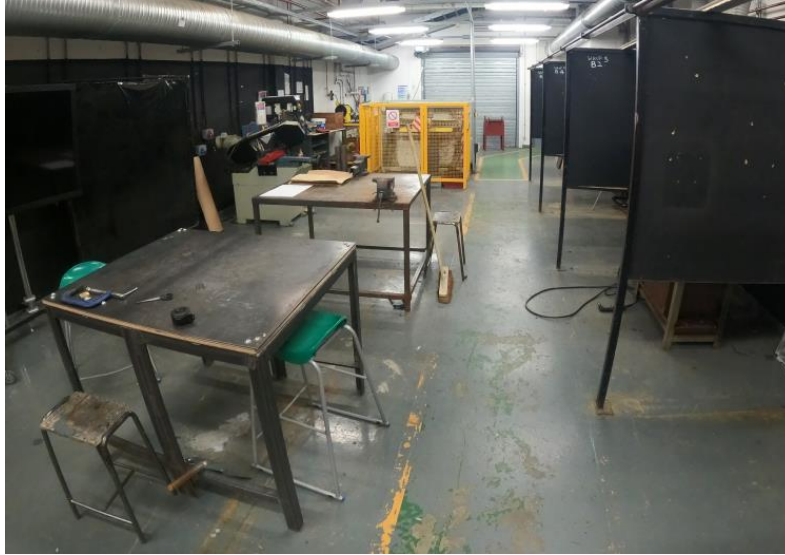
Preparing the work area (Photograph 1)

Photograph 1 – showing the work area prior to activities being started. Photograph shows the area of work has some tools left on bench, with a cable slightly onto the walkway. Stools should be tucked away or removed completely and tools to be stored correctly.

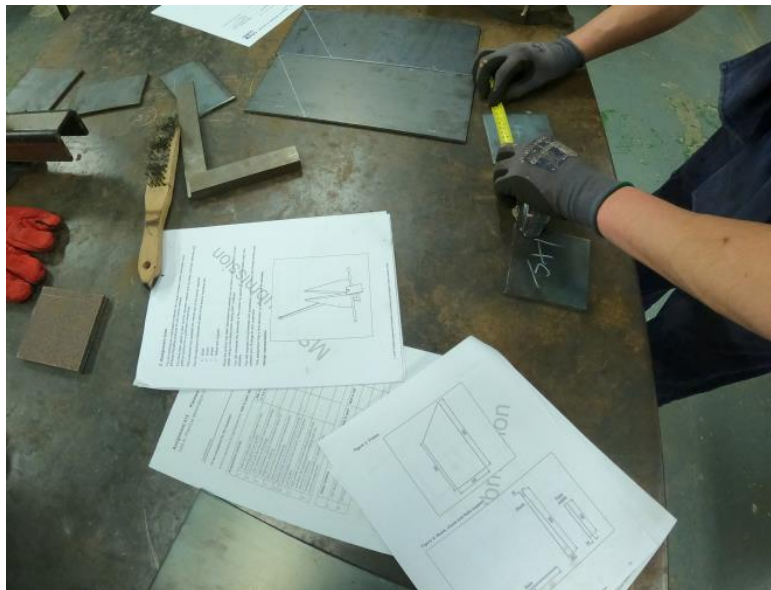
Photograph 2 - showing the candidate using a tape measure and chalk to produce marked components. Excess tools, materials are still present on the workbench such as wire brush.

Use of measuring equipment	<p>The candidate completed visual checks on the measuring equipment. Some poor techniques of measuring (using end of tape rather than 100mm from the end) was observed. The measuring tape and chalk is a less accurate method than that of an engineer’s steel rule and scribe.</p>
Assessor signature	Date
Assessor A	17.11.21

Marking out has been completed, the methods used lack efficiency resulting in some inaccuracies and some excessive waste materials created. For example, the candidate opted for using equipment such as a measuring tape and chalk, which is less accurate than that of an engineer's steel rule and scribe as the ends of tapes are prone to damage – therefore becoming less accurate over time. A more developed level of knowledge and understanding would have been demonstrated if the candidate had measured 100 mm from the end of the tape or had chosen the scribing method.

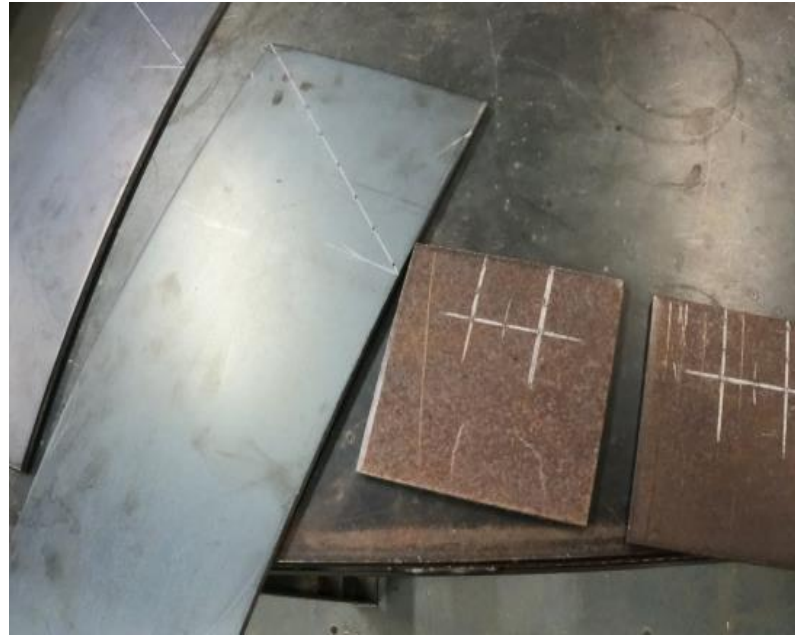
Photograph 3 – showing the markings on the plates, it can be seen there are scribed marks which are inaccurate on the right-hand side. These were eventually corrected by the candidate.

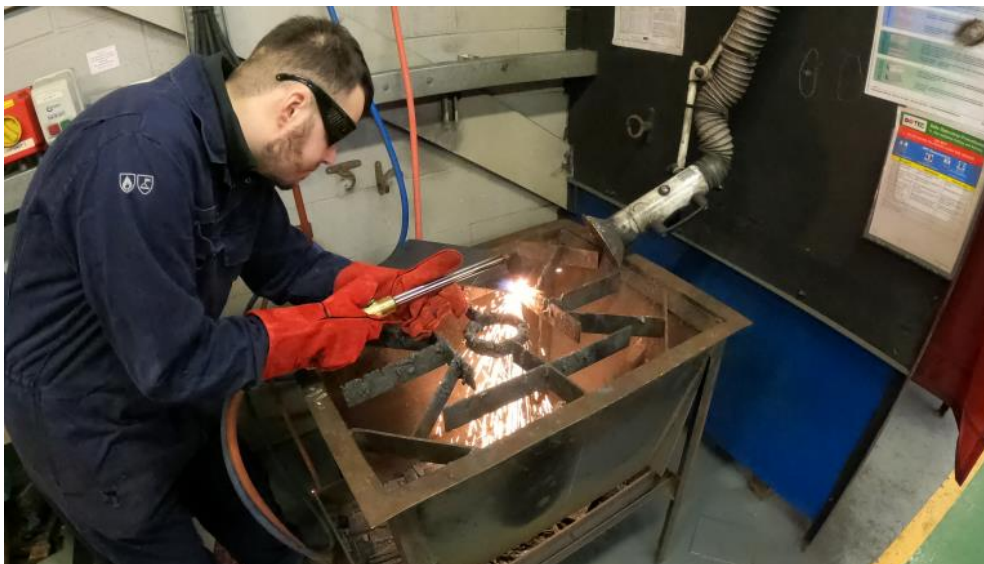
Photograph 4 – showing the cutting of the components using oxy-fuel (acetylene) cutting process.

The candidate did carry out basic checks for safety on the oxy-fuel equipment including performing a gas leak test prior to use, showing some good knowledge of the safety process.

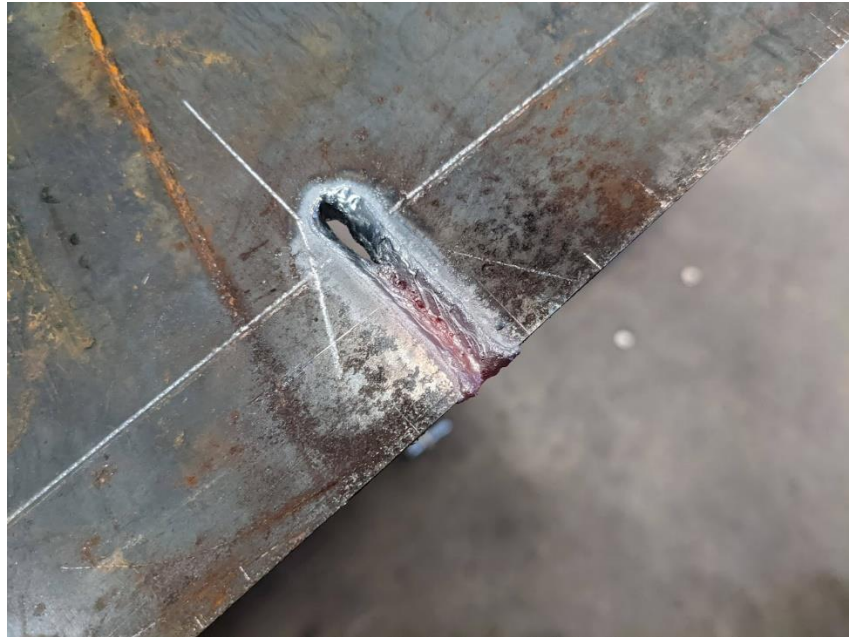
Photograph 5 – showing inaccurate cutting when cutting the metal using oxyacetylene, the cut extends beyond the scribed marks.

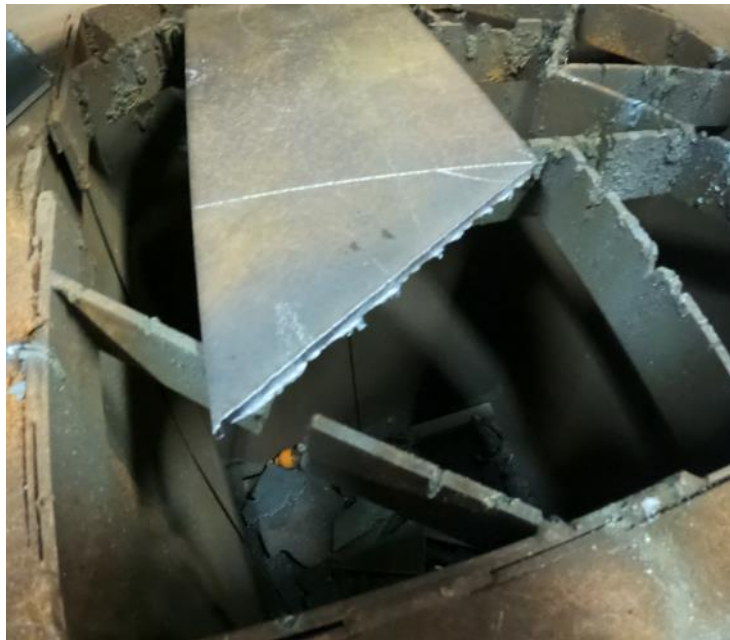
Photograph 6 – showing the cuts before any welding preparation. Cut lines should be straight to the scribed lines to maintain the dimensions of the component.

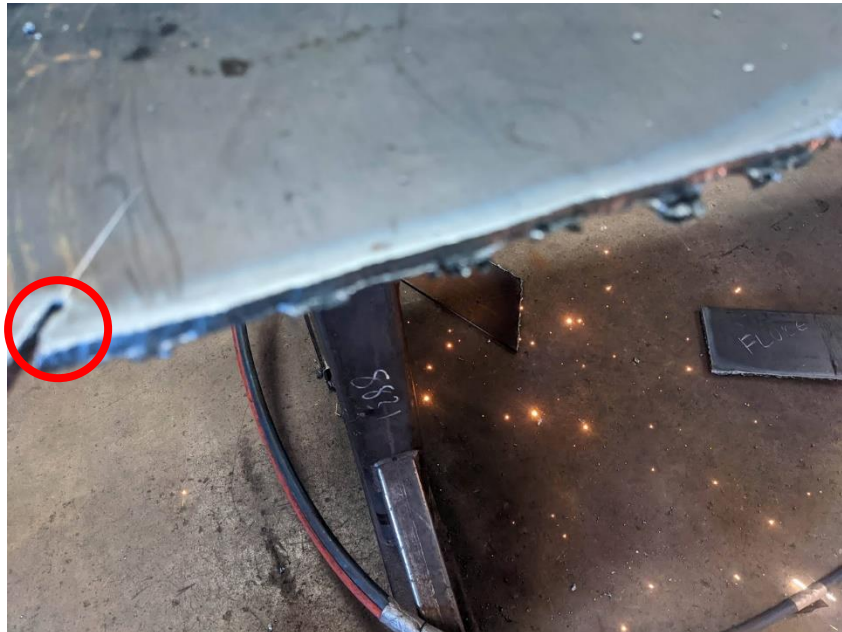
Photograph 7– showing an example of uneven cutting. Cut lines should be straight to the scribed lines to maintain the dimensions of the component. Note the extra cut made to the left of the picture. Note the trailing gas hoses under the work bench which should be avoided to prevent damage to the hoses from falling debris.

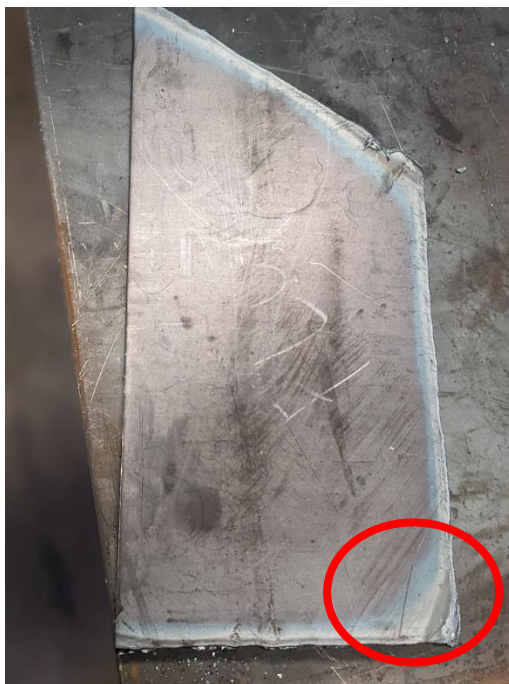
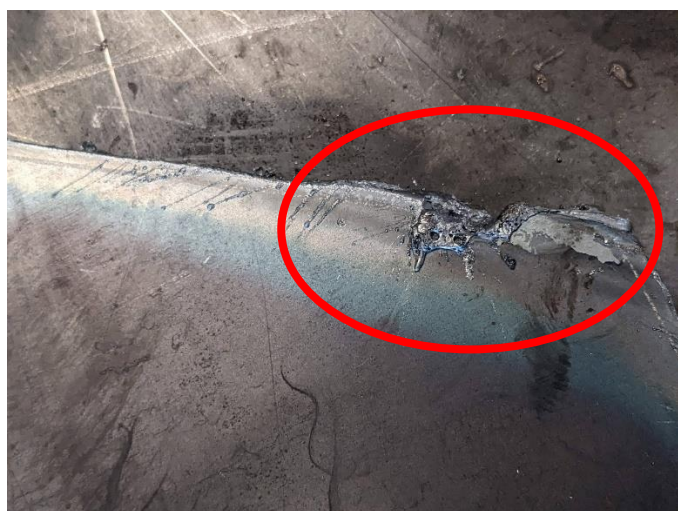
Photographs 8 and 9 – showing an example of uneven cutting and some warping to the bottom left corner. Cut lines should be straight to the scribed lines to maintain the dimensions of the component. Note the defect to the top right of the picture (enlarged).

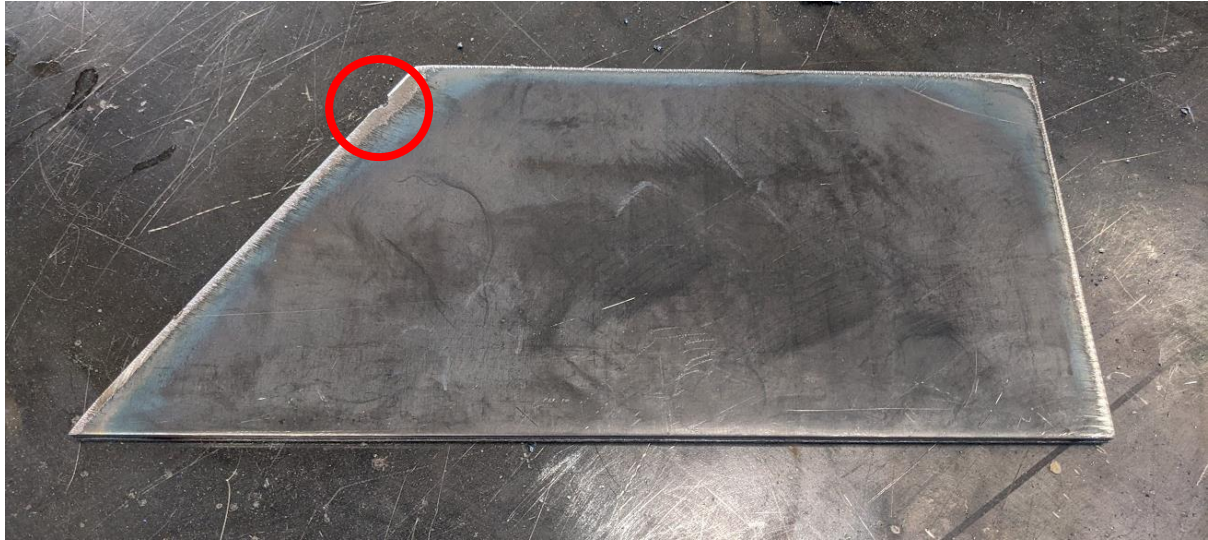
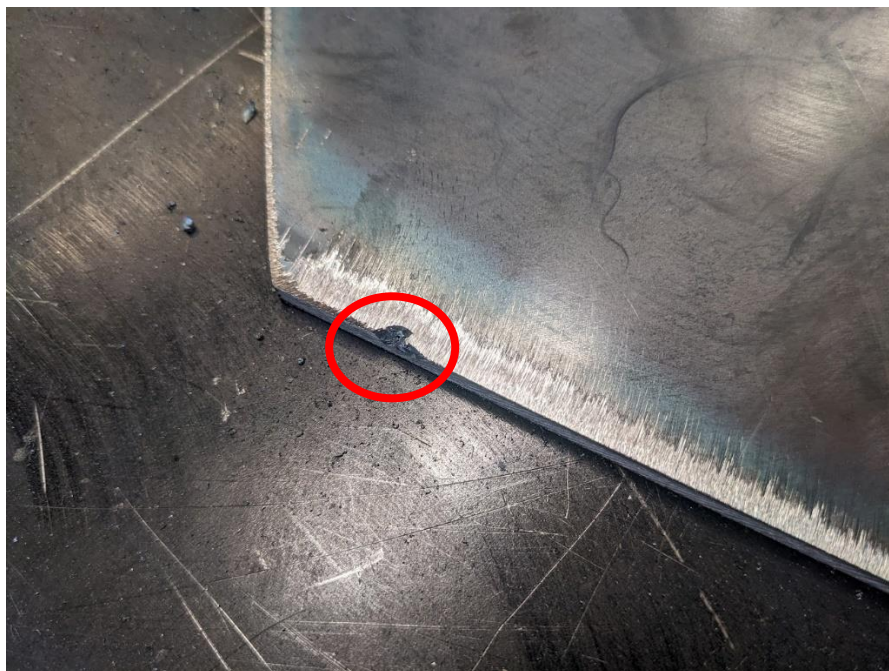
Photographs 10 and 11 - showing the fluke component shown in photographs X and X after grinding and preparing the component for welding. Note the defect in the cut remains and the warped corner has been rectified.

Preparing cut components for welding	<p>The candidate selected an angle grinder and appropriate wheel to abrade the cut edges. The candidate checked the grinder and the condition of the selected wheel before use.</p> <p>The candidate clamped the cut piece to the table. The candidate mostly used the appropriate angle, speeds and pressure when applying the grinder to the surface, but this was not consistent resulting in some unevenness.</p>

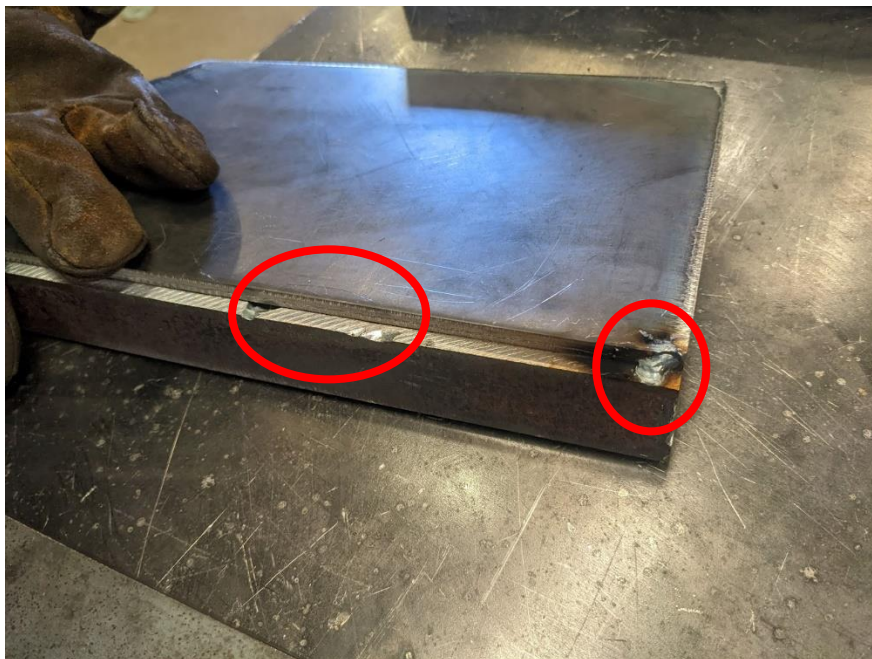
Photograph 16 – showing application of tack welding, note the damage to the component.

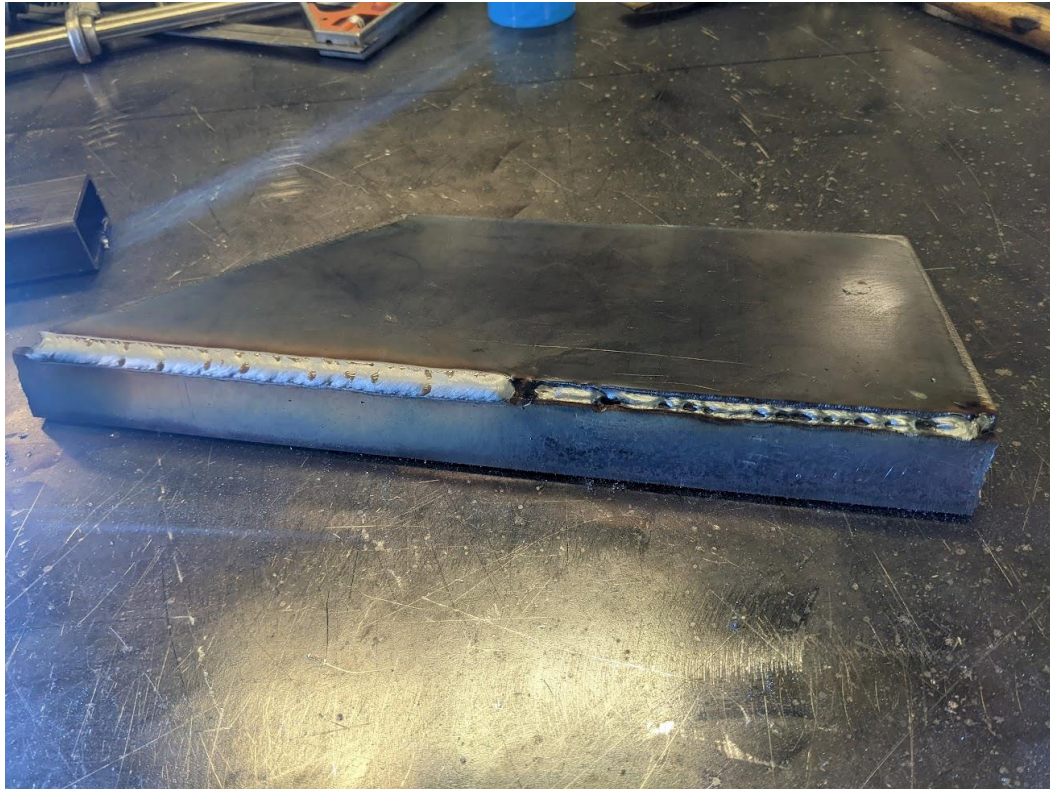
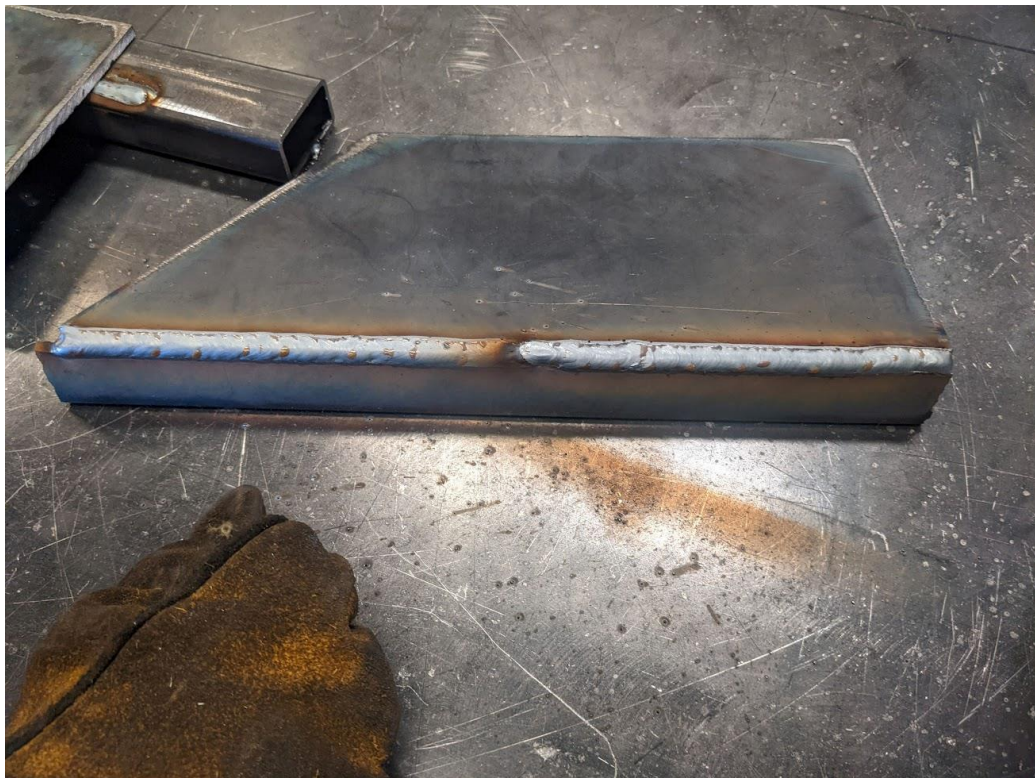
Photographs 19 and 20 – showing the welding of the fluke support to the fluke. The welding application has been unevenly applied and required rectification.

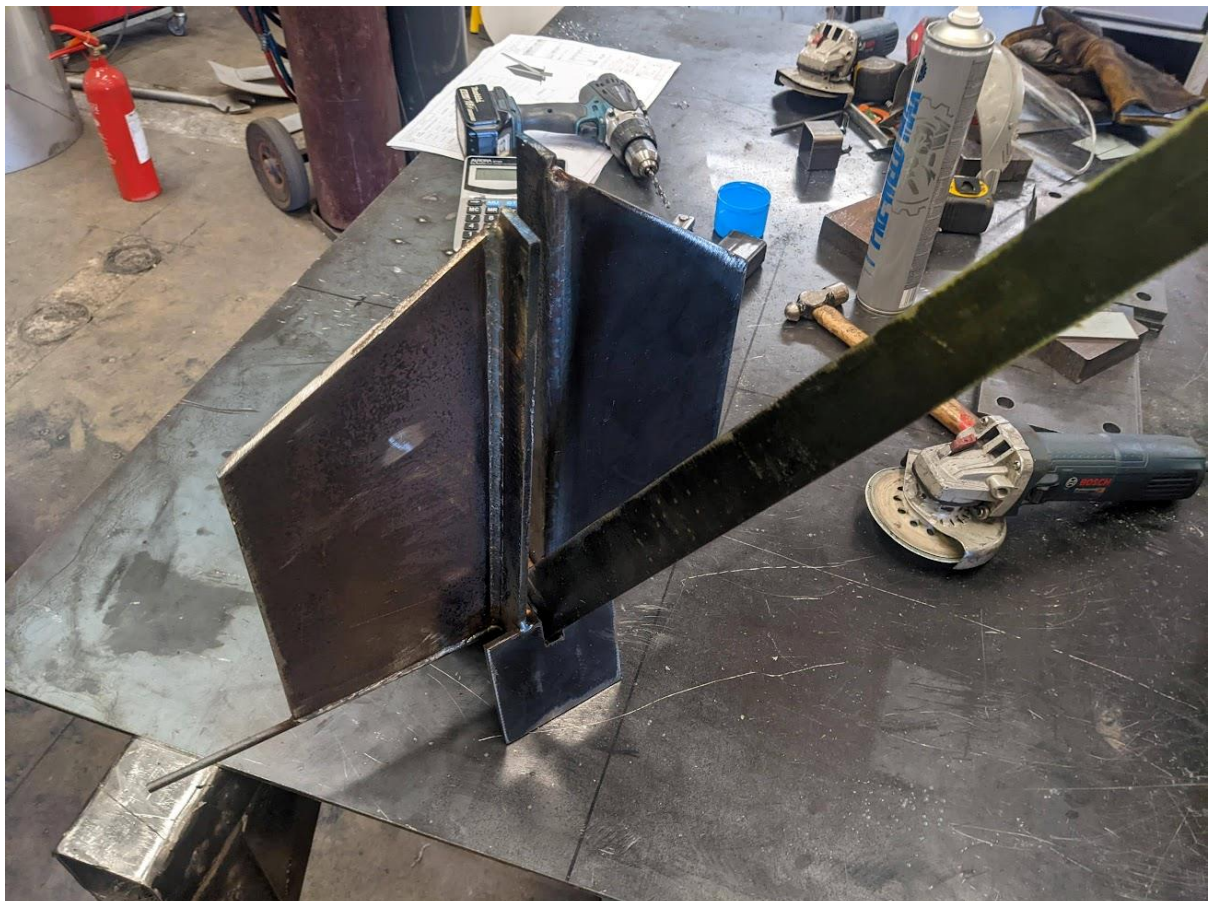
Fabricated anchor (Photographs 21 – 23)

Photographs 21, 22 and 23 – showing the fabricated anchor.

I completed a visual check of the completed assembly to check the finish and identify any visible surface defects. There were no obvious breaks in the welds and some excess weld material was seen on the flukes. The flukes had some areas of warping.

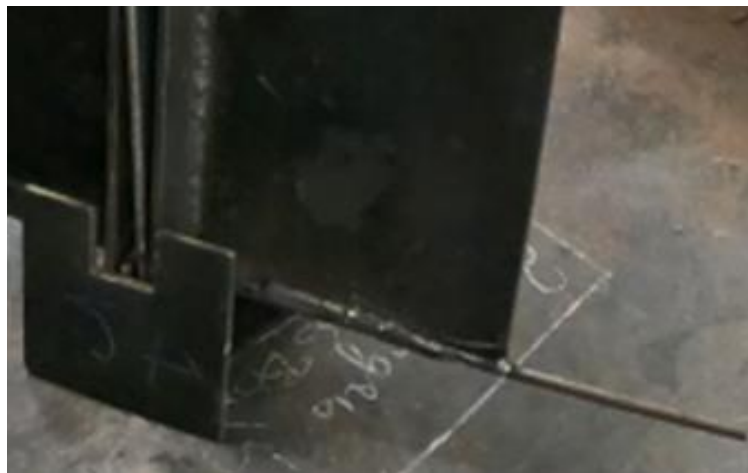
Photograph 26 – showing close up of the welding, some uneven weld can be seen.

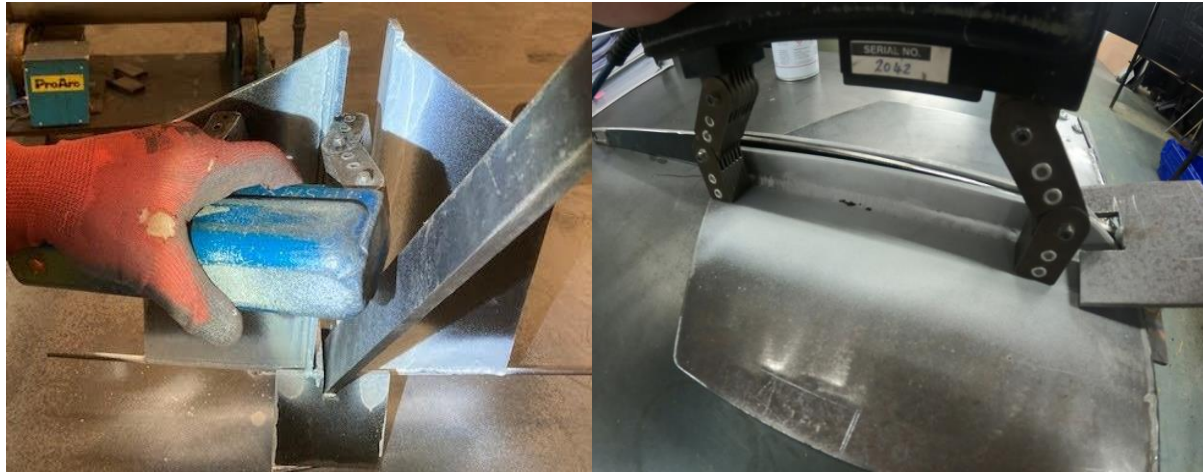
Photographs 27 – 28 show the application and result of using the magnetic particle inspection (MPI) non-destructive testing method.

Photographs 27 and 28 showing the application of the magnetic particle inspection method process. The MPI test showed small surface defect (crack along weld-toe). This could be rectified by grinding and then re-welding. Incorrect use of the magnet shown, welds need to be sprayed with white magnetic particle powder before applying the magnetic. An even coverage should be applied but care should be taken to not saturate the workpiece or the work area.

The candidate demonstrated Magnetic Particle Inspection (MPI), a Non-Destructive Testing (NDT) method on three welds to check for sub-surface defects or flaws. Detectable defects were identified, recorded and attributed to a process or procedural deficiency, for example, the NDT process revealed a sub-surface defect in the fluke support. The candidate demonstrated a basic understanding of NDT procedures, for example, as a result of poor technique using the testing equipment during the testing of the Crown weld, an equipment fault was encountered, resulting in the candidate having to do a retest.

where a defective weld is detected and give a visible indication. This process is used for all three selected welds. Once tested the anchor is demagnetised and the anchor is cleaned of all MPI fluid and residue.

The MPI test result showed that the two selected welds on the crown had passed and were to BS EN ISO 5817 standard. The weld on the fluke failed the test. The test showed a sub-surface break in the weld. The fluke weld failed due to a defect within the welding process, where the base metal and weld metal had not properly fused. A copy of my quality check sheet is included below:

Three welds selected and tested using MPI method. Fluke weld failed due to incomplete fusion between the base metal and weld metal. Crown welds passed minimum pass criteria.
One of the welds tested did not pass the quality required due to a defect within the welding process. Rectification would be grinding down and re-welding.
The final appearance was acceptable, some surface markings that were slightly inaccurate, leaving marks on the surface, detracting from the final appearance.
