# **T Level Technical Qualification in Manufacturing, Processing and Control – Machining & Toolmaking**

## **Centre Standardisation Materials**

# Candidate A

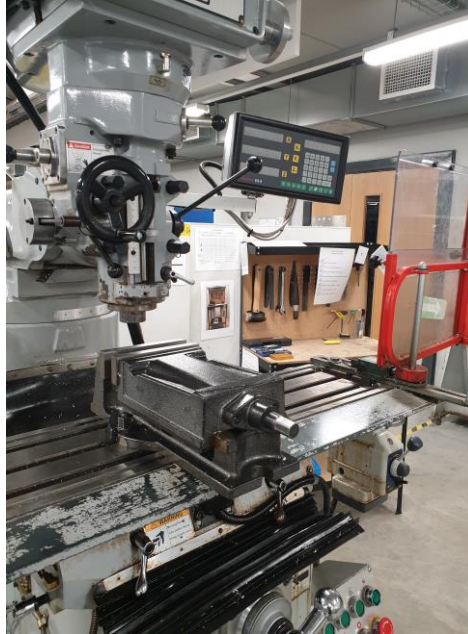
Photograph 1 – showing the prepared mill work area.

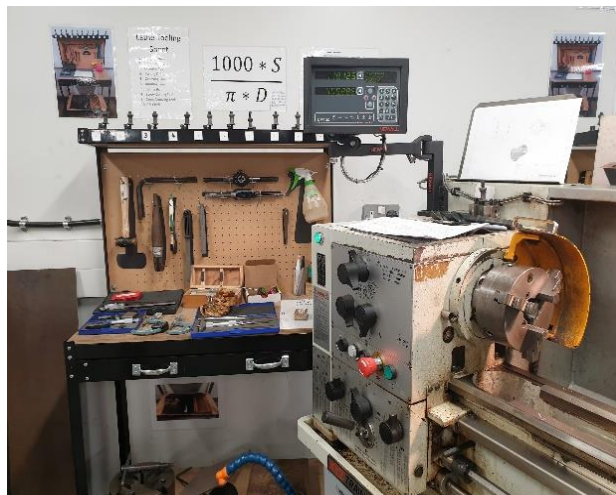
Photograph 2 – showing the lathe area, clear of debris and all tools and equipment are correctly stored on the shadow board next to the machining area.

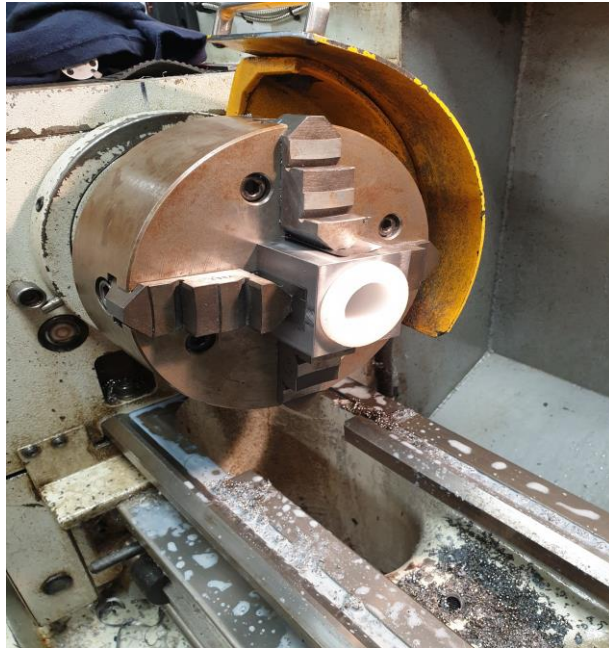
Photograph 9 – showing the bored out bearing housing, some additional adjustment was required until the nylon top hat was a push fit.

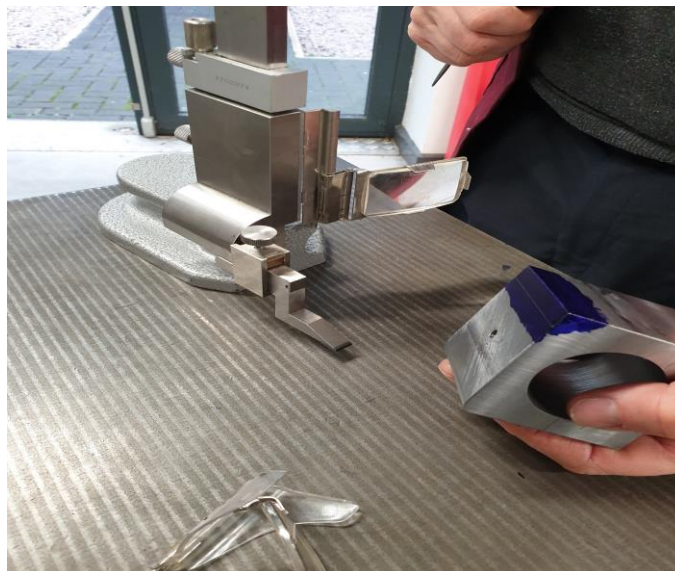
Photograph 10 - showing 8mm chamfer blued and marked with the vernier height gauge.

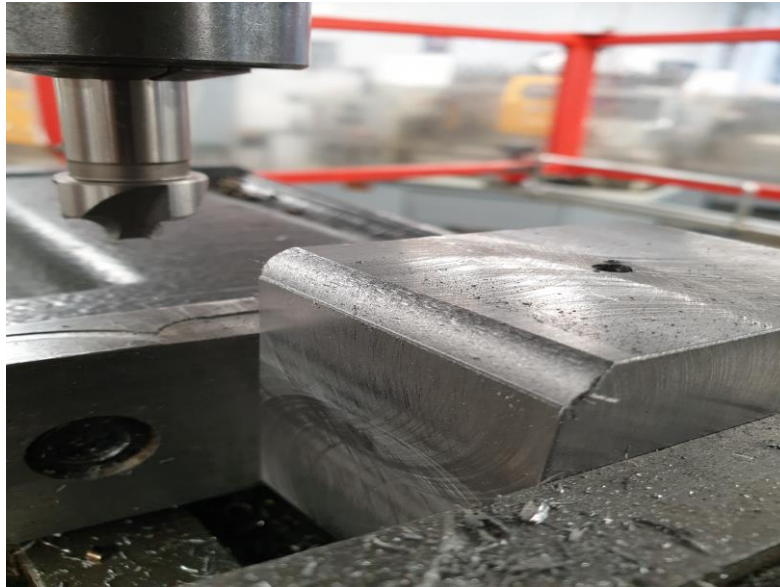
Photograph 11 – showing the chamfer machined using a 45-degree setting piece and a carbide tipped 16mm end mill. The R10 has cut in too deeply on the X axis. This means the form is too far in the block and has created a step.

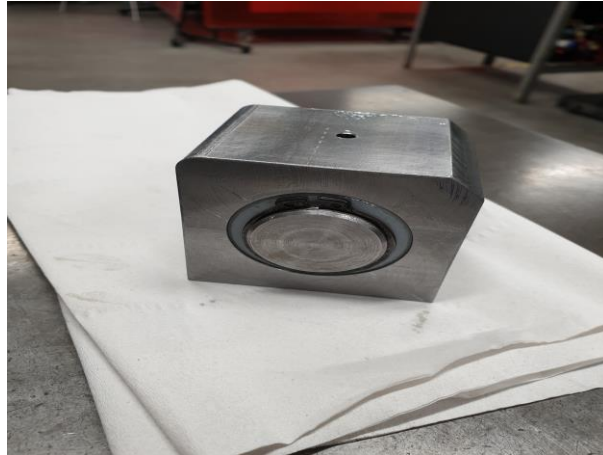
Photograph 21 - showing the completed bearing assembly, all components correctly seated. The candidate had to make several adjustments to the fit before the components were sufficiently seated in the bearing housing.

To check the functionality, I checked the fit of the components by spinning the assembly to check the bearing operated correctly. The fit was a little loose but was acceptable.

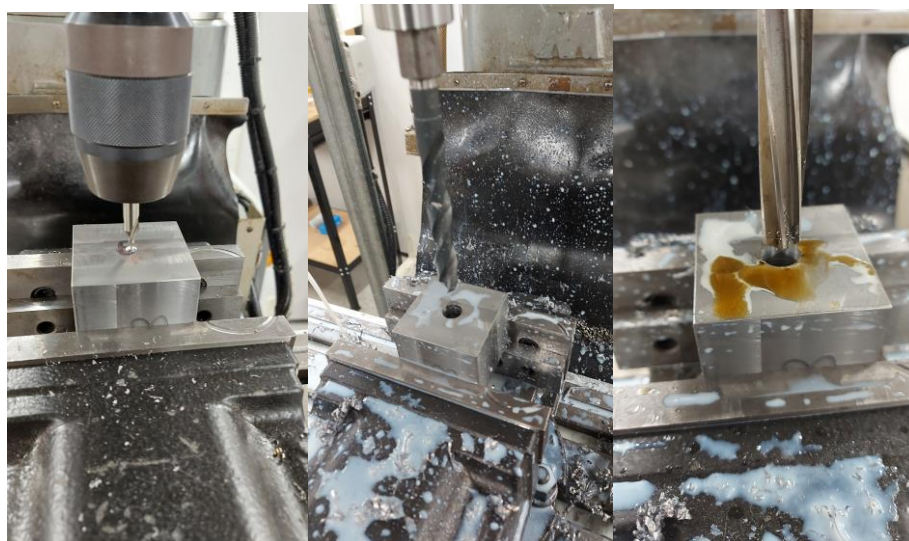
Photograph 11, 12 and 13 – showing the wobble bar into the centre and centre drilled, 13.7 drill and 14 reamer.

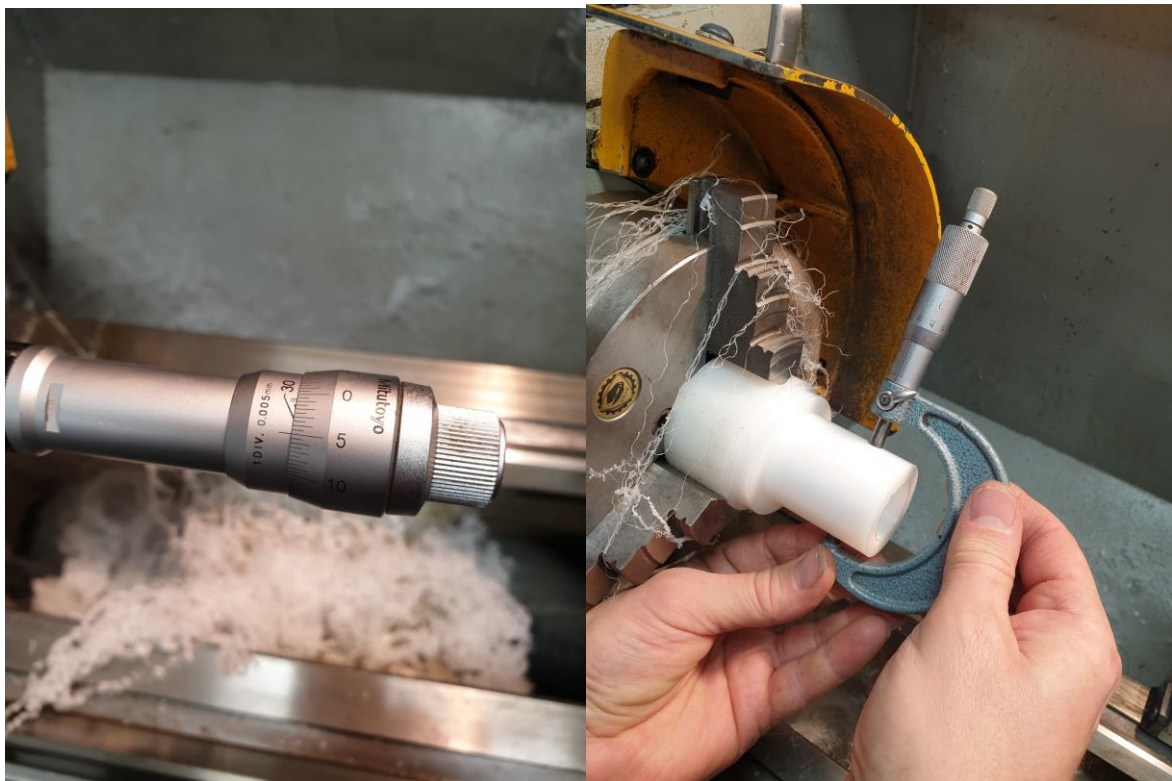
Photograph 21 and 22 – showing in-production accuracy checks being taken. Measuring the internal diameter with a bore mic and the external with an external micrometer.

The top hat bearing was manufactured from nylon using the manual lathe. The nylon was machined using a range of tooling to remove the material. Due to the properties of the material it created a lot of excess swarf when machined which had to be cleared from the moving parts to prevent damage to the lathe. The external bore was checked with a micrometer to ensure a good fit into the bearing housing.

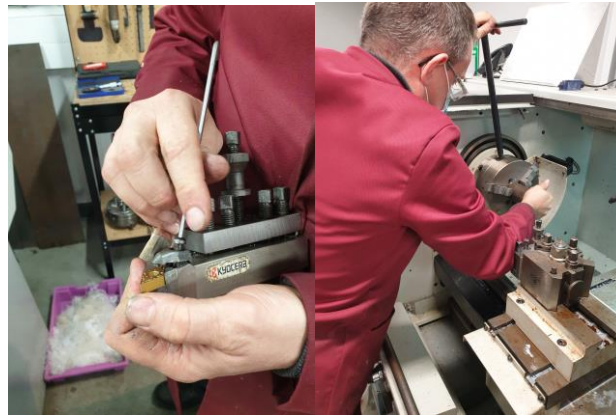
Photographs 23 and 24 – showing a tool change, the tool tip had wear and the tip was changed, the bar was chucked into the right distance from the chuck.

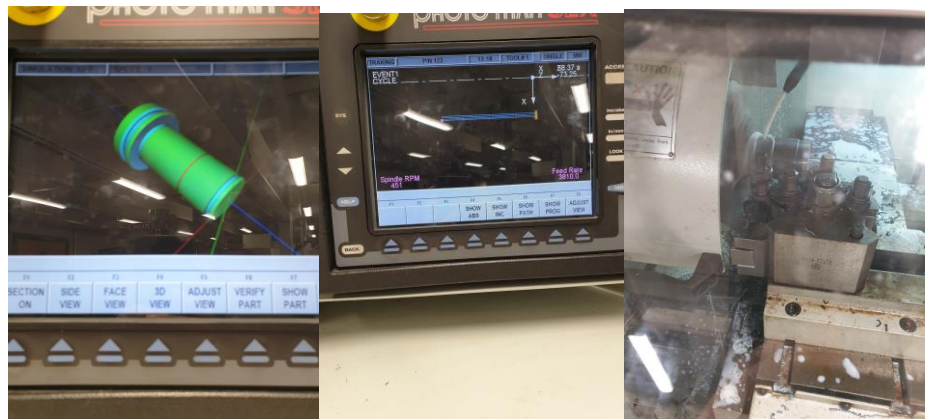
Photographs 25, 26 and 27 – showing the preparation of the CNC lathe. The program simulation was run to see the general outlook of the part. The program was then run but in tracking mode to start with to prove first pass. The program was then changed to CNC mode. Coolant was turned on and part run with the 4 tools being changed at the right time.
