# **T Level Technical Qualification in Agriculture, Land Management and Production**

## **Land-based Engineering Occupational Specialism**

**Guide Standard Exemplification Material Distinction –  
Sample 2023**

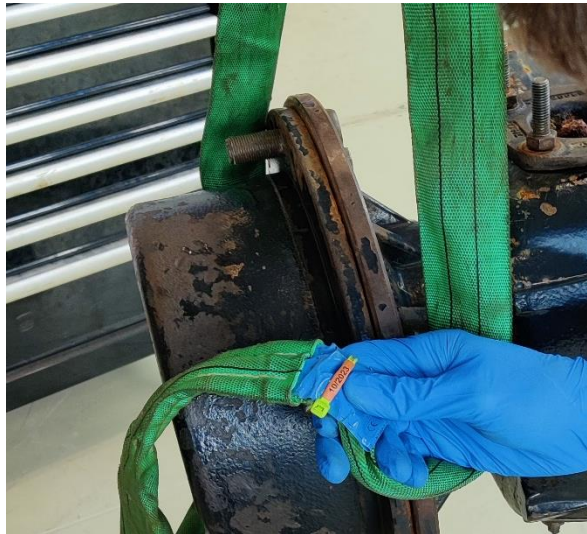
Photo 1 Checking safety of lifting equipment

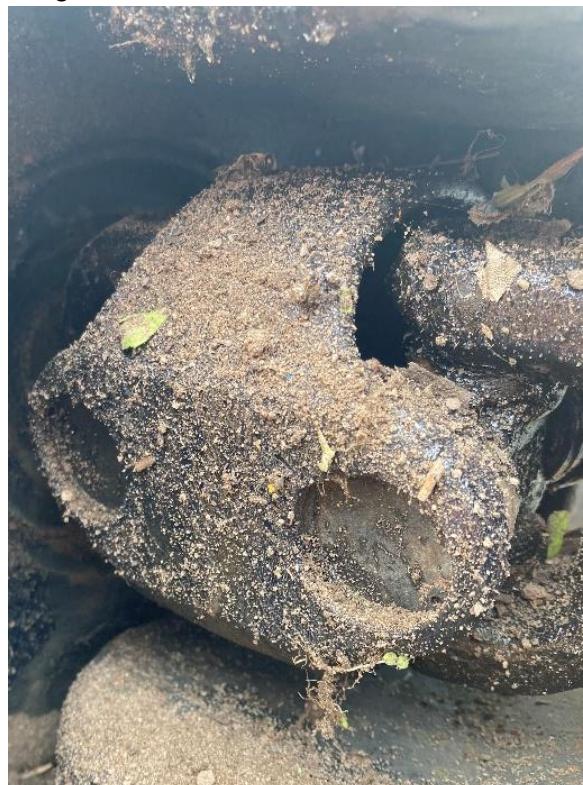
Photo 2 Condition of bearings and seals: before cleaned

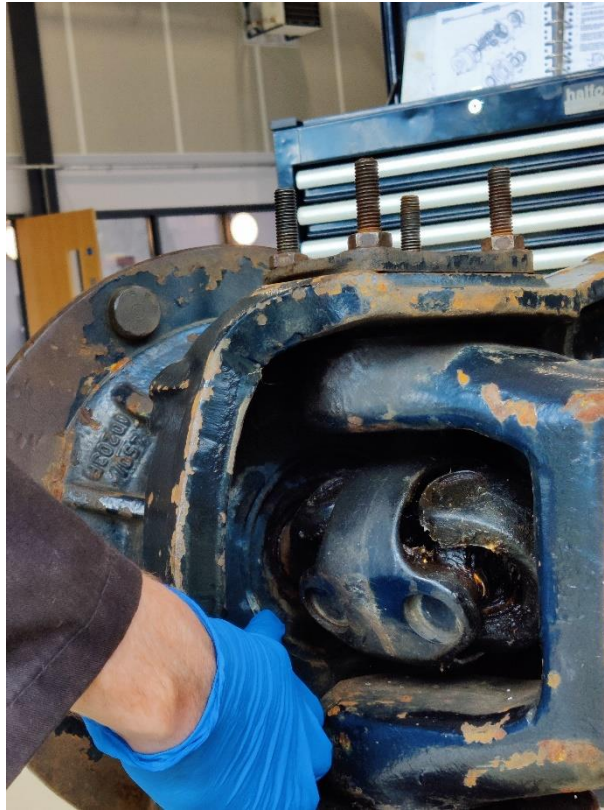
Photo 3 Condition of seals: candidate check after cleaning

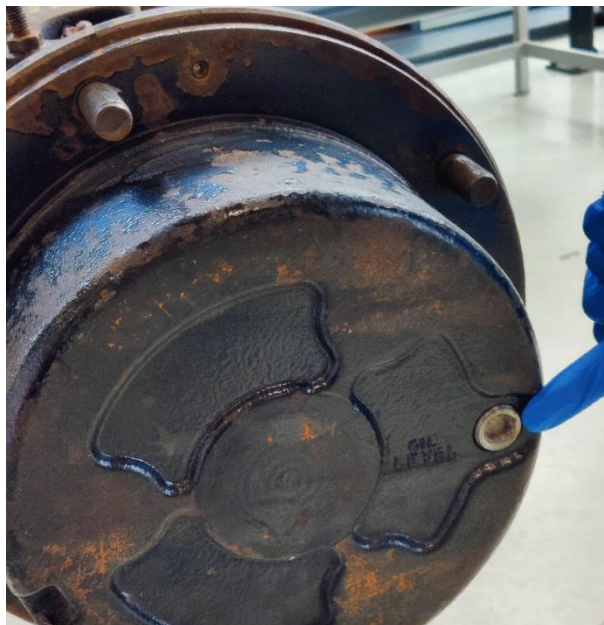
Photo 4 Checking hub oil level

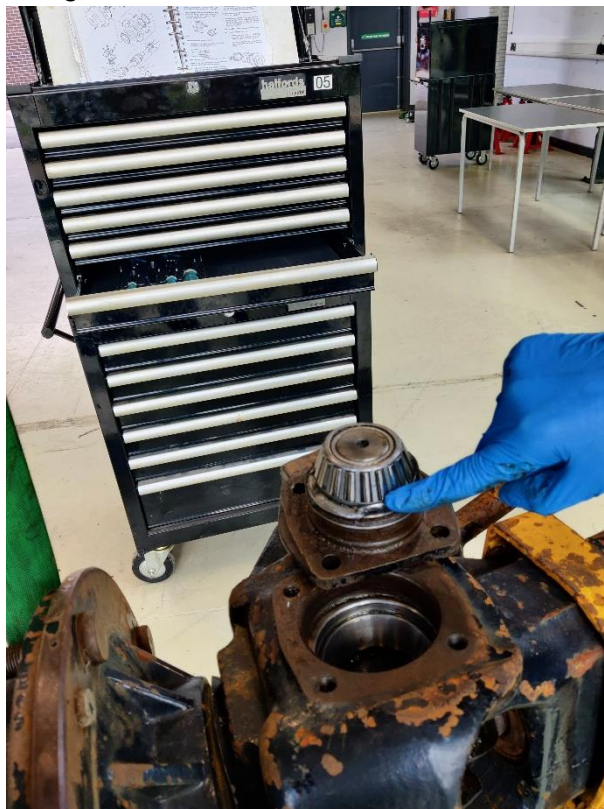
Photo 6 Condition of bearing: candidate check

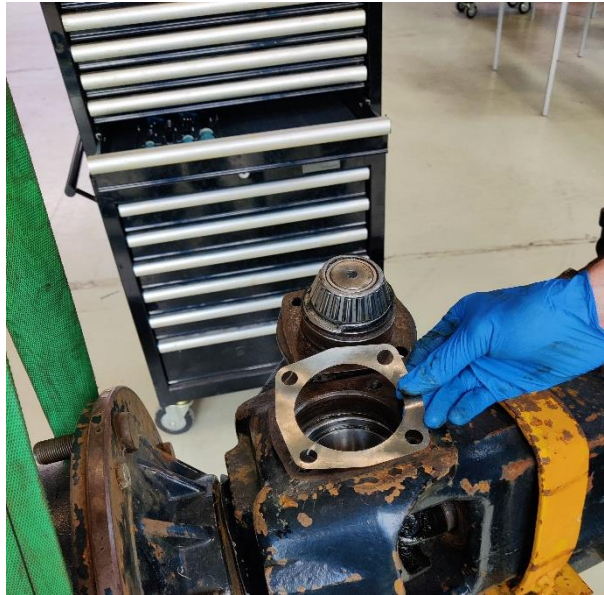
Photo 7 Removal of shim

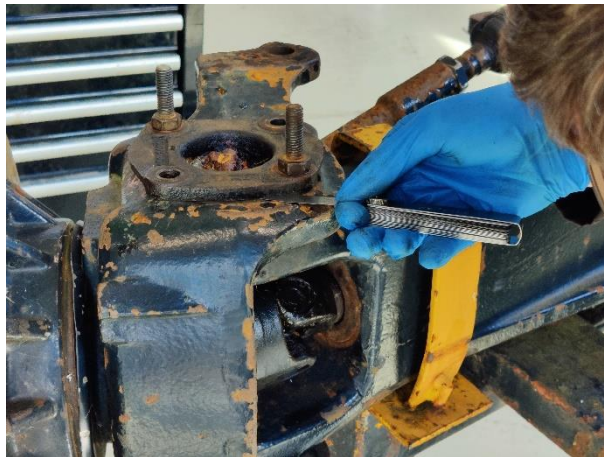
Photo 8 Measuring gap

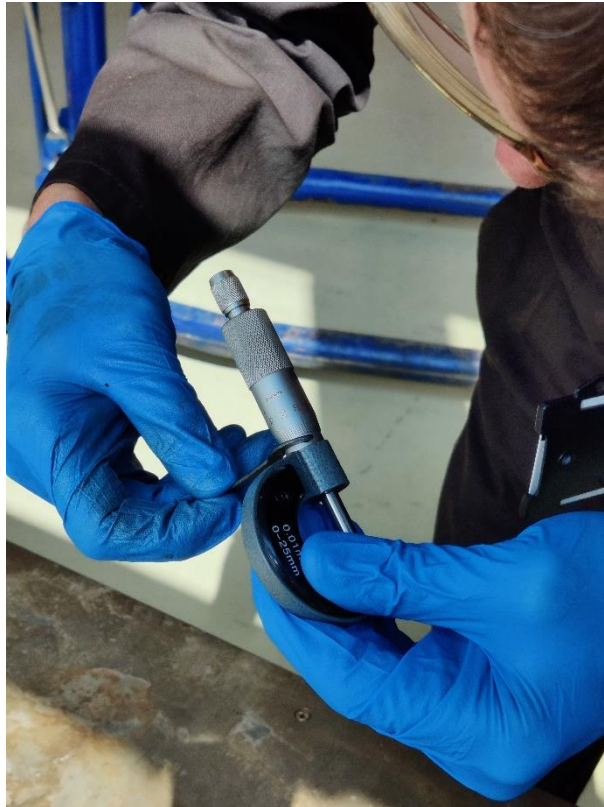
Photo 9 Setting micrometer

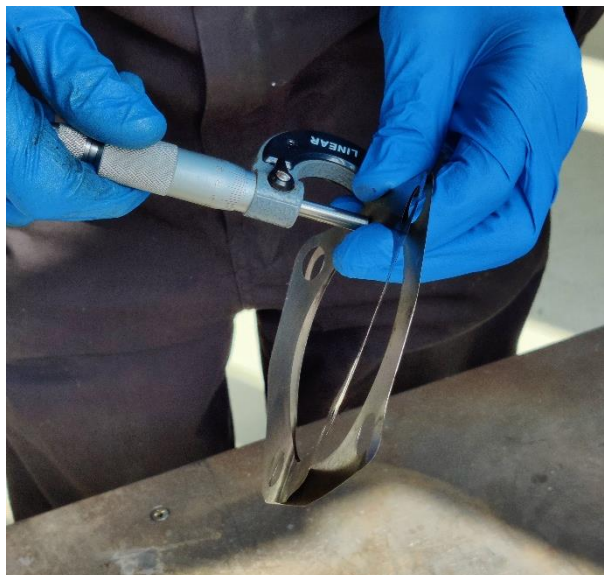
Photo 10 Measuring shims

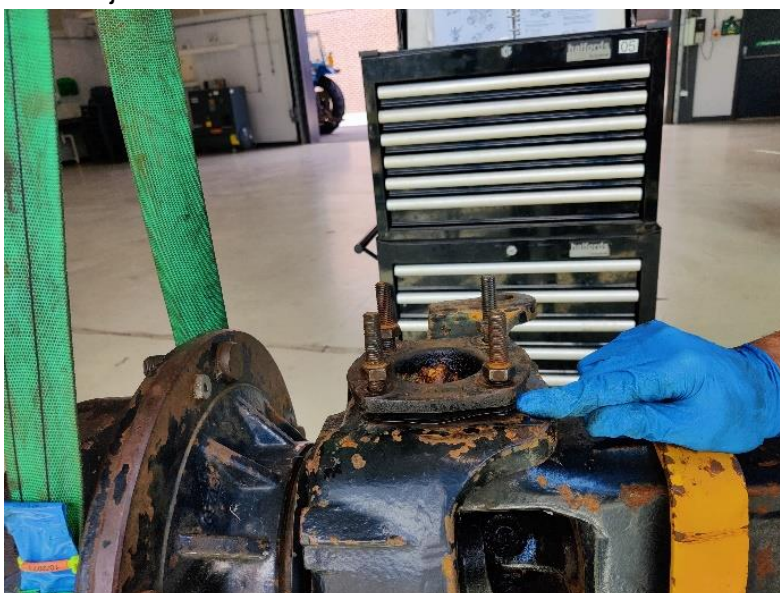
Photo 11 Shims after adjustment

The candidate provided a detailed record of the **maintenance work carried out**, including both the action taken and outcome where appropriate ('visual and physical inspection of the Universal joint on the drive shaft – serviceable, visual inspection of axle drive shaft oil seals – no leaks'). The record includes the detail of the size of the shim needed to achieve the correct adjustment.

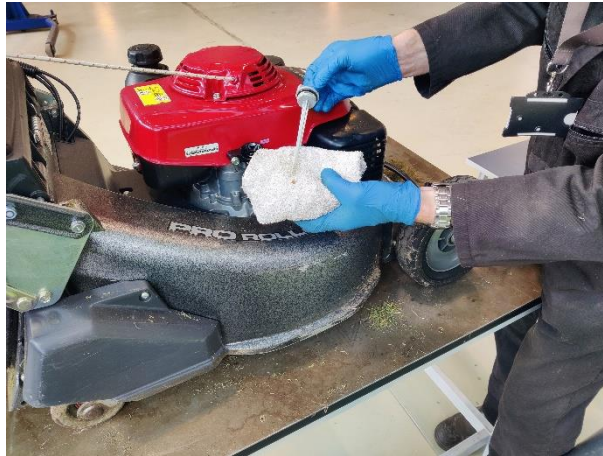
Photo 2 Lubrication level of mower

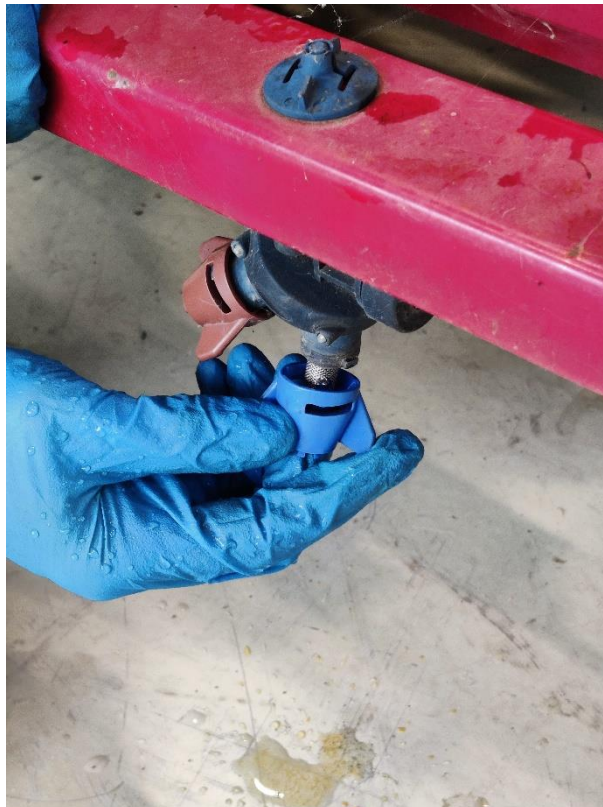
Photo 3 Serviced parts: removed nozzles

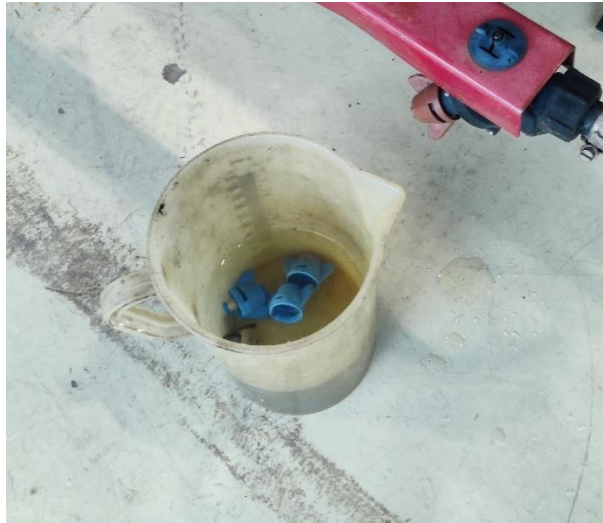
Photo 4 Sprayer: keeping nozzles safe

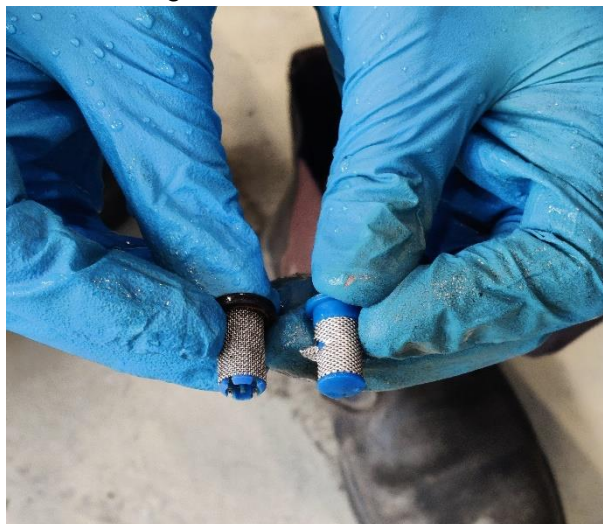
Photo 5 Possible nozzle filter damage

Materials	Lubrication - one cartridge of grease. Rust inhibiting coating – 1 can. Antifreeze – 1 litre. Cleaning sundries.
Time taken	2.5hrs
Further action required/ recommendations	Schedule pre-season service with hire company. Mower: pre-season service, including check/replace air filter, fuel filter, spark plugs. Add fuel, top-up oil level, sharpen blade. Store under cover over winter. Crop sprayer: pre-season service including refit nozzles and filters (noted that some nozzle filters will need replacement). Store under cover over winter.

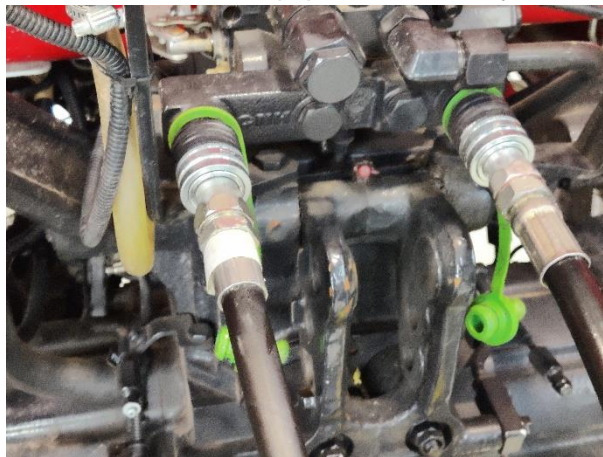
Photo 2 Connecting the tractor to the test equipment: correctly connected

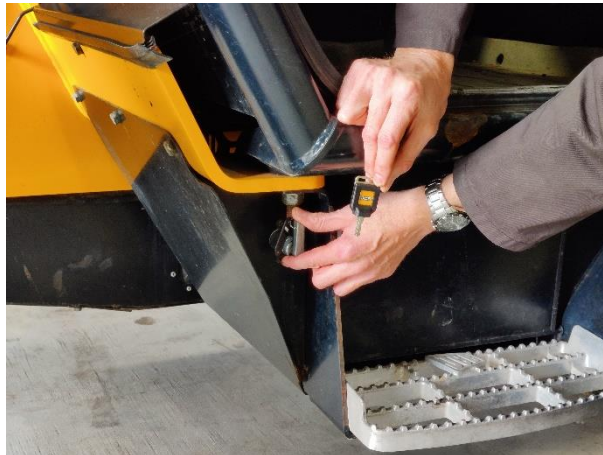
Photo 1 Preparation and immobilisation of the machinery: the machinery once prepared and immobilised: removal of the ignition key

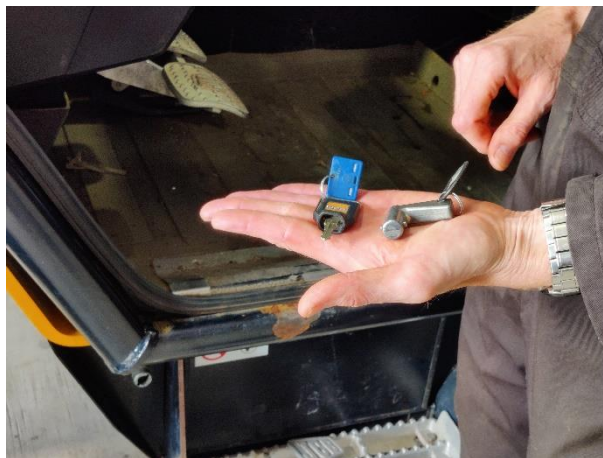
Photo 2 Preparation and immobilisation of the machinery: the machinery once prepared and immobilised: removal of the isolator

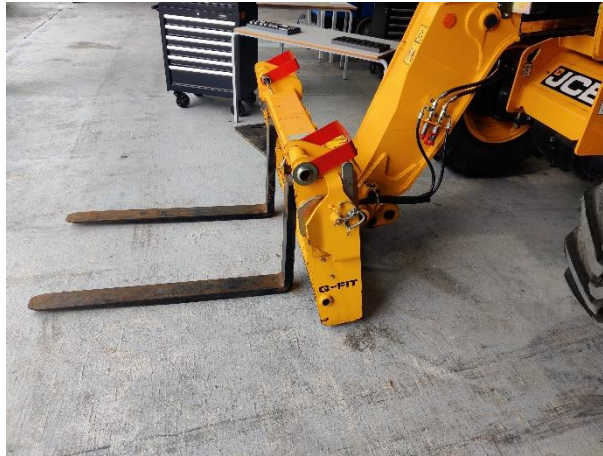
Photo 3 Preparation and immobilisation of the machinery: tines in neutral position

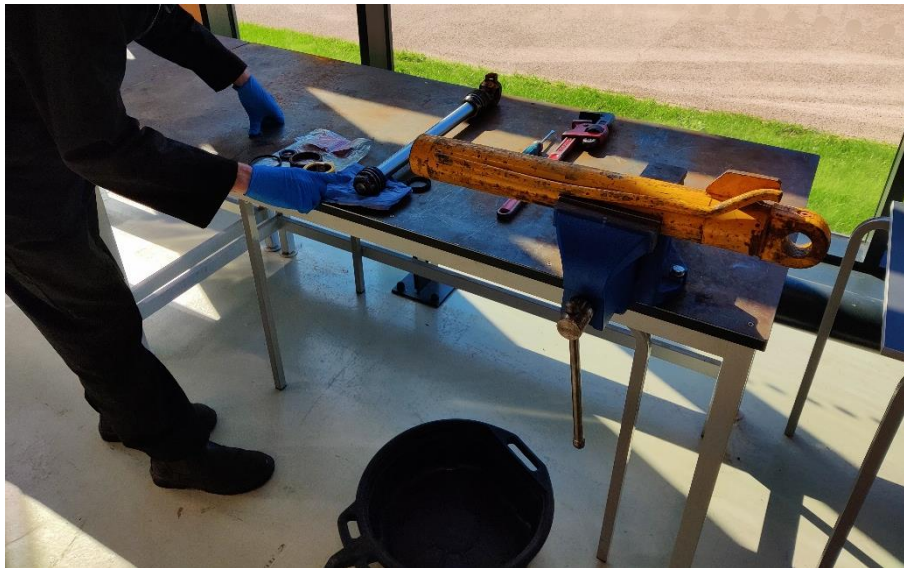
Photo 1 Stripped cylinder before repair

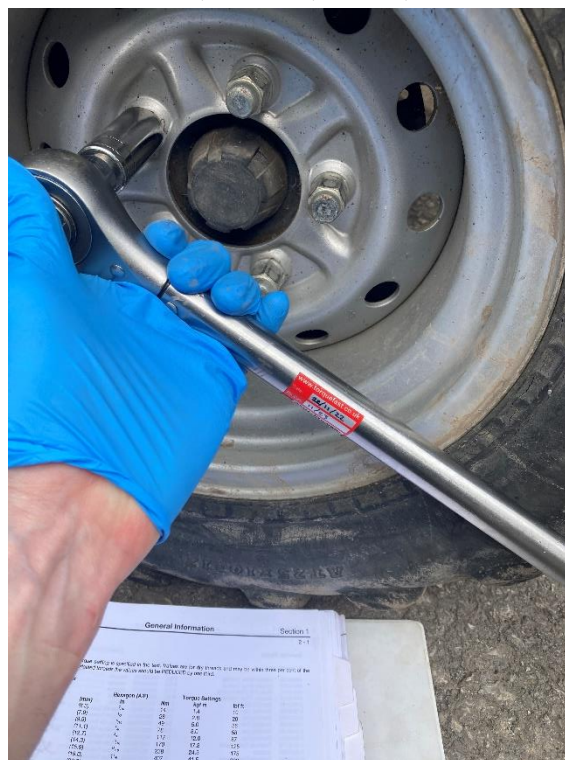
Photo 1 Using the torque wrench: hand, wrench, wheel, and manufacturer’s specification

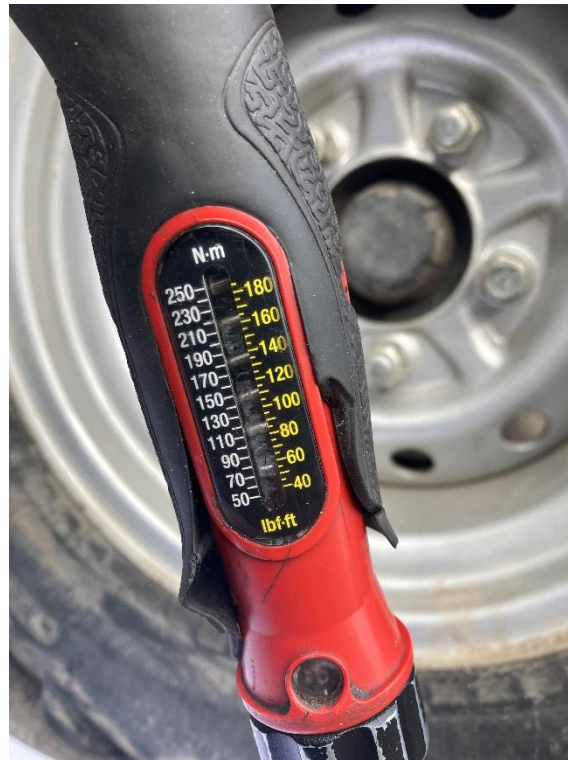
Photo 2 Torque wrench setting

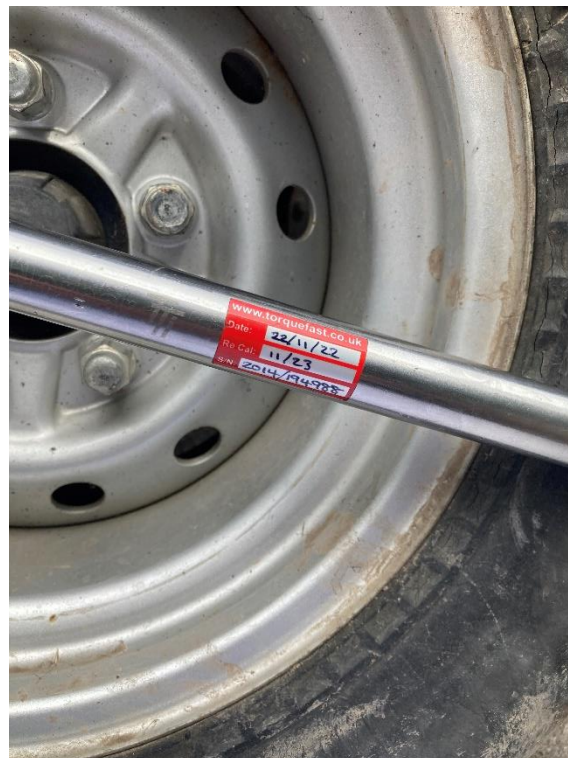
Photo 3 Checking torque wrench calibration date
