T Level Technical Qualification in Engineering, Manufacturing, Processing and Control (8713-33)

Composites Manufacturing Technologies (333)

Guide Standard Exemplification Material

Threshold Competence – Sample 2022

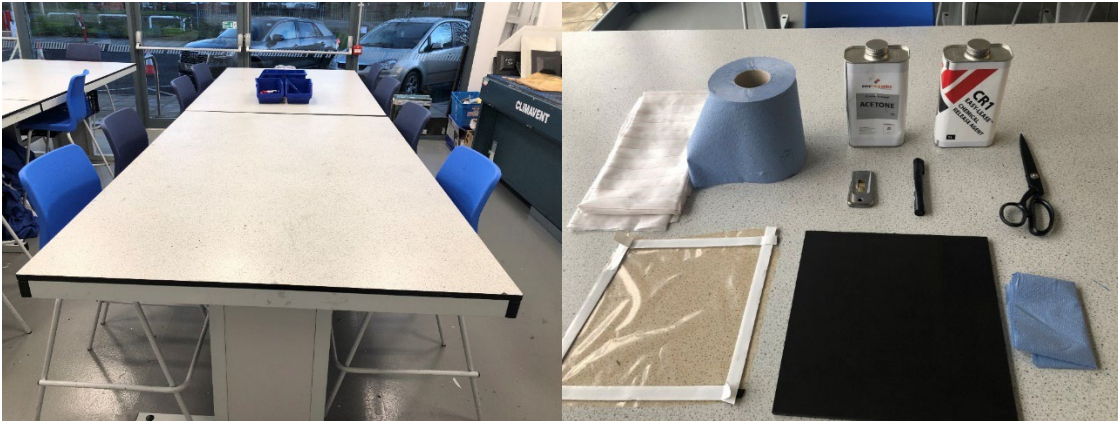
Work area (photographs 1 – 2)

Photographs 1 and 2 – showing the prepared work area cleaned and the resources selected. The resources selected should be for the first task only to prevent overcrowding the workstation. Note: No additional PPE has been selected (gloves, mask).

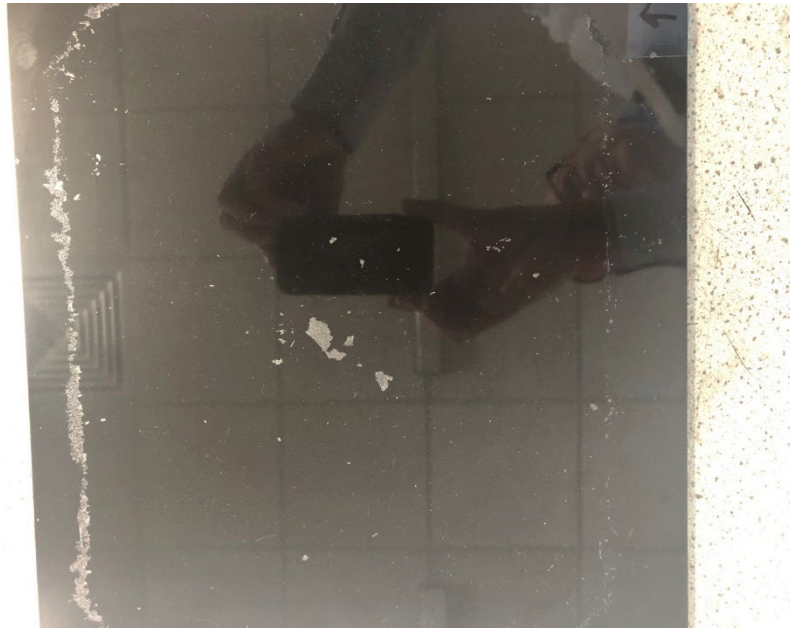
Photograph 5 – showing a prepared mould but with some residue still showing on outer edge. The residue left on the mould will create adhesion issues during the creation of the vacuum bag. The candidate should remove all residue to prevent this from arising later in the consolidation process.

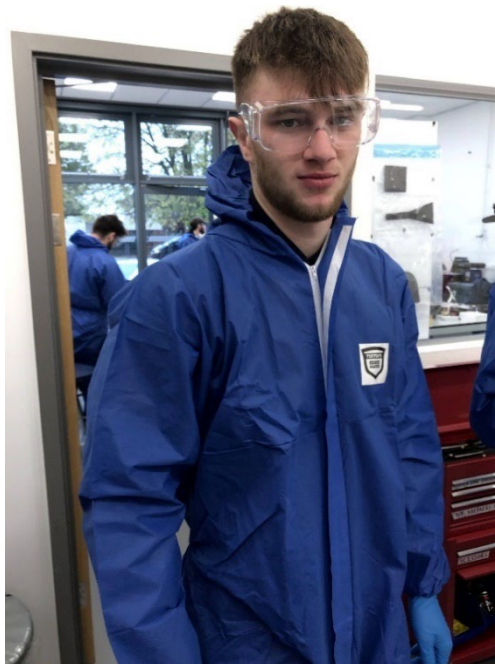
Photograph 6 – showing candidate wearing suitable PPE which has been checked for integrity. The candidate is safe but did not put the hood up and apply the zip cover to prevent FOD occurring within the production of the spacer block components and assembly which is required when simulating a clean room environment.

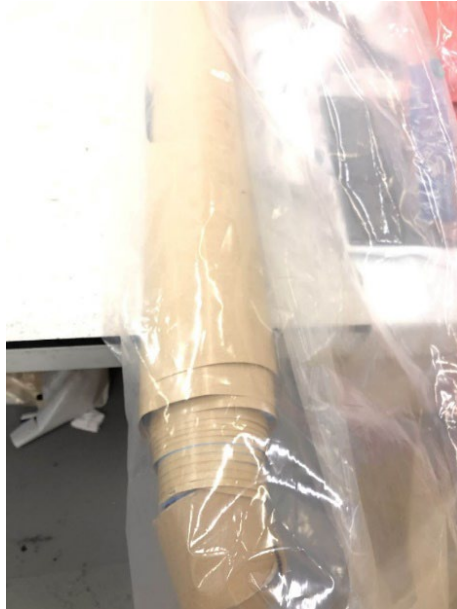
Photograph 7– showing composite material removal from storage (freezer). The material is kept in its bag and allowed to thaw for a period of time at room temp, before being unwrapped and rolled out to cut to size.

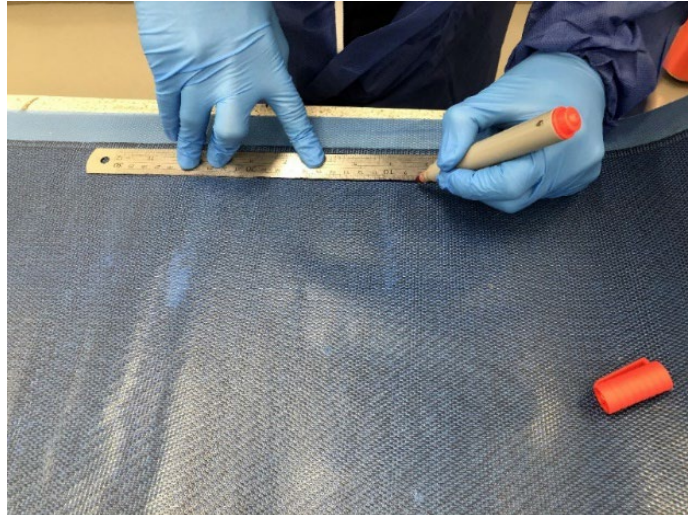
Photograph 8 – showing the material unrolled, being marked out before being cut to usable size. Note: At this point the remaining pre-preg material would be returned to the freezer.

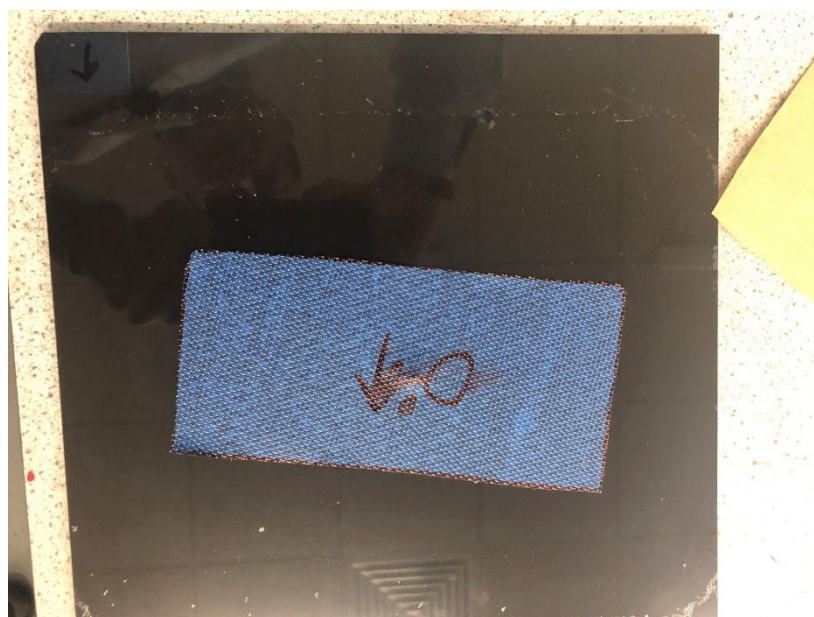
Photograph 11 – showing the first ply laid onto the prepared mould surface. Some waviness of cutting of materials and blemishes on the mould surface.

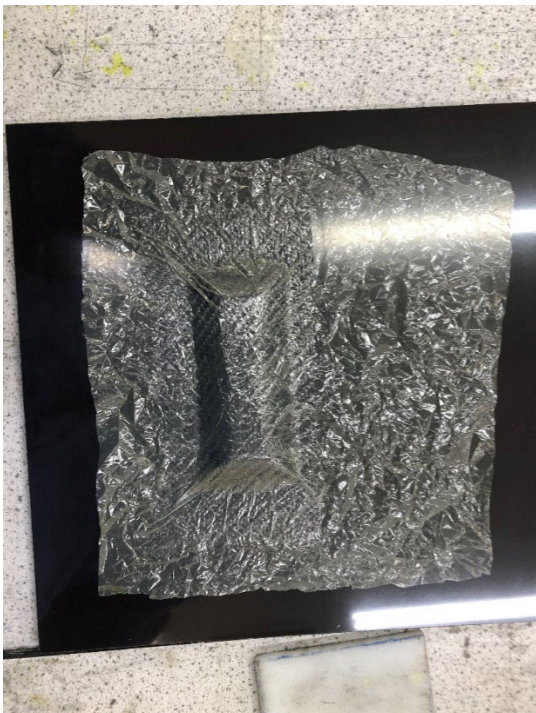
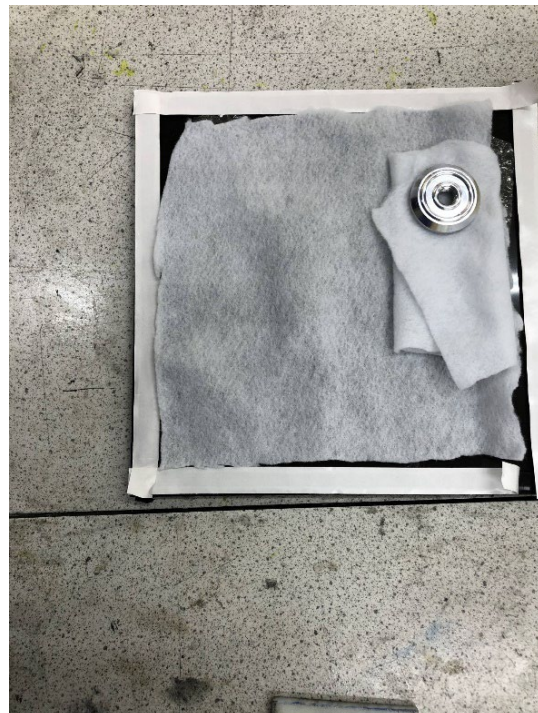
Photographs 13 and 14 - showing the upper plies applied and consolidated using a moulding tool. De-bulk applied according to method statement. Release film has been wrinkled and placed on top of the final ply. Peel ply applied on top of the release film with additional breather fabric cut to make an air passage out of the moulding. VBU lower portion placed on top of breather fabric but on the moulding. Some issues with adherence to the mould surface.

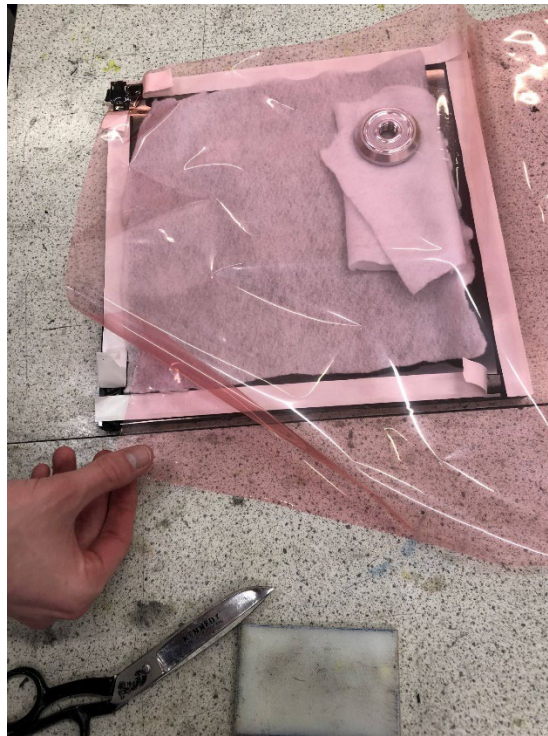
Photograph 15 - showing one corner sealed and the adjacent corner is stuck down leaving (in this case, too much material) slack to allow the bag to drape across the laminate.

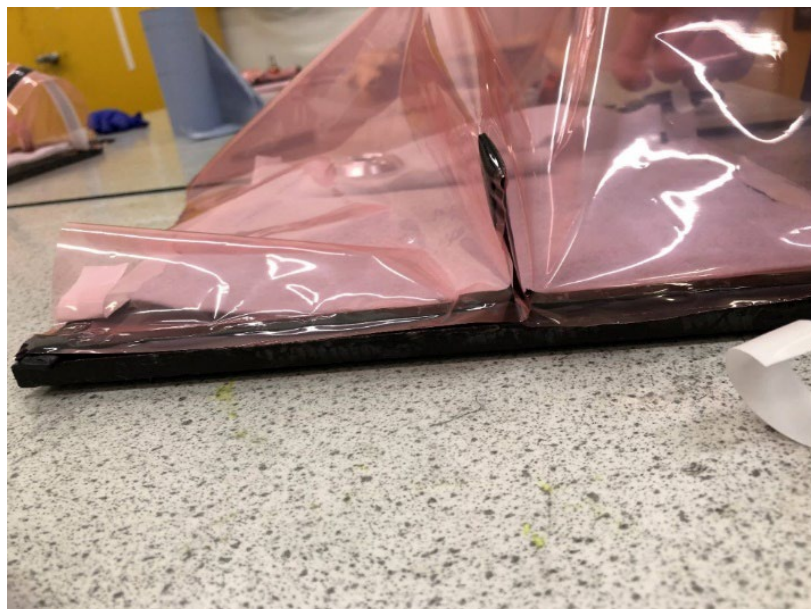
Photographs 16 - showing the first pleat created to create the vacuum tight seal to ensure good application of consolidation pressure. Some issues with the adhesion of the film to the mould.

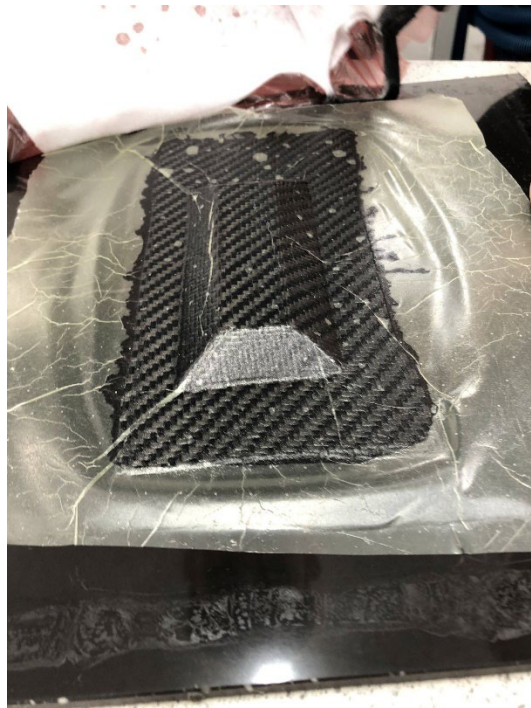
Photograph 23 - showing bagging film being removed to reveal the release film. Evidence of good consolidation and curing. Some wrinkling of release film but the surface of the moulding is acceptable. Some resin bleed identified.

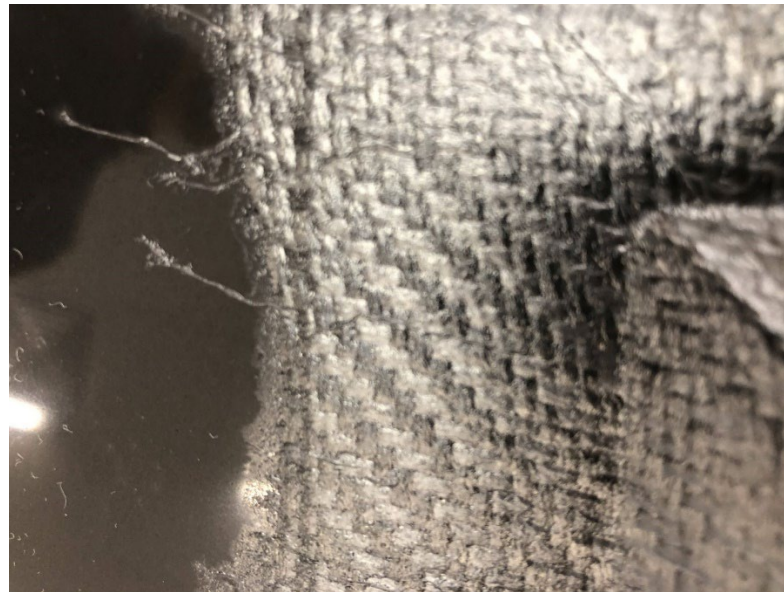
Photograph 24 – showing detail of edges, corners and transitions showing inconsistent definition and orientation of fibre.

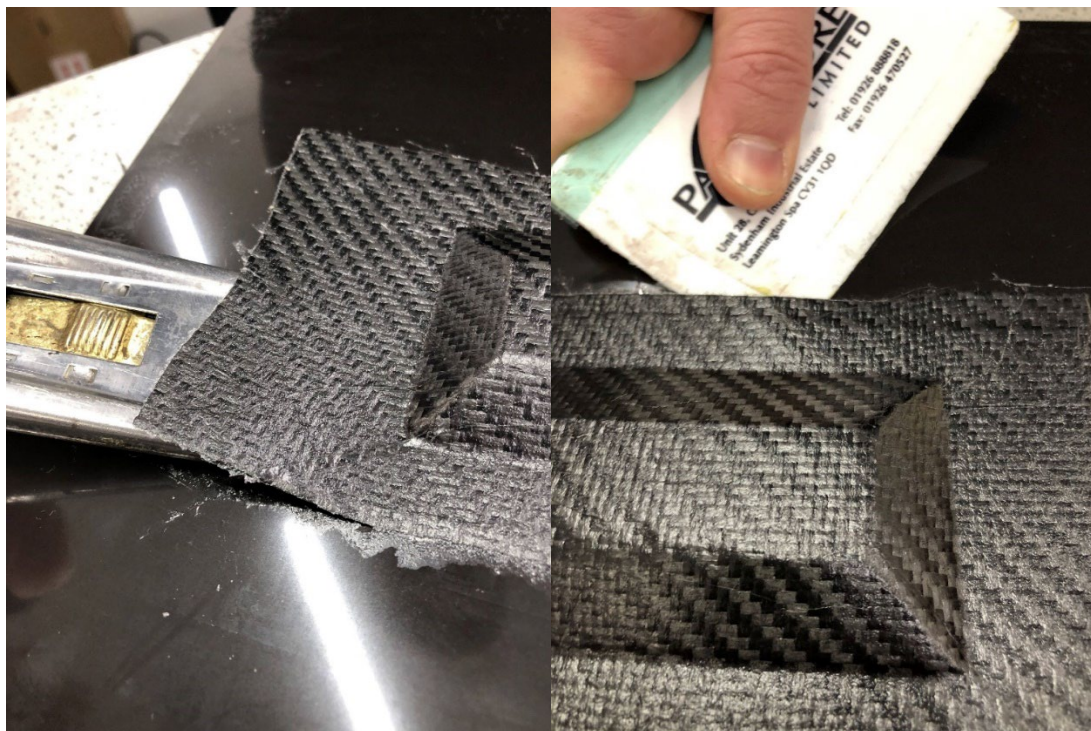
Photographs 25 and 26 – showing a scraper being used to lift one corner at the beginning of the demoulding, followed by a plastic wedge to complete the process of demoulding, ensuring that the lift is not too abrupt to overstress or crack the laminate.

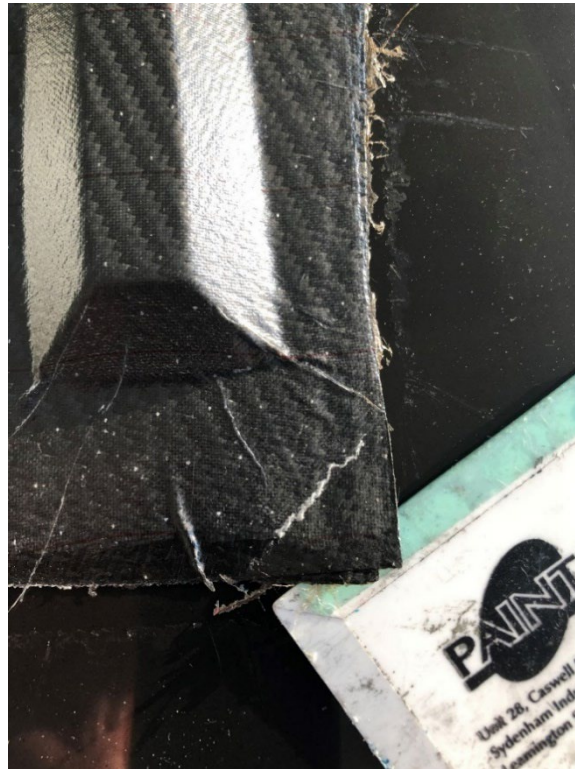
Photograph 27 – showing the lower corner has been cracked because of poor mould preparation and inserting a wedge that was too large. Some evidence of surface imperfections caused by the wrinkling of the moulding consumables.

The candidate's lower level of understanding of the material properties is demonstrated by their approach to demoulding the cured laminate. They followed the correct procedure to remove the laminate from the mould, using the correct tools for the job and for the type of mould used but the excess pressure applied to the lifting tool caused the corner of the material to crack, see photograph 27.

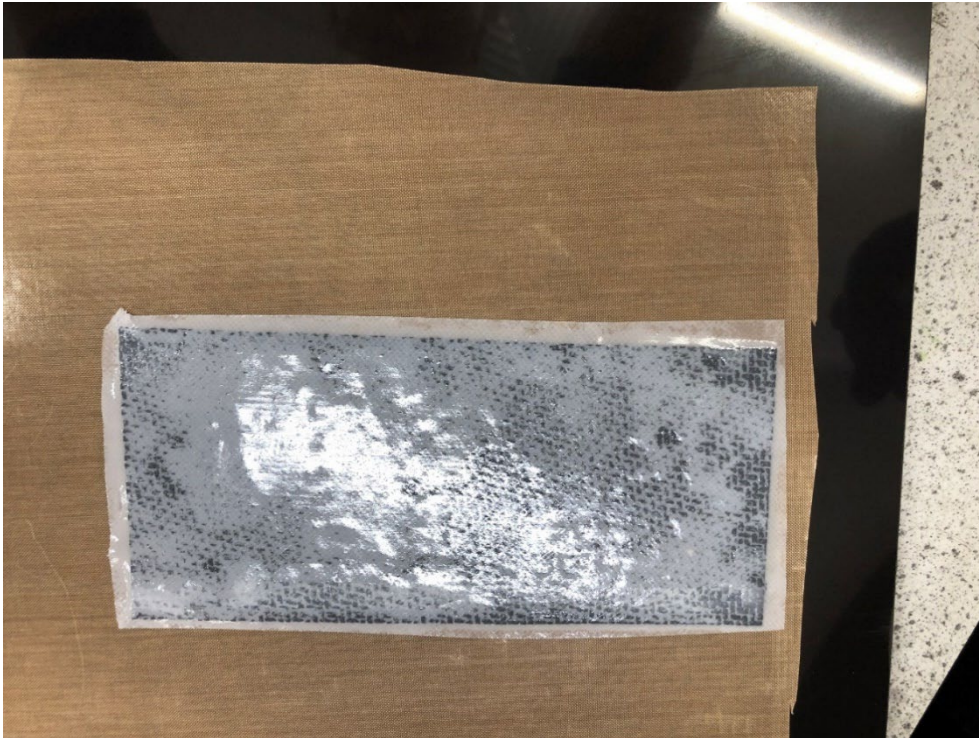
Photograph 33 – showing the backing film removed from the adhesive film and cut to size to ensure minimum bleed out.

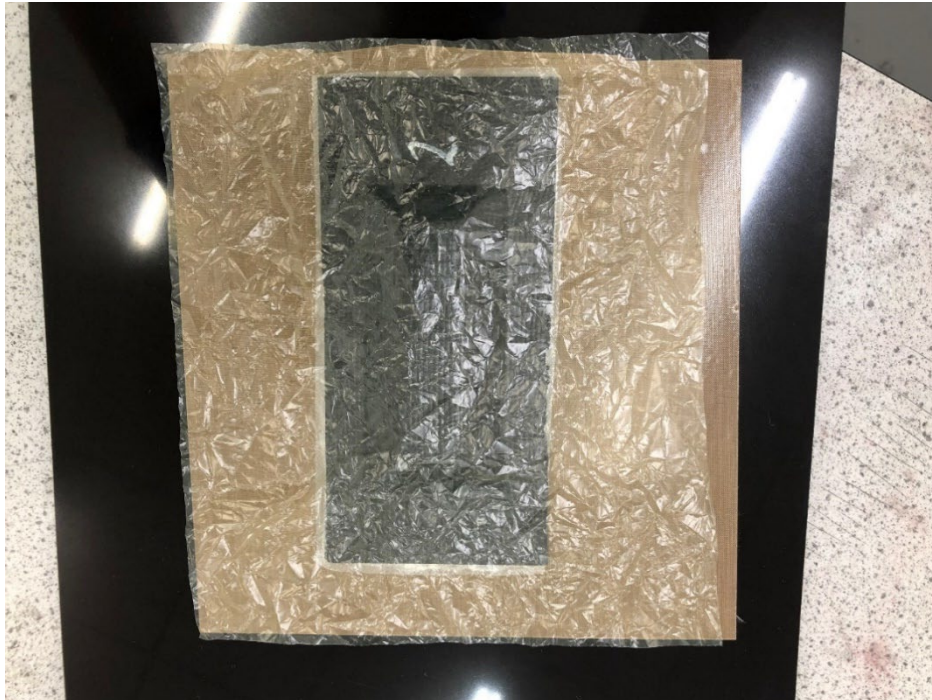
Photograph 35 – showing release film placed on top of the moulding. Note: wrinkled to aid draping.

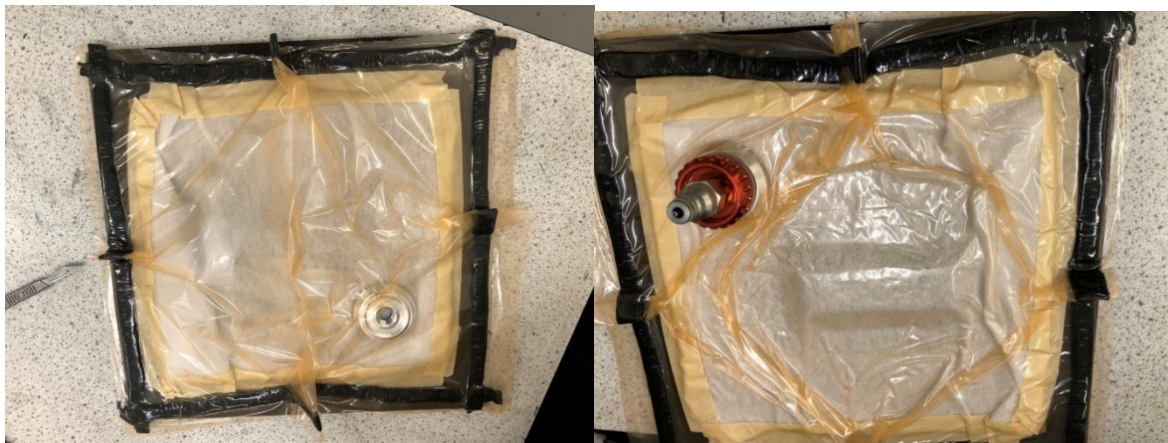
Photographs 36 and 37 – showing breather fabric placed onto moulding and taped down with VBU being trial placed to ensure no interference with the moulding. Vacuum bag created. Pleats allowing for effective consolidation. Vacuum applied.

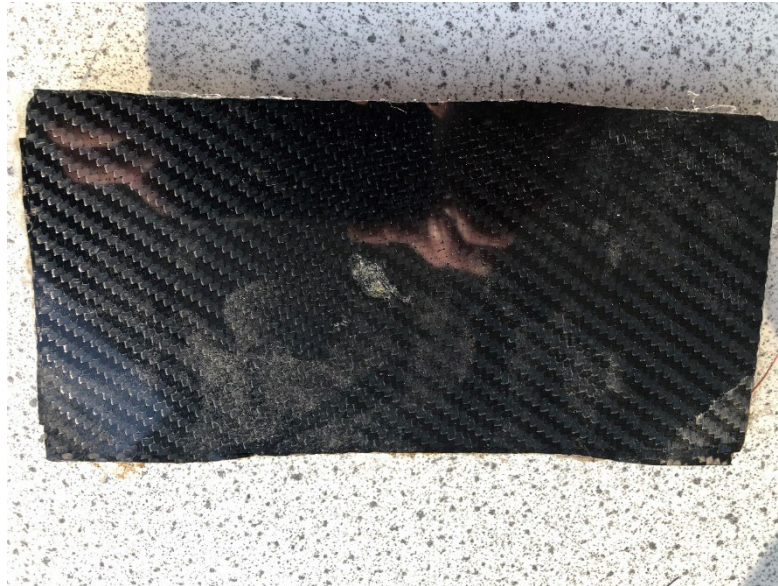
Photograph 40 – showing the checking of “A” side for defects or FOD. Some inclusions present.

The response could further have been developed if the candidate had demonstrated a higher level of cleanliness throughout. This would have prevented the foreign object debris (FOD) from being trapped during the manufacturing process and causing the visual defects in the spacer block, see photograph 40. In addition, the candidate could have demonstrated cleanliness through cleaning their tools and workstation more thoroughly.

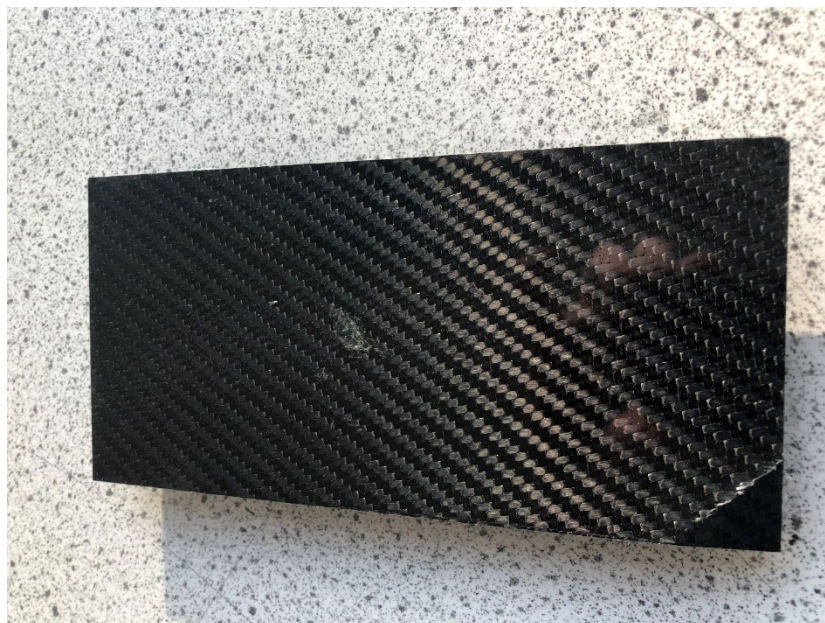
Photograph 41 - showing the final assembly which has been safe edged and ready for machining to final dimensions. Note the cracking of the bottom left corner and the presence of FOD embedded in the laminate that was present as a result of not cleaning the mould sufficiently.

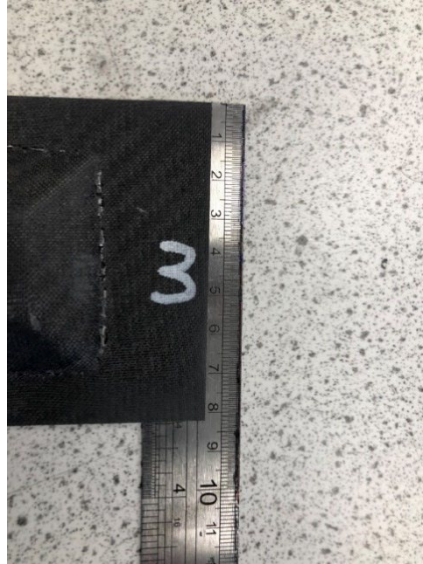
Photograph 42 – showing candidate checking the width of the assembly. Note: some run-out of the core in terms of not being parallel with the edge. Dimension not consistent with drawing.

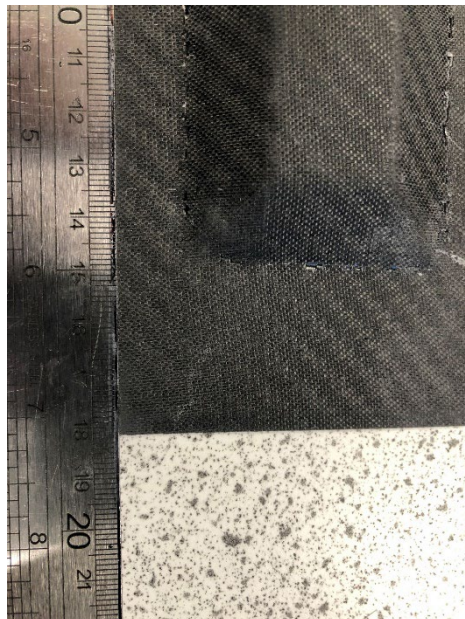
Photograph 43 – showing dimensional check of length. Some more material removal required. Note poor definition of edge or core and evidence of poor consolidation over the core and in the transitions.

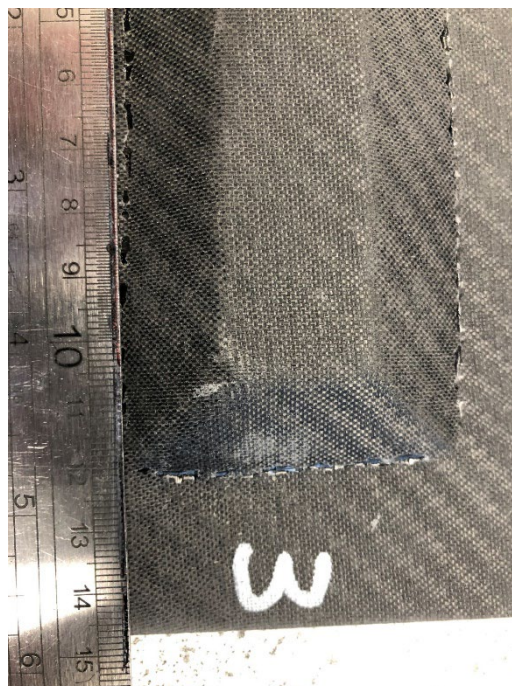
Photograph 45 – showing candidate checking straightness of long core length dimension.

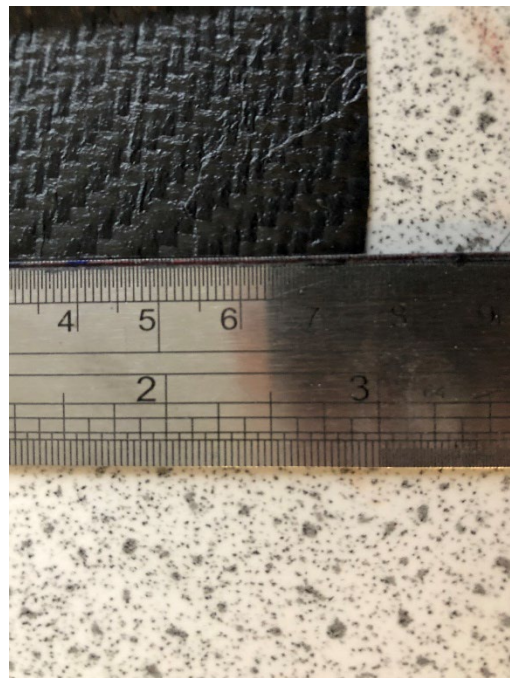
Photograph 47 – showing candidate checking straightness of short edge. Note: the tapering of the edge and lack of straightness.

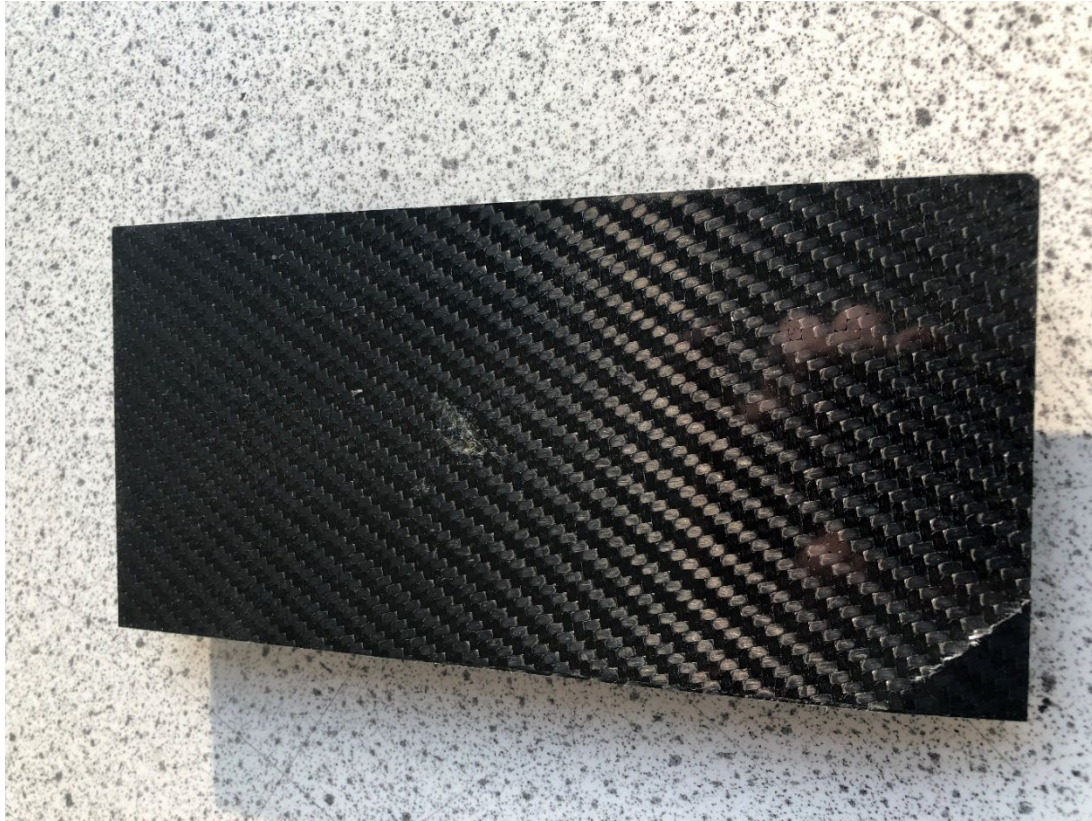
Photograph 48 - showing check of surface finish and warp and weft patter. Note: a warp or weft position is selected, and a check is made to ensure that the feature remains constant along the length of the assembly. Some tapering of this is evident.
