T Level Technical Qualification in Onsite Construction

Plastering

**Guide exemplification material
Distinction – Sample 2021**

Task 2a - Install a dry lining system and finish to a window wall

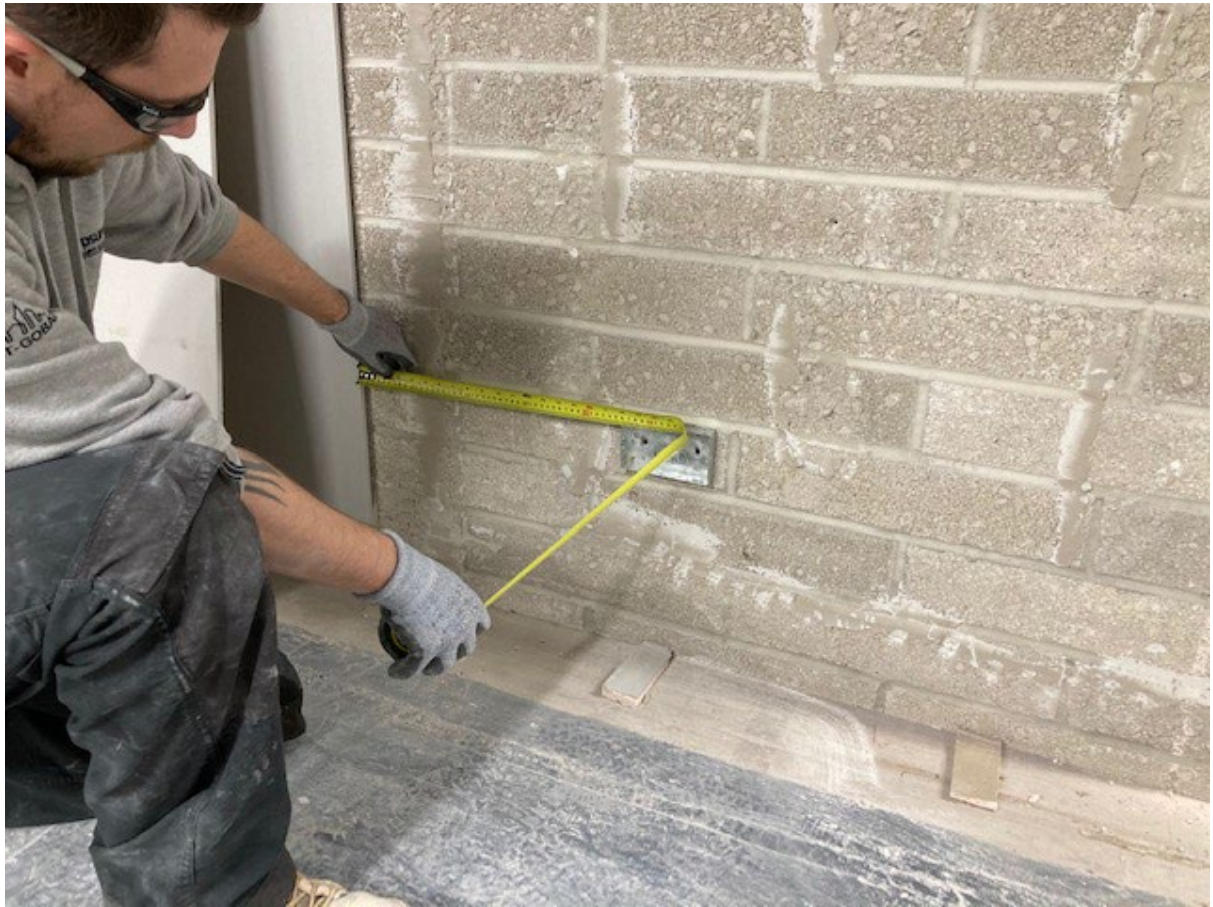
Photograph 2 – Showing accurate service box measurements for transfer to plasterboard.

Photographs 1 – 5: Showing measurements of wall surface, and transference of dimensions to the plasterboard in preparation for cutting.

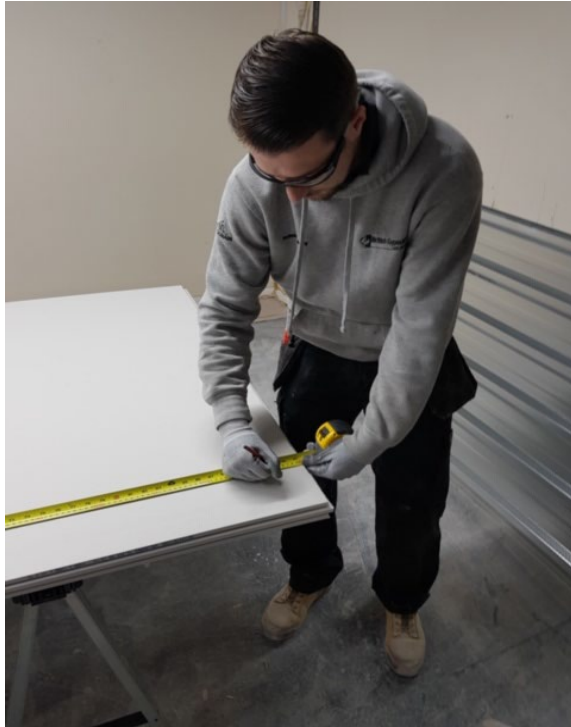
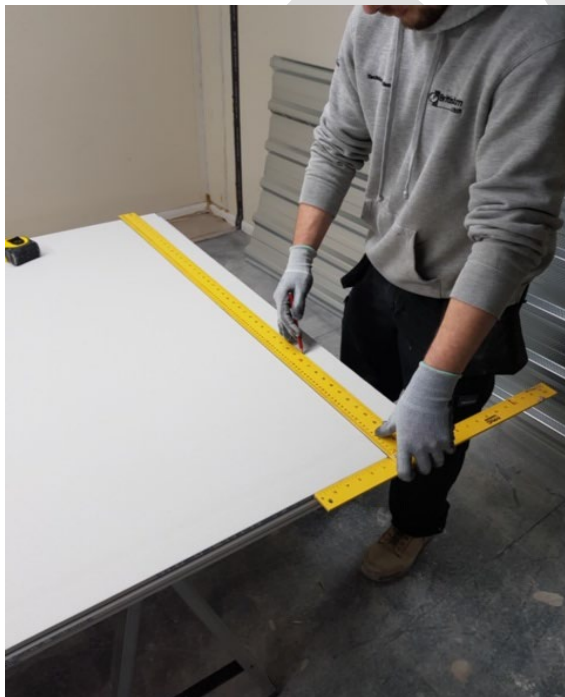
Photograph 3 – 5 - Showing transference of measurements/dimensions to plasterboard.

Photographs 3-5 showing
transference of
measurements to
plasterboard (error free)

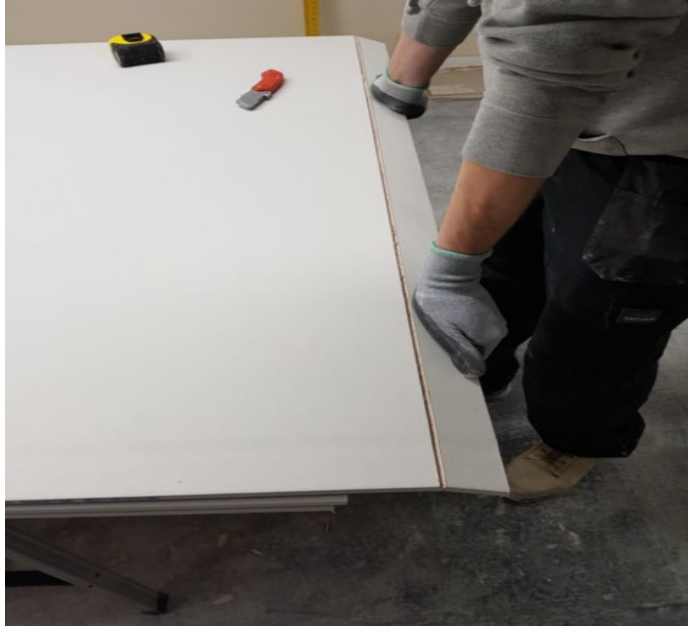
Photograph 6 – showing vertical cut of plasterboard

Photographs 6 and 7 showing cutting of plasterboard, without error

Photograph 6 and 7: Showing cutting on plasterboard following measurements and transference of dimensions to the plasterboard. Photographic evidence show accuracy and no damage during cutting.

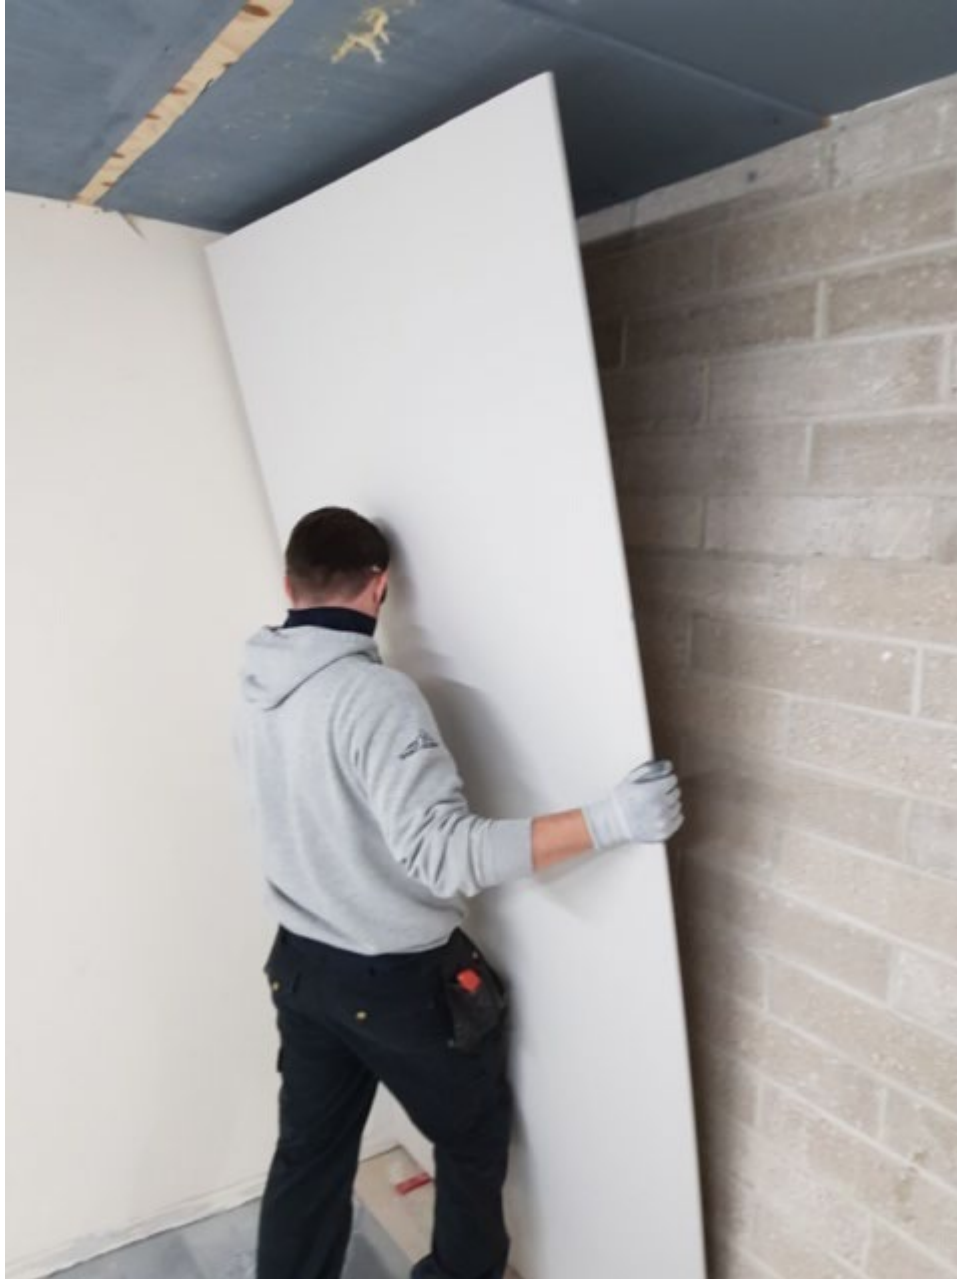
Photograph 8 - Showing accurate pre - positioning to wall surface

Photograph 8 and 9: Dry Fit - showing pre- positioning of plasterboard to the wall surface (post measure, setting out and cutting)

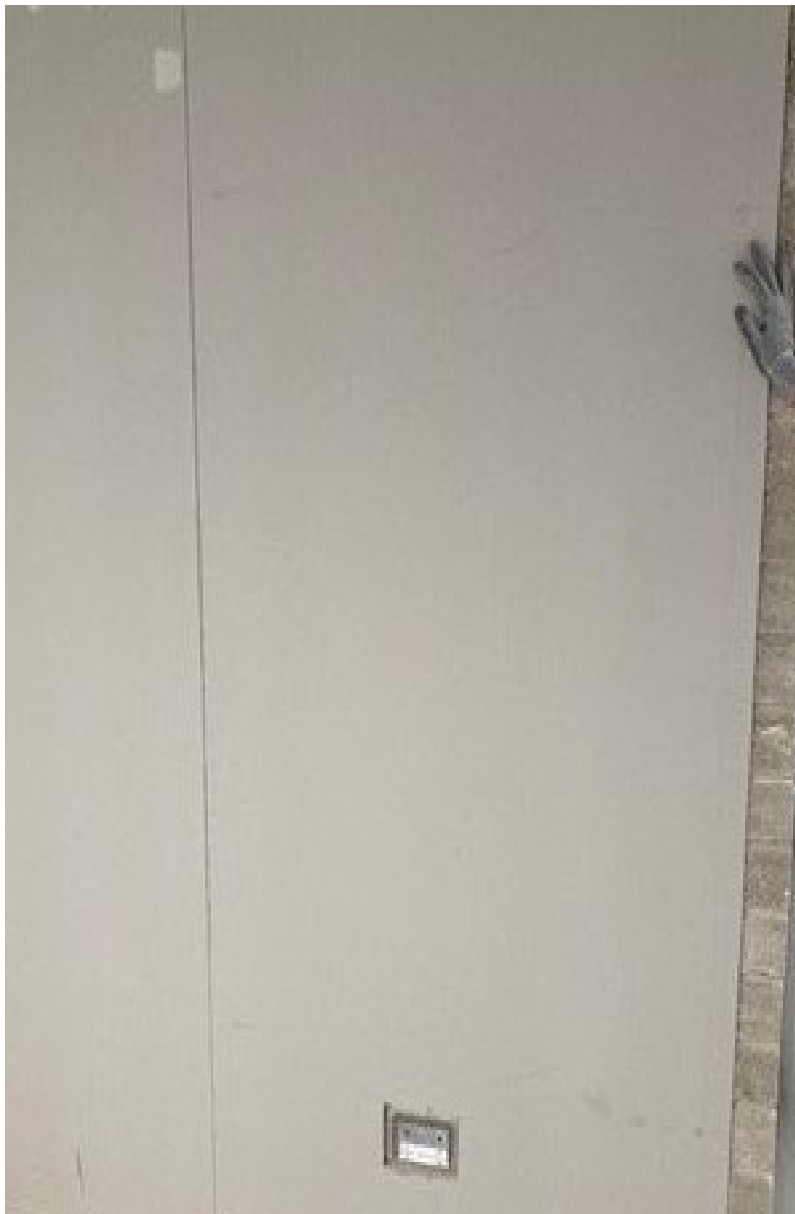
Photograph 9 – showing accurate prepositioning to wall surface

Photograph 9 showing accurately measured and cut plasterboard to the correct dimension for the wall surface, returns and the service box cut out in the correct position

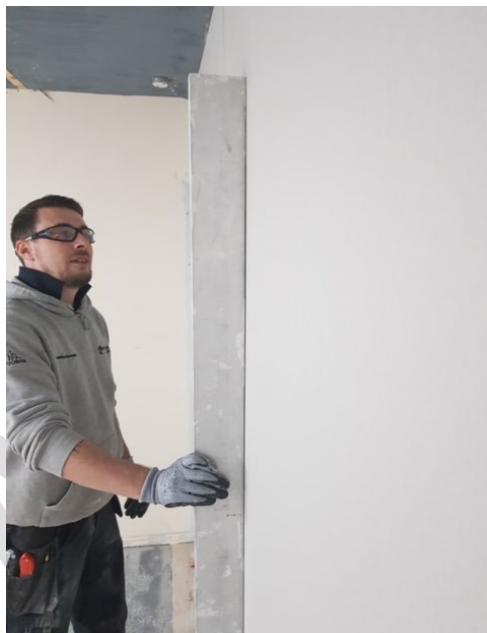
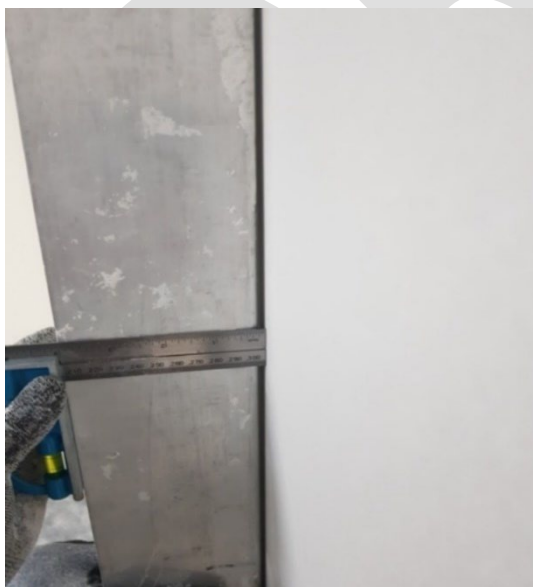
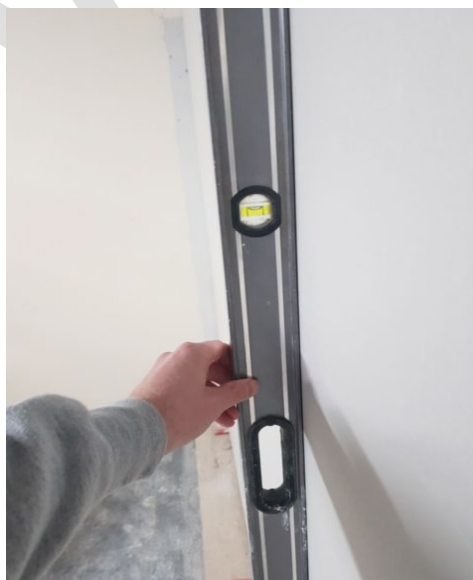
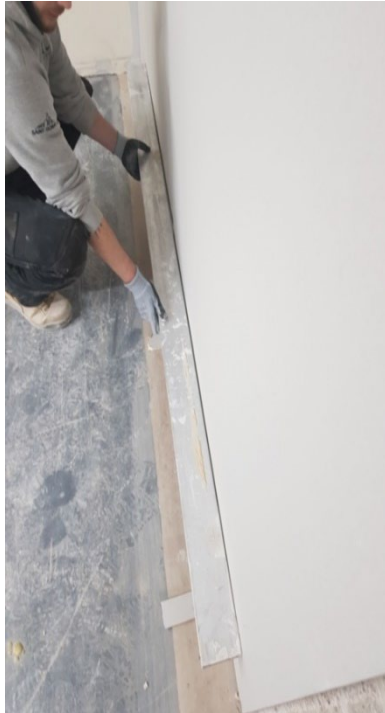
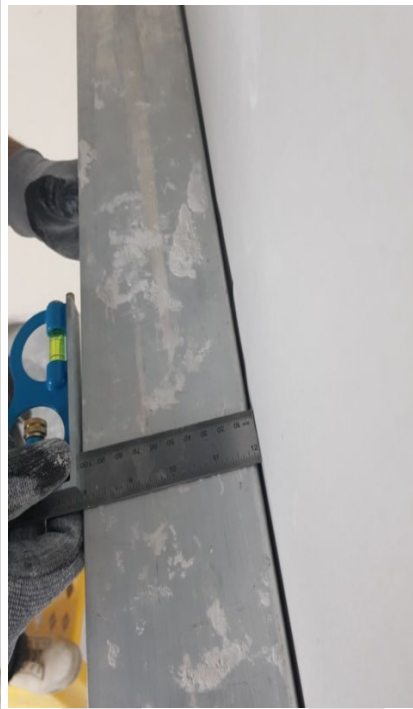
Photo 11 – 16: Photographic evidence of plasterboard installed to wall to show plumb, returns and tolerances.

Photographs 11-16 showing installation with comprehensive checks on line, plumb, and accuracy of returns and all within tolerance (all within - 3mm in line).

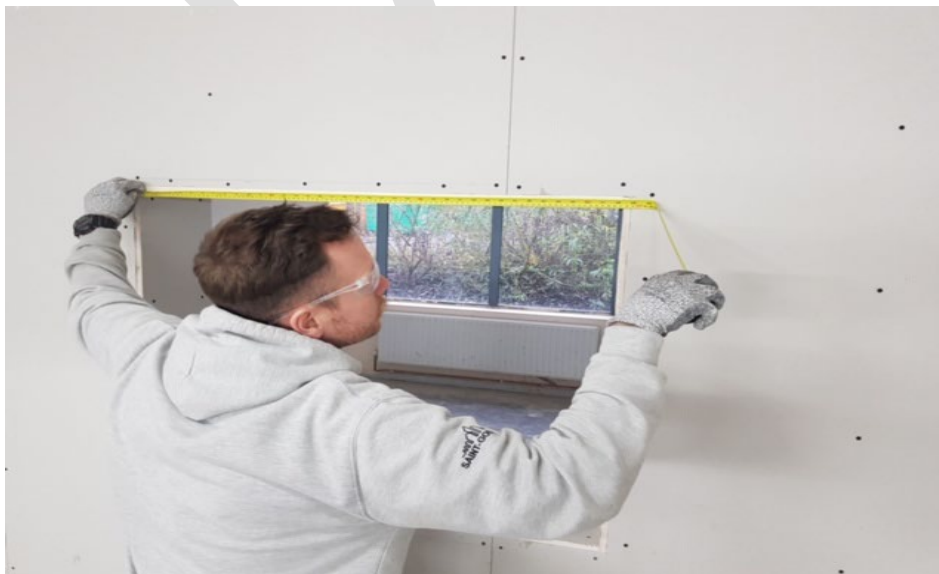
Photograph 17 : Showing accurate measurements taken for the thin coat angle beads to be fitted to window returns

Photographs 17 – 22 Photographic evidence of measurement and positioning of thin coat angle beads fixed to window returns to show positioning and plumb work, shows correct positioning and alignment in tolerance.

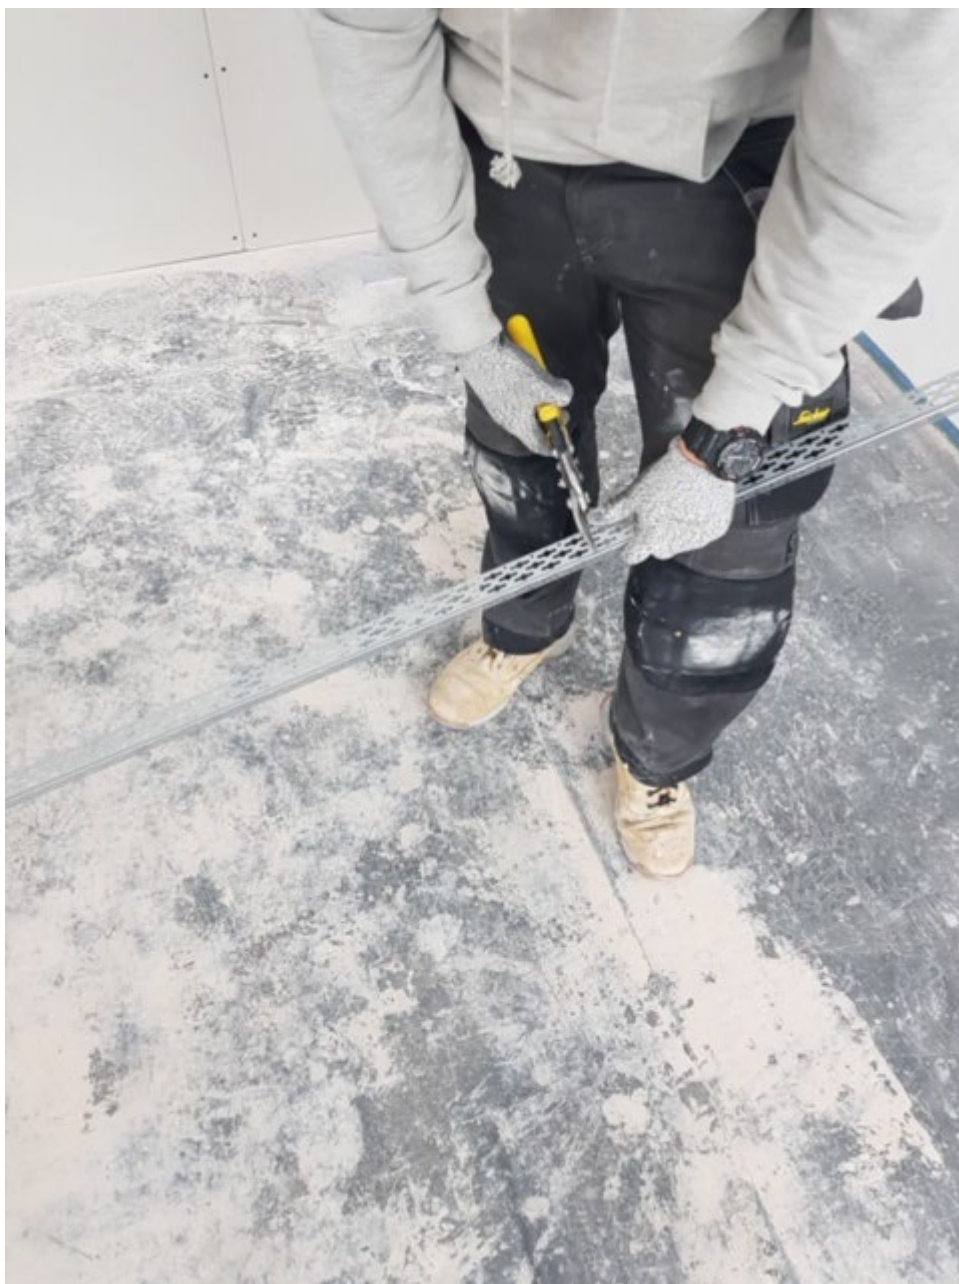
Photograph 18: Showing accuracy in cut to the dimensions for thin coat angle beads fixing (prior to positioning)

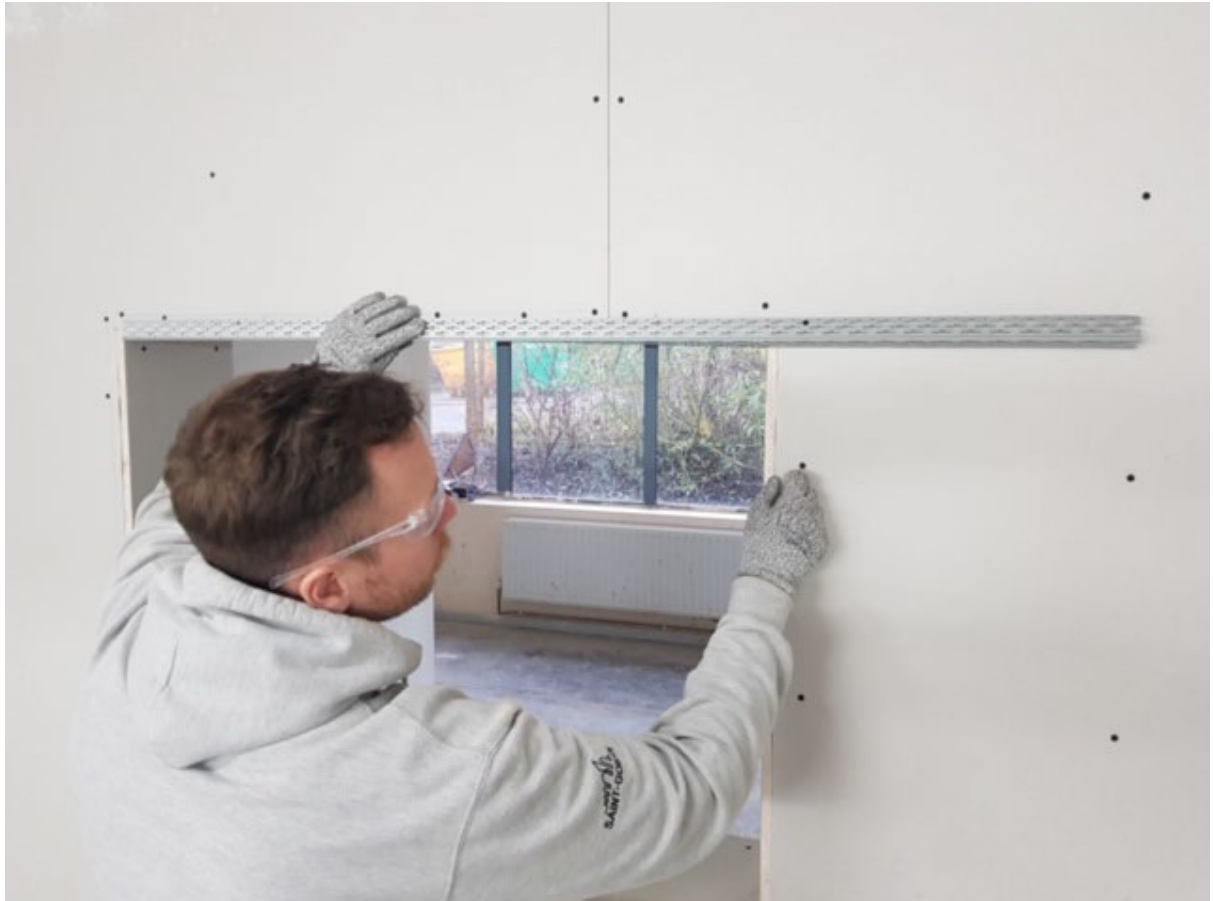
Photograph 19 - Showing pre-positioning of beads

Photographs 19 – 23: Showing the thin coat beads positioned correctly and installed in line with no steps.

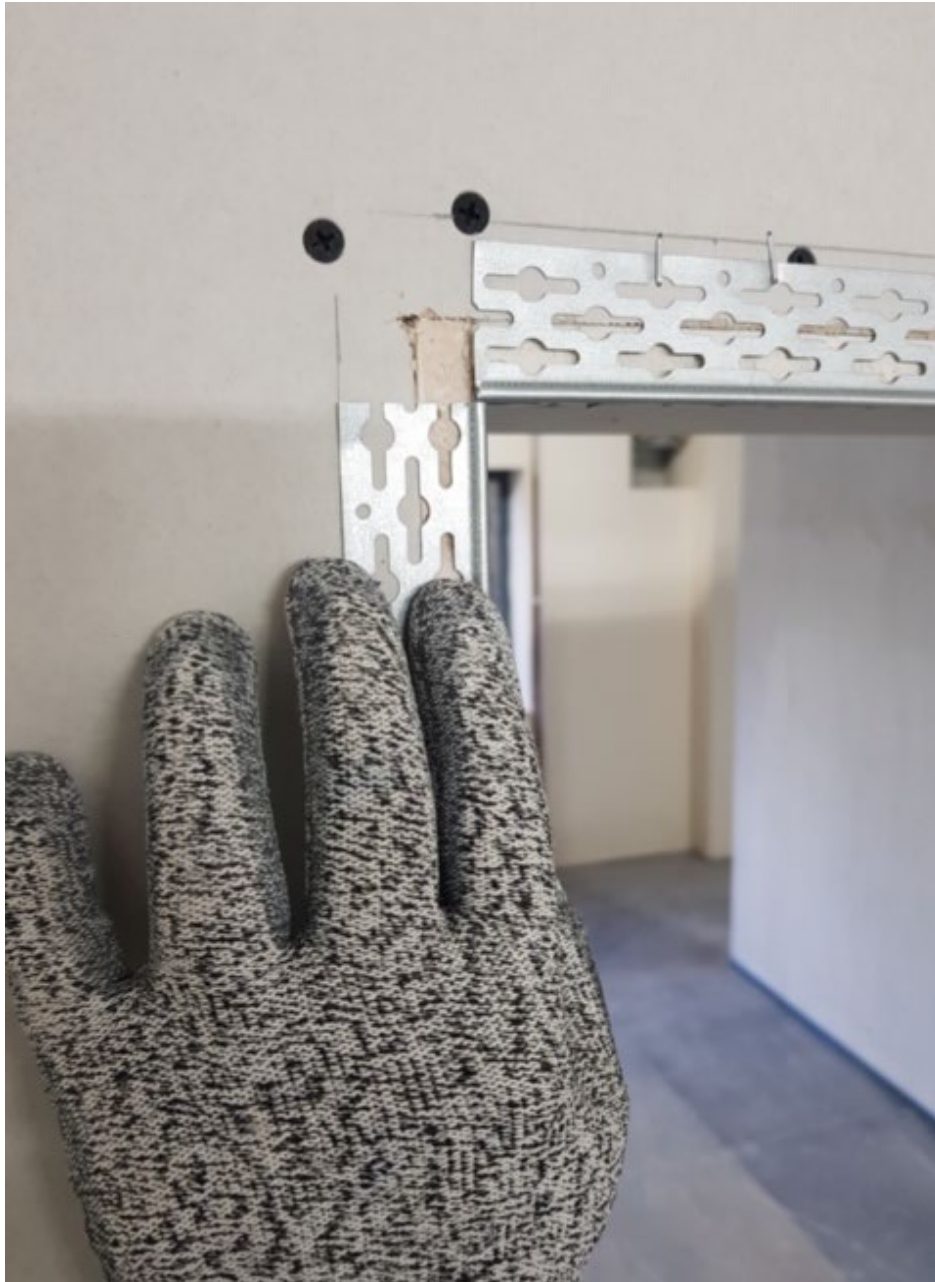
Photograph 20: showing positioning of beads

Photograph 20
showing beads,
measured, cut and
positioned accurately
and in line without
steps

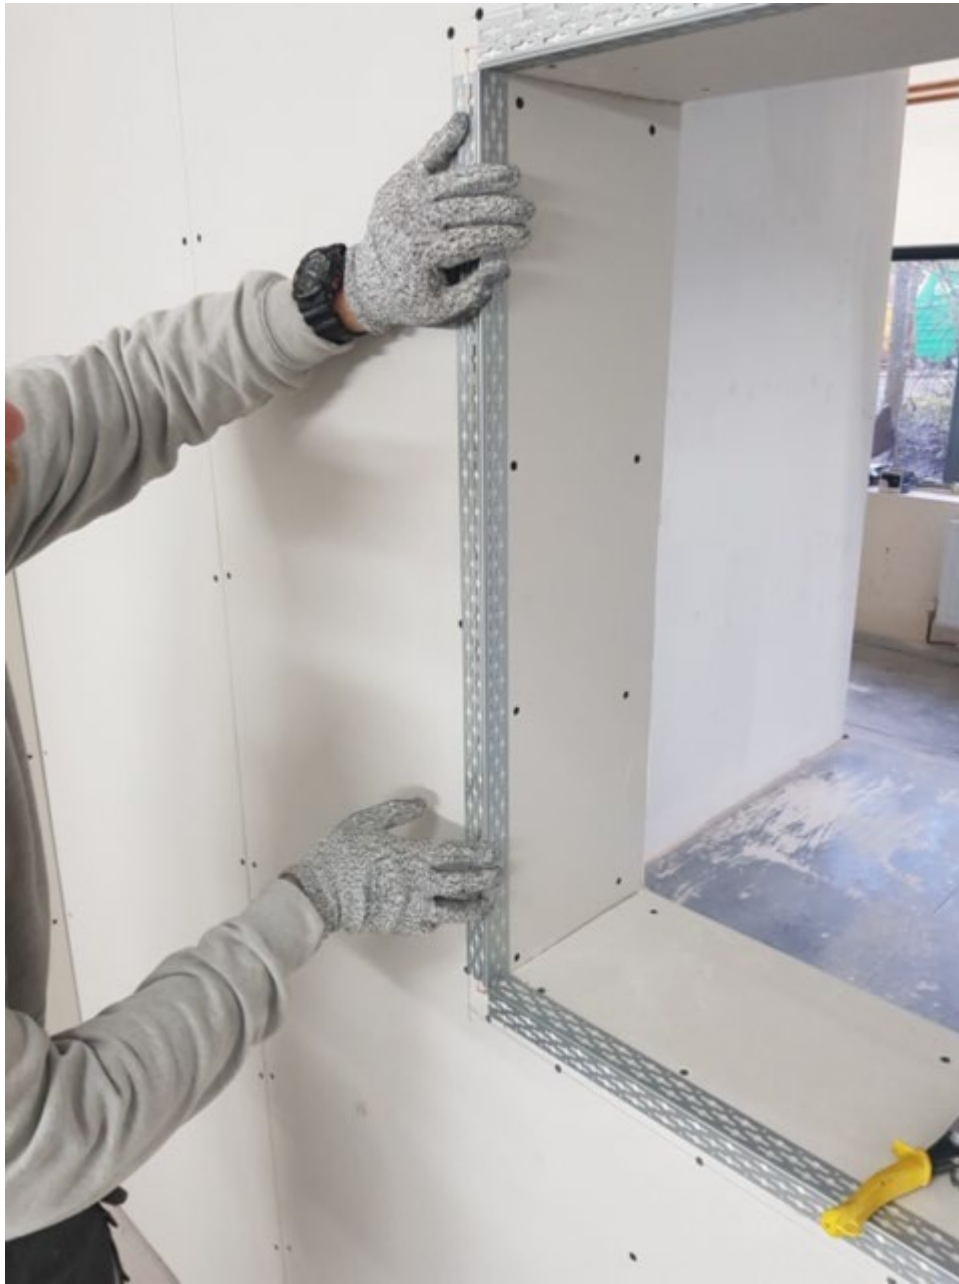
Photograph 21: Showing accuracy of all positioned beads

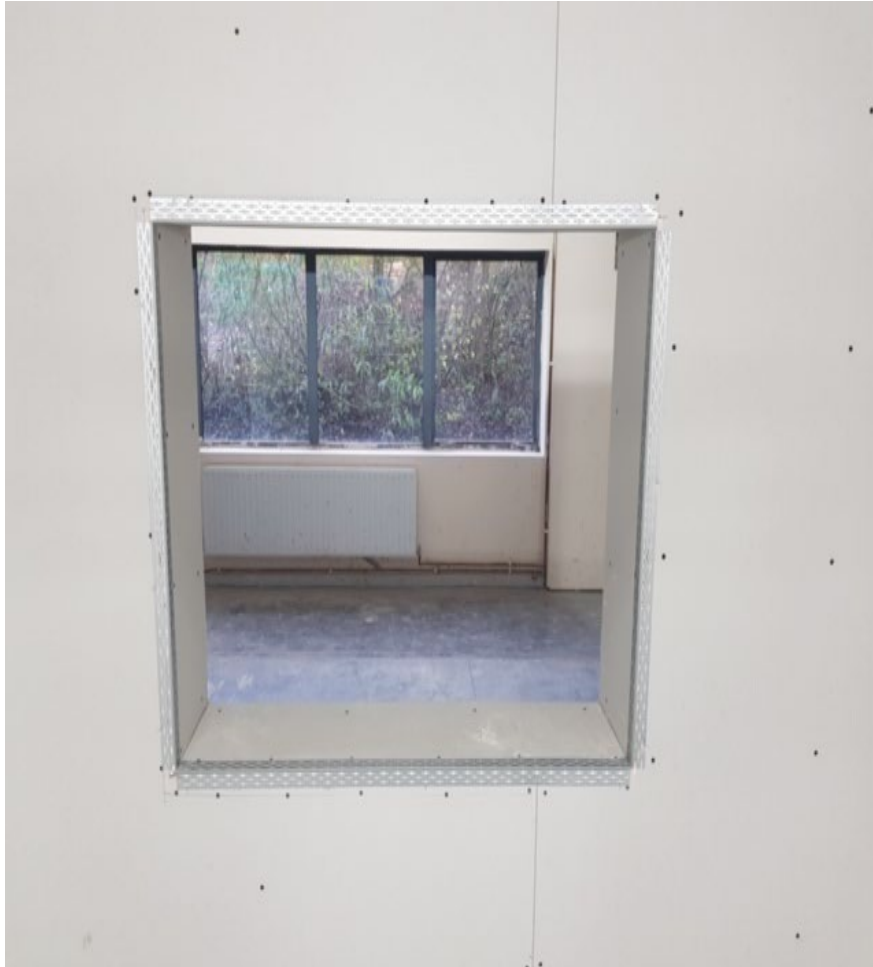
Photograph 22: Completed thin coat beads

Photograph 22 showing thin coat beads measured and cut correctly to the dimensions without readjustment, positioned and installed in line with no steps.

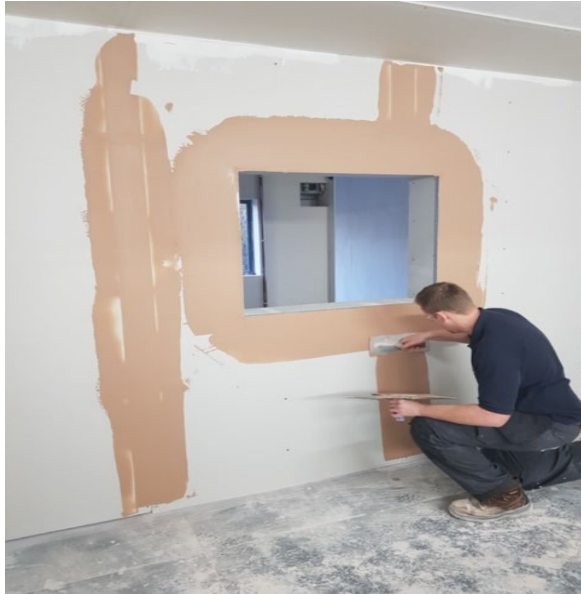
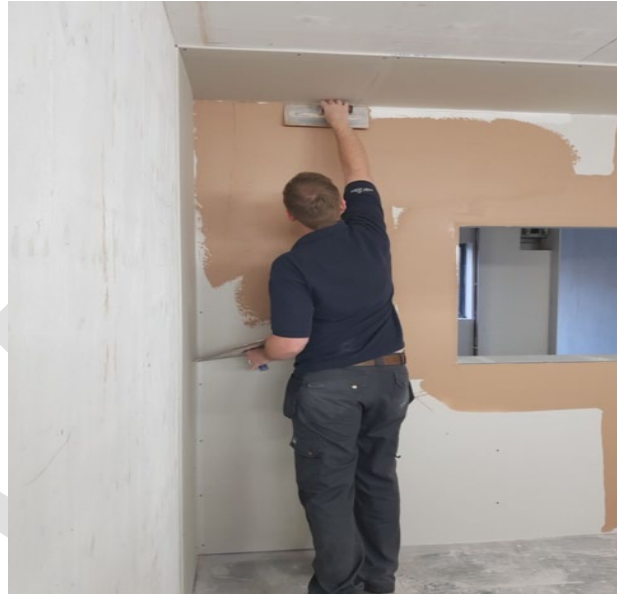
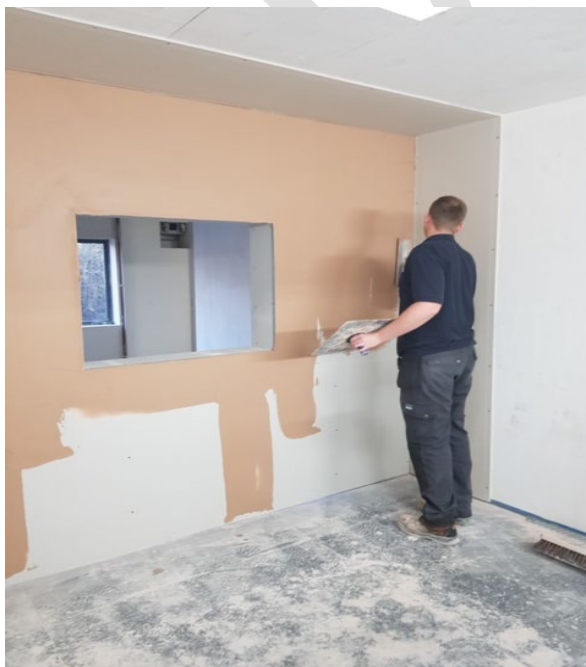
Photographs 23 – 27: Showing sequence of photographs of completed installation with plaster surface finish of wall and window trowelled and ready for decoration, without blemish, trowel marks or imperfections.

Photographs 23 – 25 showing first plaster pass applied correctly showing excellent techniques and tool use

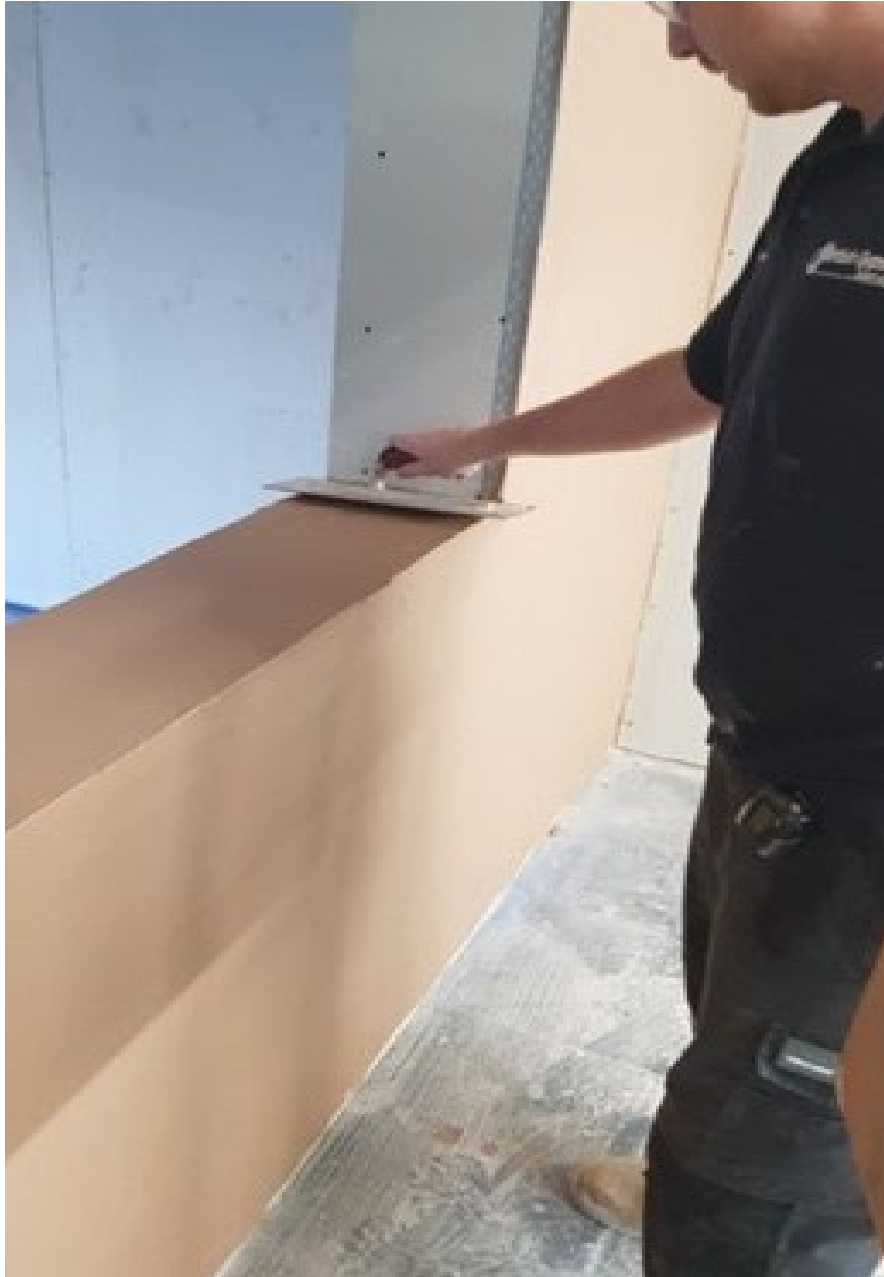
Photograph 26 - Showing plaster application in production

Photograph 26 showing window surfaces clean without scaring marks or imperfection, sharp clean lines and regular cleaning of beads

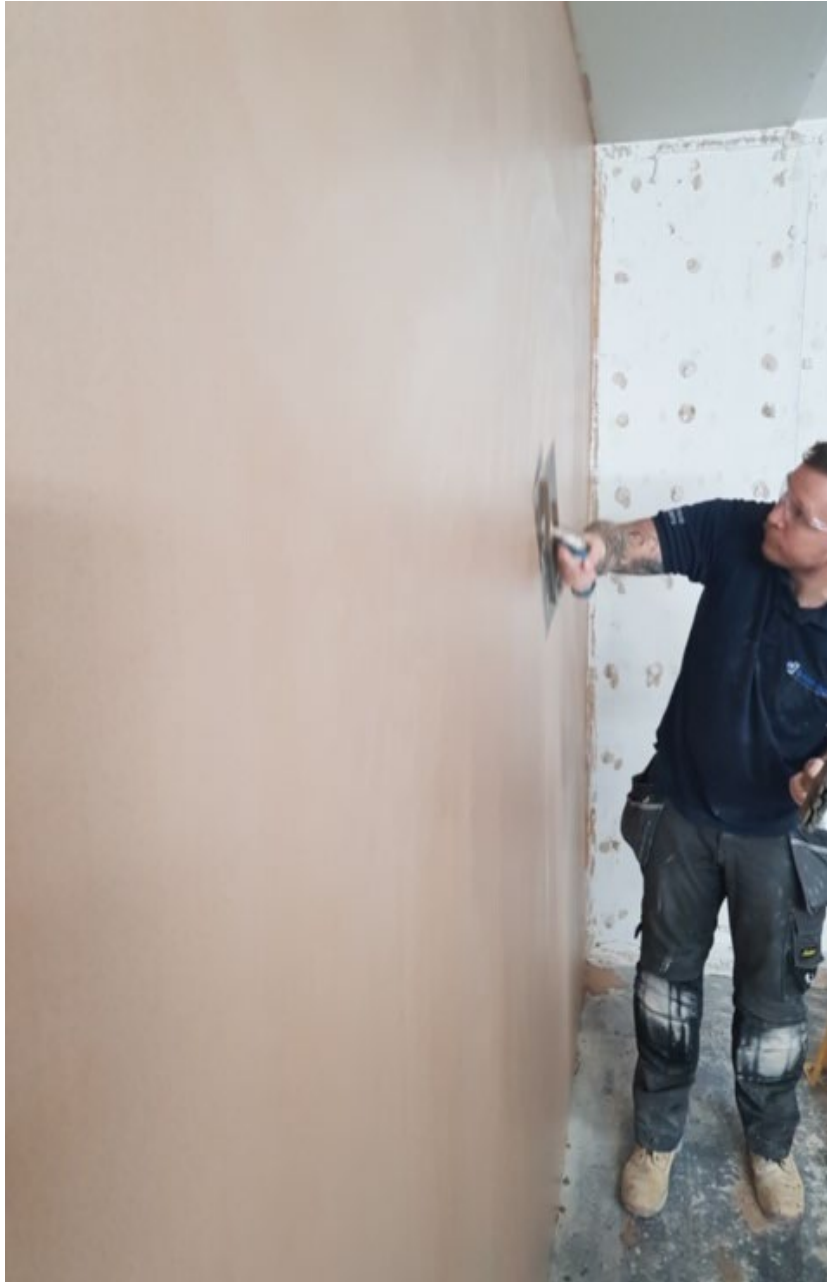
Photograph 27: Showing completed surfaces without marks and of a high standard of finish

Photograph 28 showing completed plaster surfaces after first and second pass with clean edges without error. Overall an excellent quality finish.
