**T Level Technical  
Qualification in  
Building Services  
Engineering for  
Construction**

**Plumbing Engineering**

**Guide standard exemplification material**

**Distinction – Sample 2021**

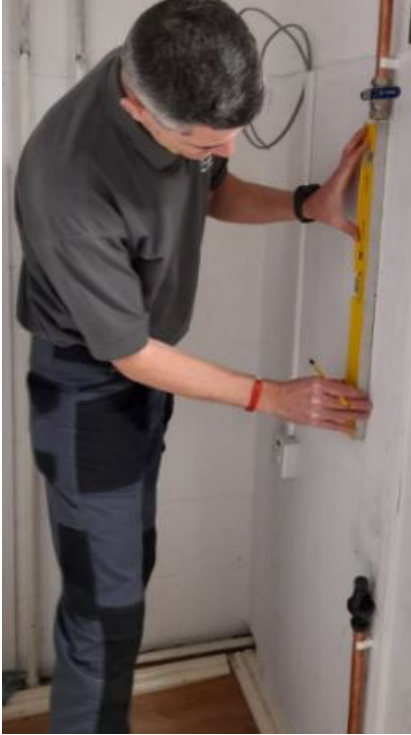
### Photograph 1

Candidate marking out a work area using a spirit level to provide a straight and vertical line on the first attempt.

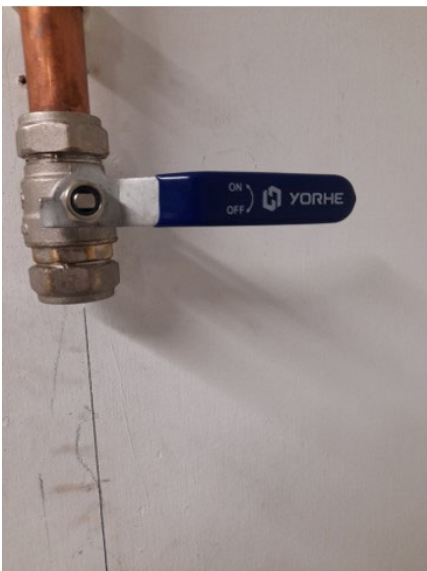
### Photograph 2

Work area shows accurate and clear marking out on work surface.

The pipe clips have been marked out and the spacing is equal, showing an excellent consideration to the aesthetics of the finished installation.

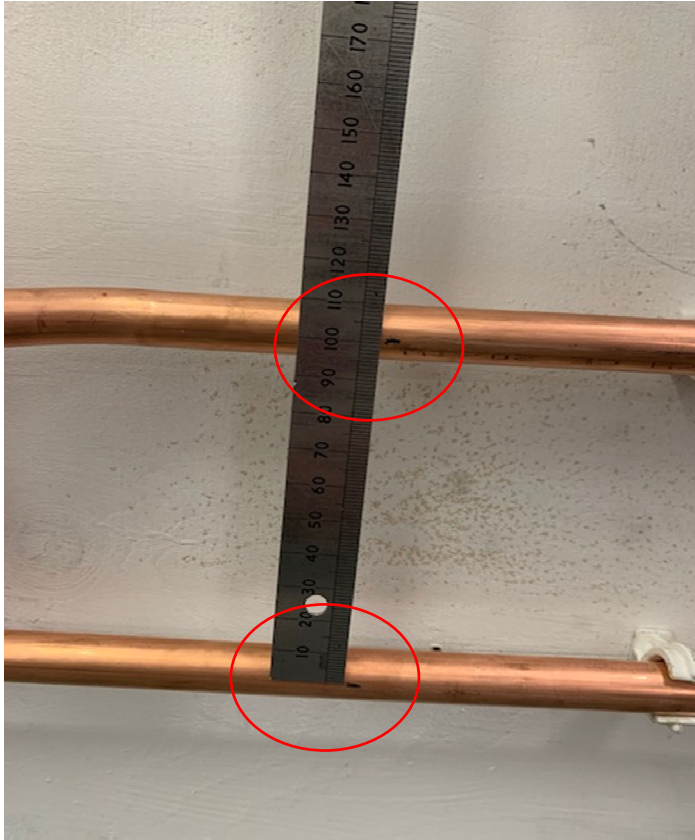
### Photograph 3

Tolerance of (+/-2mm) have been met during the installation of pipework.

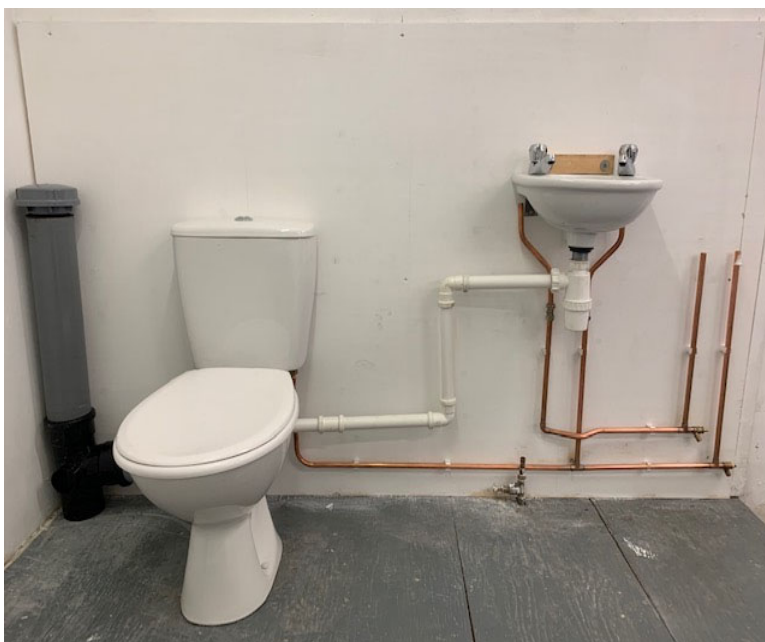
### Photograph 4

Finished installation of the cloakroom including appliances and pipework to tolerances/standards.

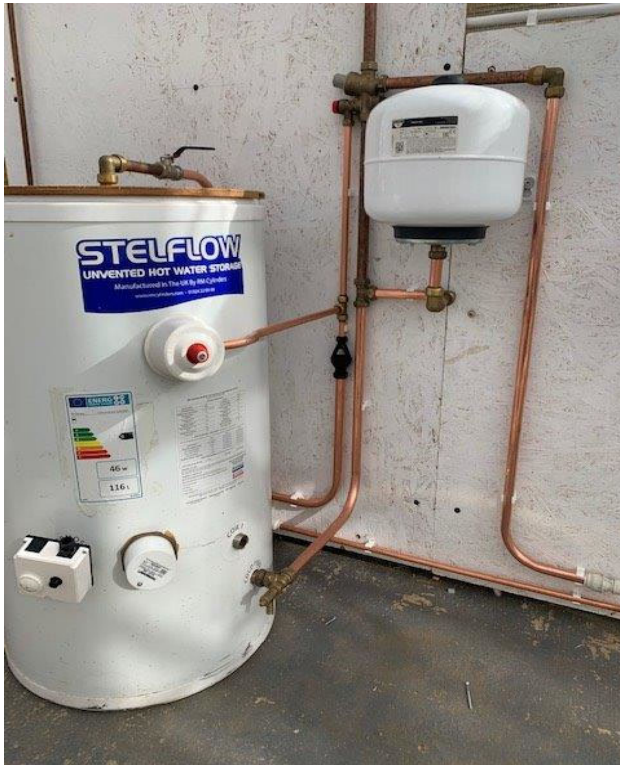
**Photograph 5**

Finished installation of the unvented hot water cylinder and associated pipework including the installation of both functional and safety controls.

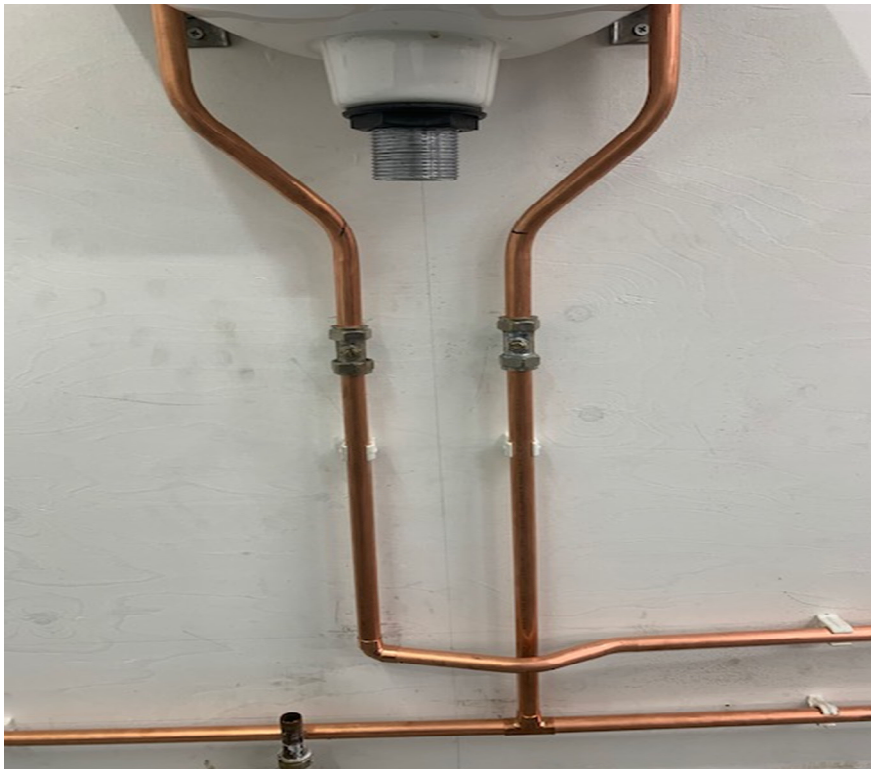
**Photograph 6**

Pipework installed to the required tolerance ( $\pm 2$ mm). Bends have been completed to a high standard with no signs of throating or rippling.

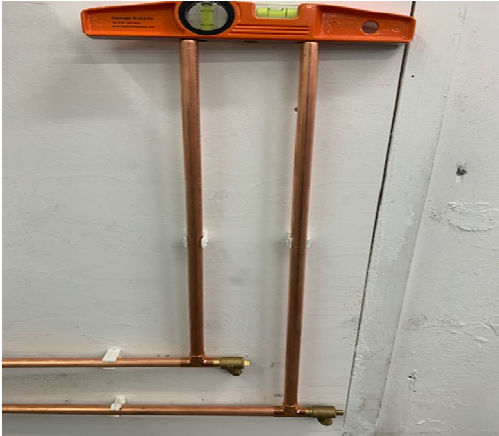
**Photograph 7**

Pipework level and within tolerance. (+/- 2mm)

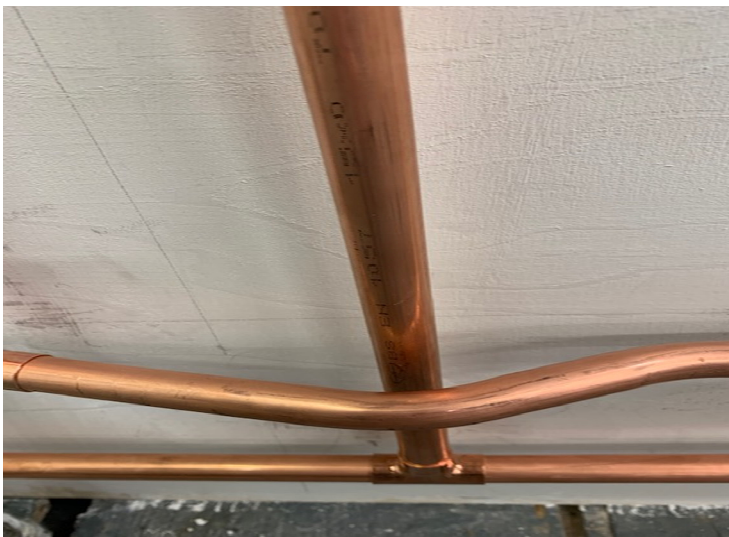
**Photograph 8**

Fabricated passover with appropriate clearance. no signs of

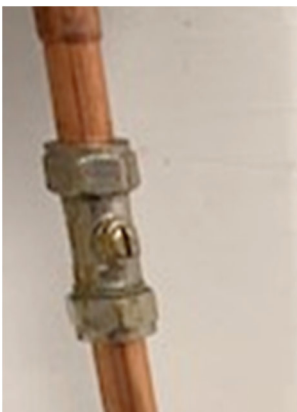
**Photograph 9**

Component fitted correctly with no signs of tool marks from installation.

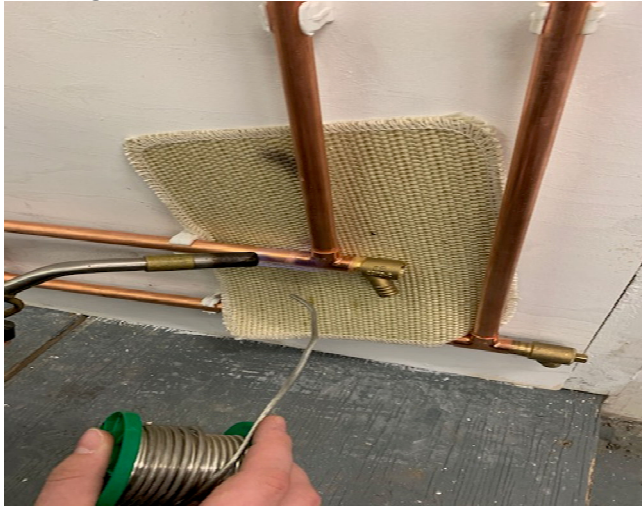
**Photograph 10**

Correct use of blow lamp, safe soldering, correct selection of solder, protection of customer property with heat mat centrally positioned. Removal of vulnerable heat sensitive components before soldering commences.

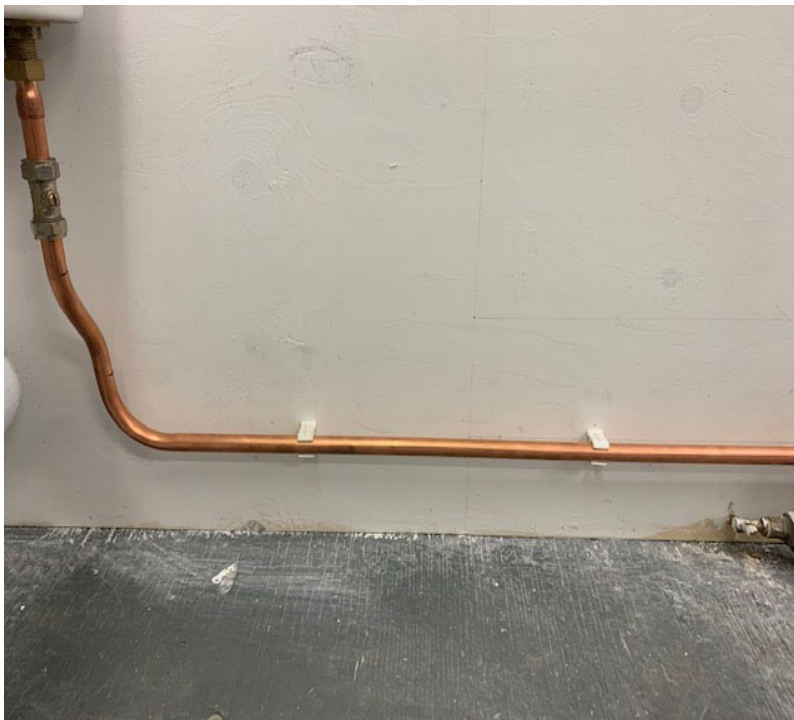
Use/type of clips  
**Photograph 11**

Pipework level and adequately clipped with appropriate spacing. Pipework fabricated without the use of additional fittings.

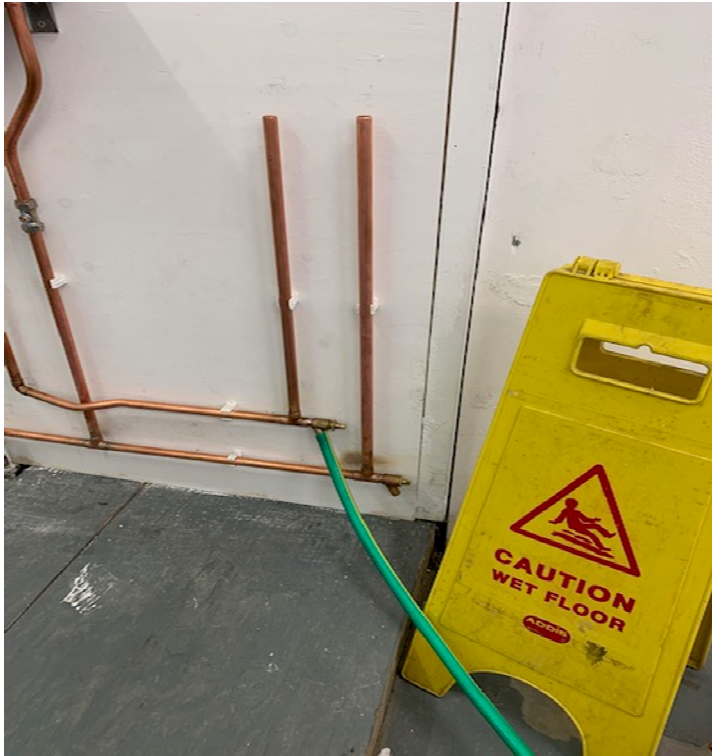
**Photograph 12**

Preparation for draining down: correct equipment and drain point used to drain down system pipework for decommissioning activities.

Use of correct signage.

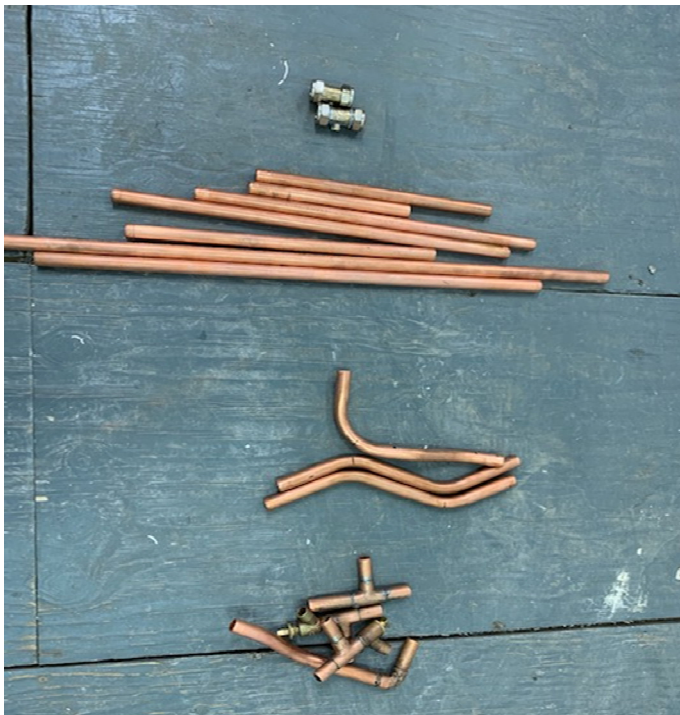
**Photograph 13**

Pipework decommissioned correctly with consideration of recycling and reuse.

Separation of clean/dirty copper.

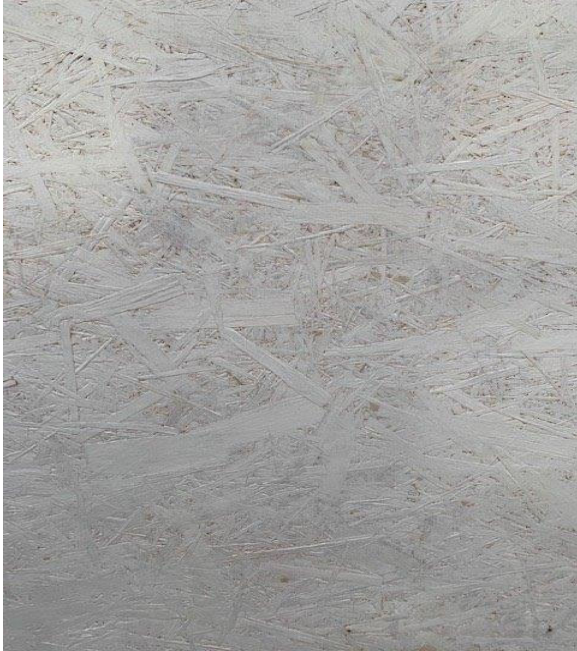
#### Photograph 14

No holes and marks evident following decommissioning of pipework and surface preparation.

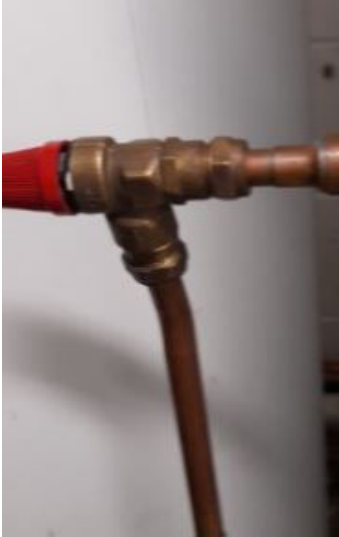
### Photograph 15

Component fitted correctly with no signs of tool marks from installation of the replacement component.

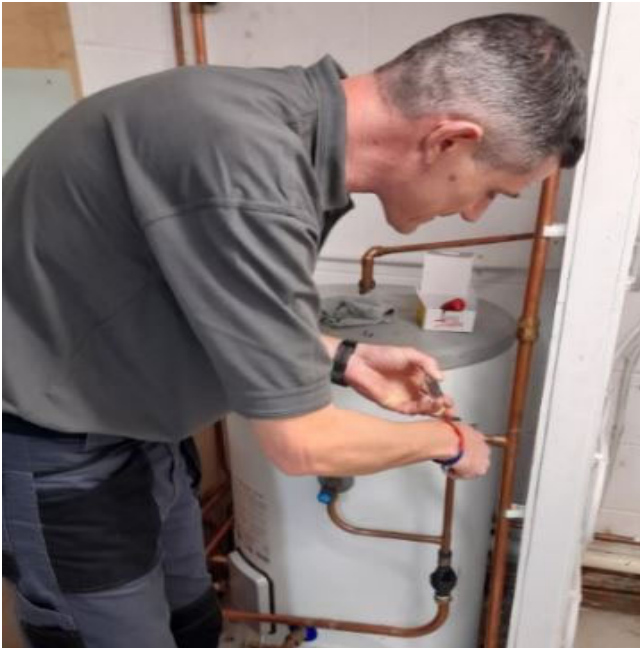
### Photograph 16

Loosening of faulty component.

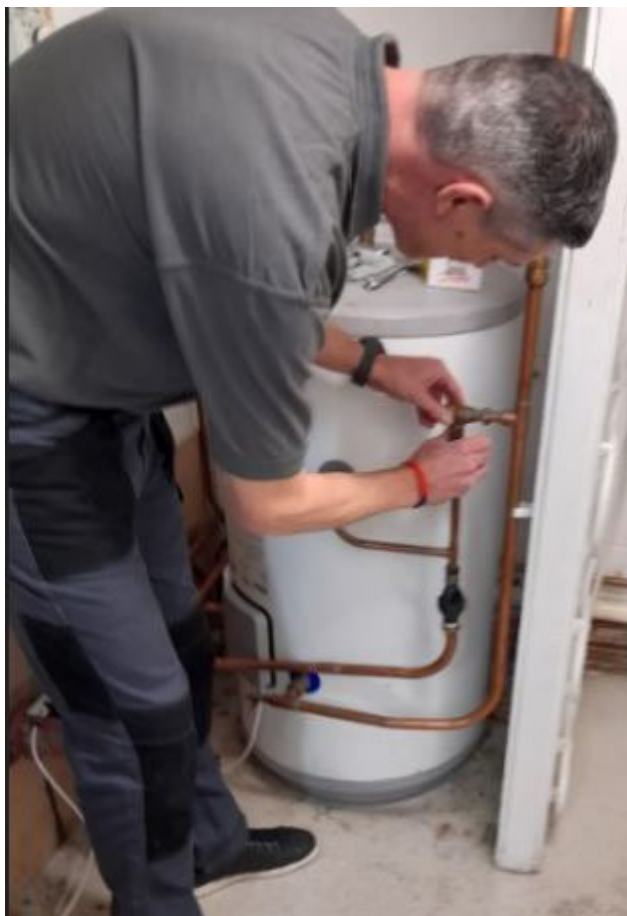
**Photograph 17**

Removal of faulty component.

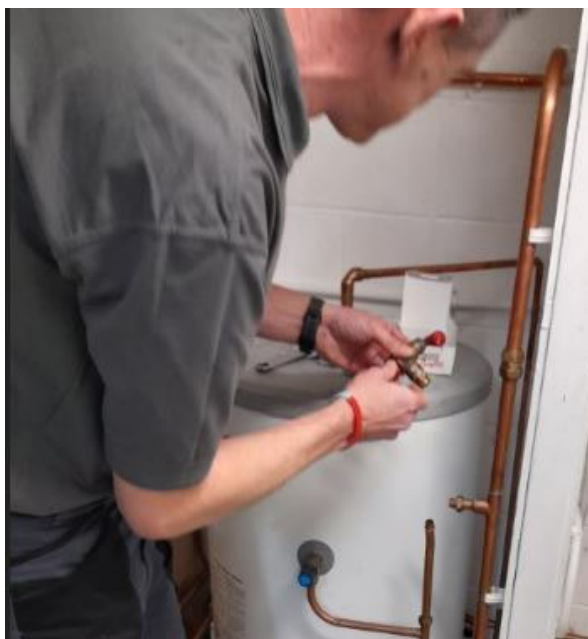
**Photograph 18**

Replacement of component.

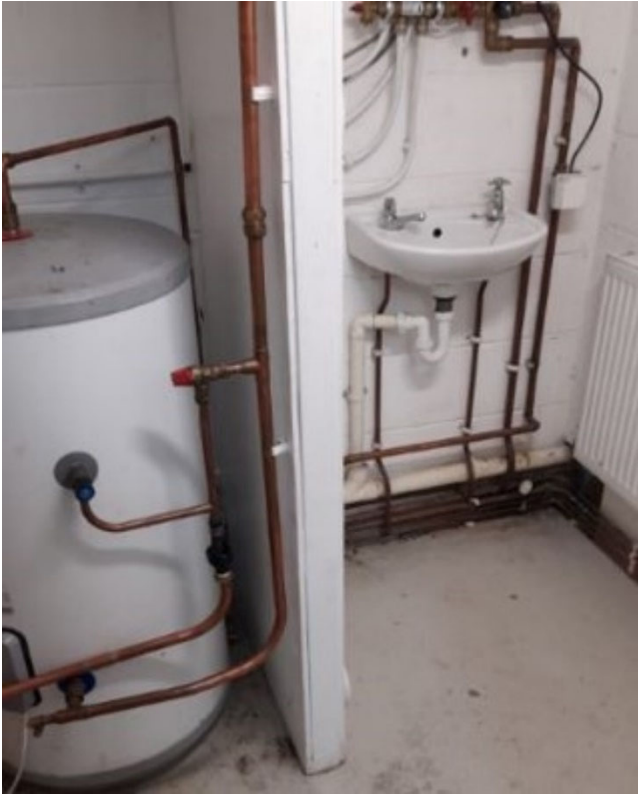
**Photograph 19**

Repair completed and work area left tidy.
