T Level Technical Qualification in Design and Development for Engineering and Manufacturing (8714-34)

Structural Engineering (324)

**Guide standard exemplification
material**

Threshold competence – Sample

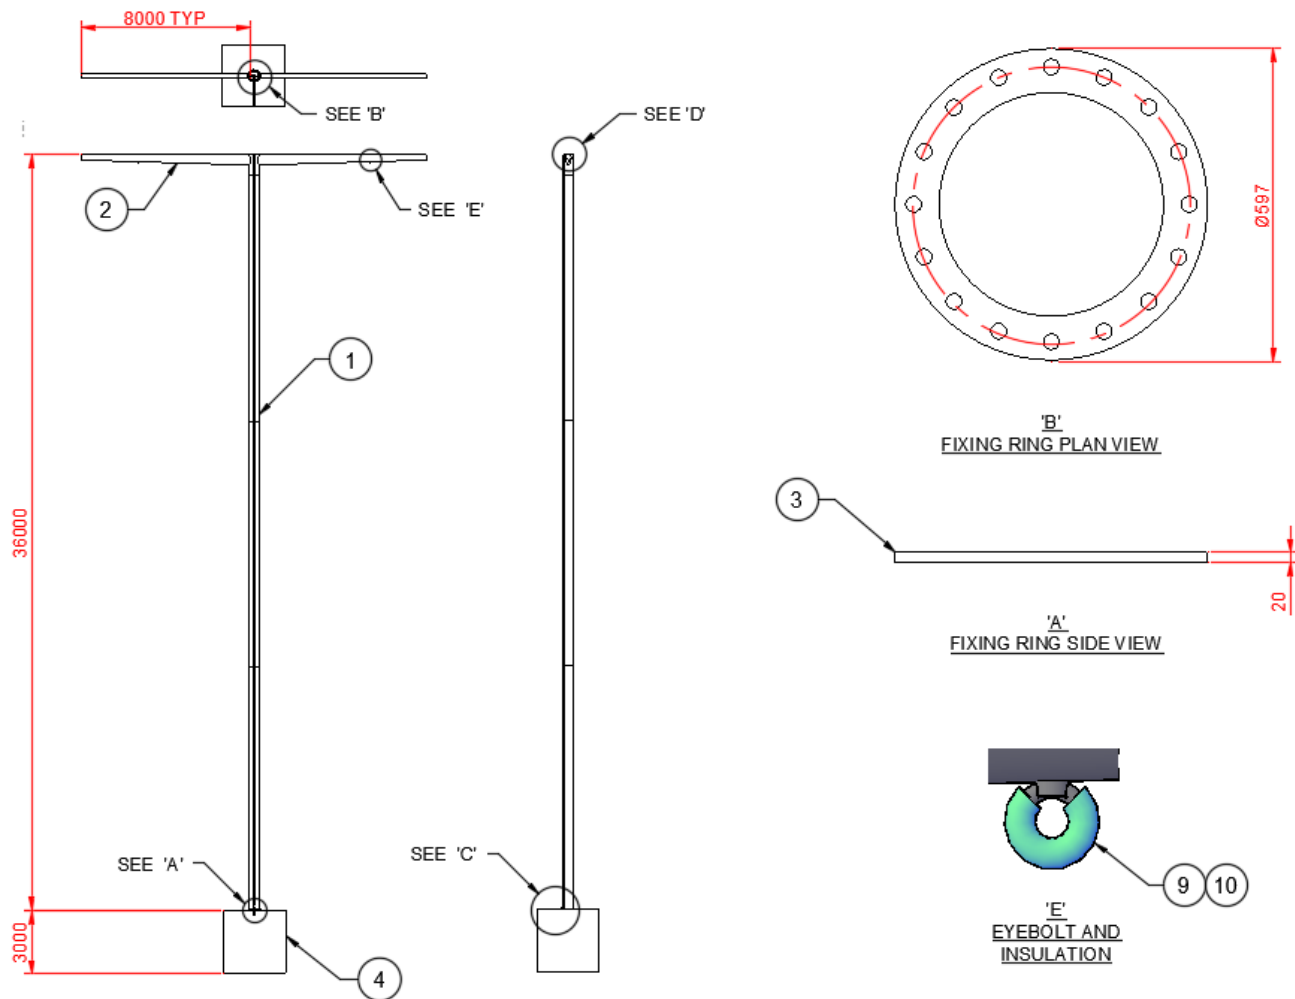
1. ITEM 1 - MAST: Ø457 x 14.2 CHS
2. ITEM 2 - CROSS ARM: (500 x 250 x 16) TO (Ø250 x 16) ELLIPTICAL TO CIRCULAR CROSS SECTION
3. ALL DIMENSIONS ARE IN MM

Explain how well the diagrams/drawings meet the specification criteria.	<p><i>The drawings mostly show the design intended from the specification, but there are gaps – the full details of the materials used to develop the pylon have not been included in the drawings.</i></p>
What are the implications for the proposed maintenance of the pylon?	<p><i>Accessing the pylon will be challenging as some parts of it are very high. There is recommendation for use of a cherry picker, but access to each pylon's location will need to be considered, as it can be difficult for cherry pickers to access different terrains.</i></p>
Explain how the system could be optimised/improved.	<p><i>The pylon has been designed to be painted white, but other colours could have been considered – light grey may be a more aesthetically pleasing colour that is less intrusive in a range of environments.</i></p> <p><i>The pylon might be better protected from lightning strikes by using an air-terminating lightning protection system.</i></p>

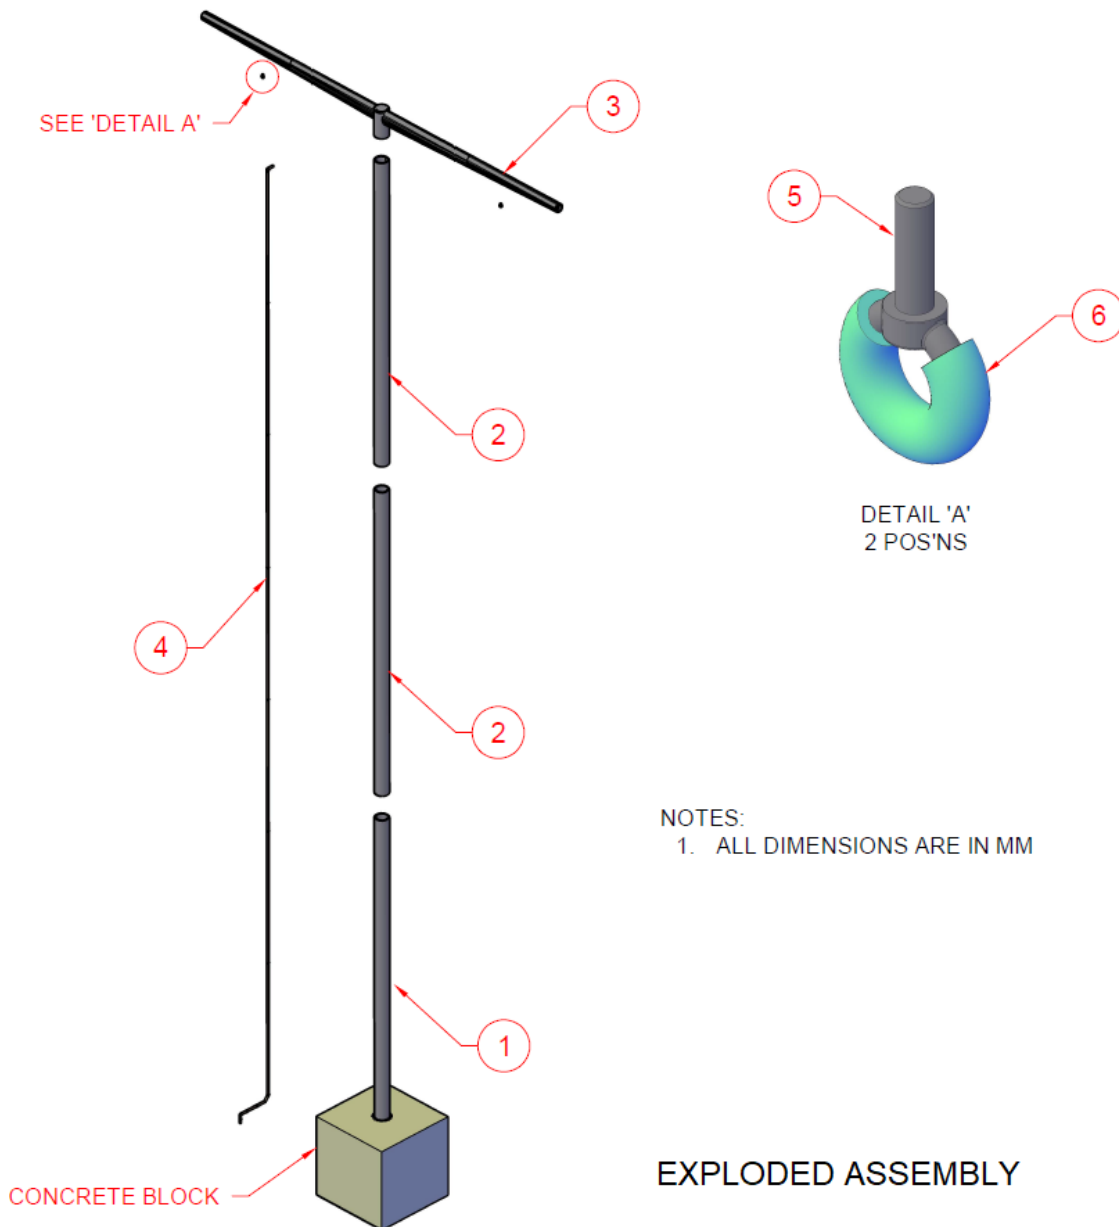
The candidate has used software to prepare a basic 3D model of their proposed pylon depicting the relationship of the principal components of the mast and arm. They have also produced an accurate isometric view of the pylon. The 3D images are proportionally correct, but they contain limited annotation.

The candidate has not developed a 3D image that simulates the pylon positioned in a rural and urban landscape along with other isometric views.

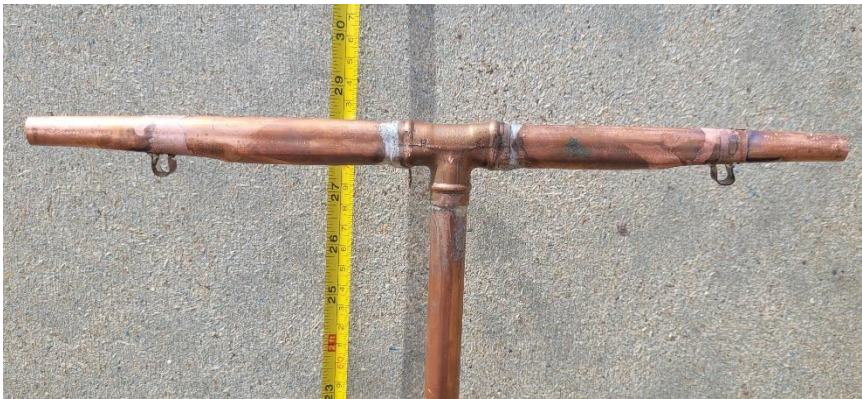
Photographs 4 and 5 show the connected components. The joining of the arms to the mast does not exactly match the drawing plan, as the candidate has used a T-connector, which adds to the overall length.

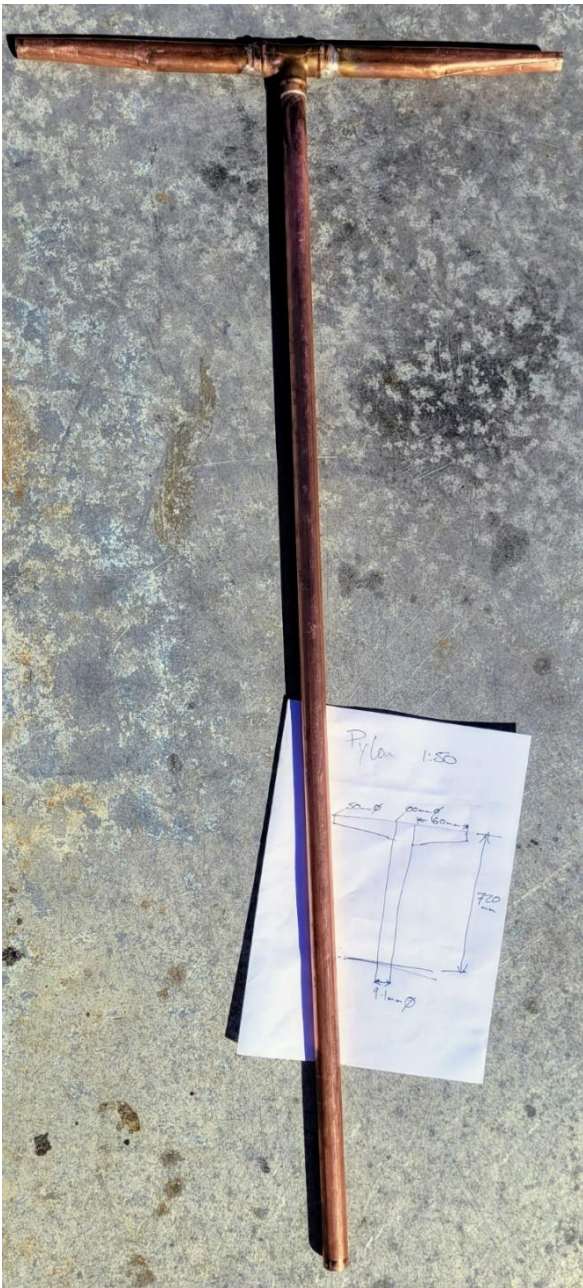
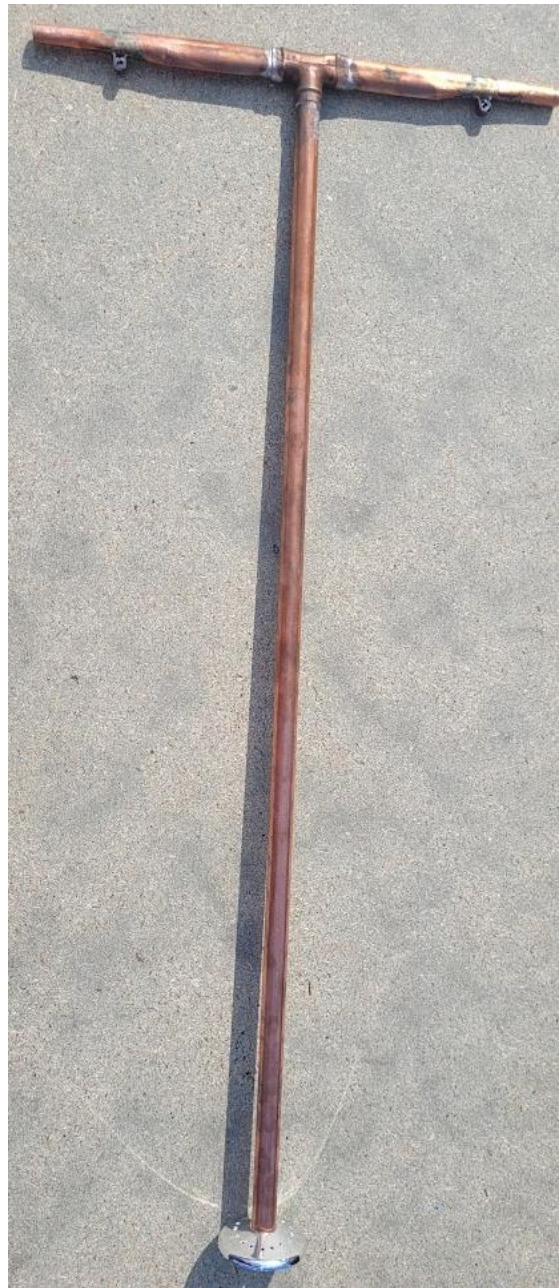
Photographs 6 and 7 show the completed soldered joints, demonstrating the taper of the arms, the cable fixing points, with insulation and base.

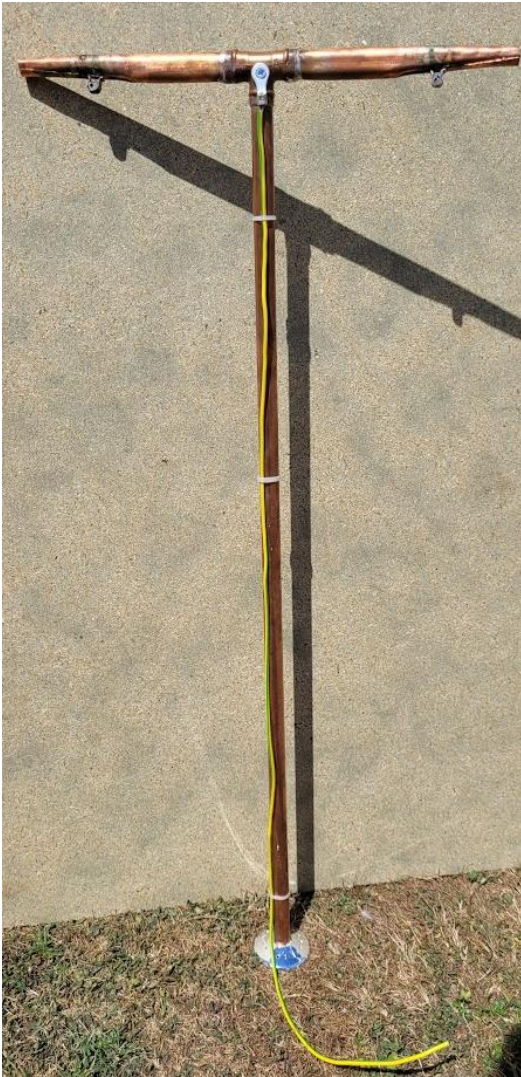
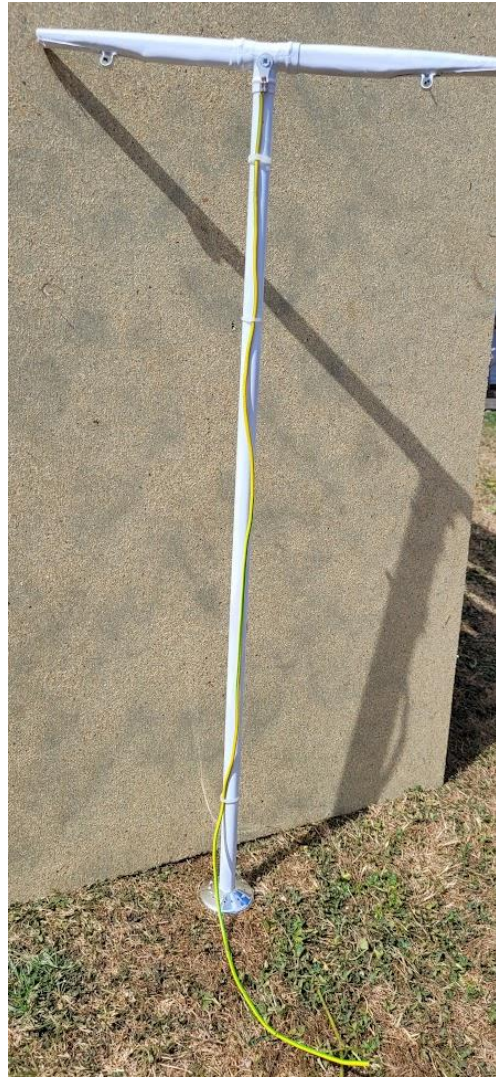
Photographs 10 and 11 show the fitted wire which acts as lightning protection. The pylon has been painted in a white finish with and fitted with sporadic cable ties. The cable fixings have also been fitted with insulation, visible in the left photograph.

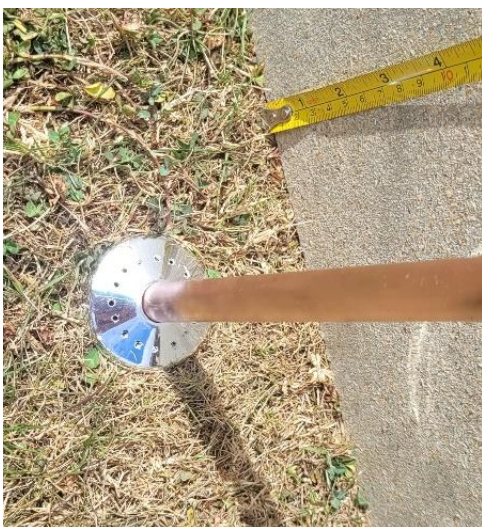
Photograph 12 shows a bird's eye view of the base plate.

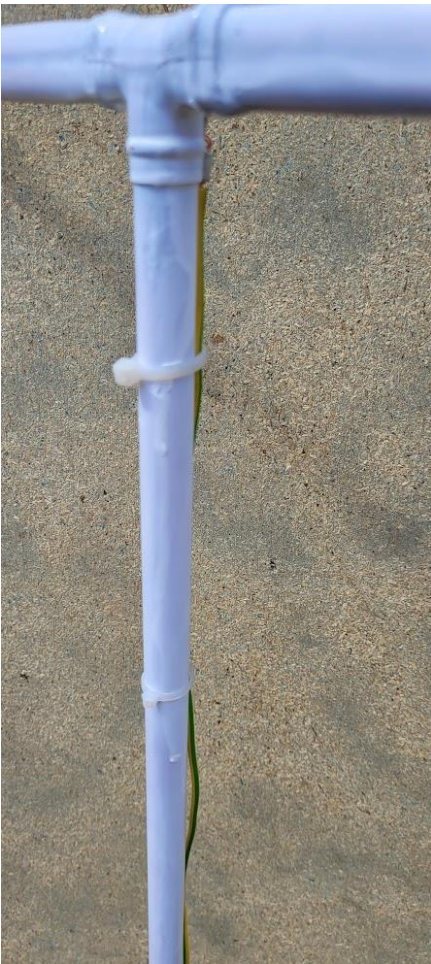
Photograph 13 shows a close-up view of the pylon. The quality of the finish is slightly patchy.

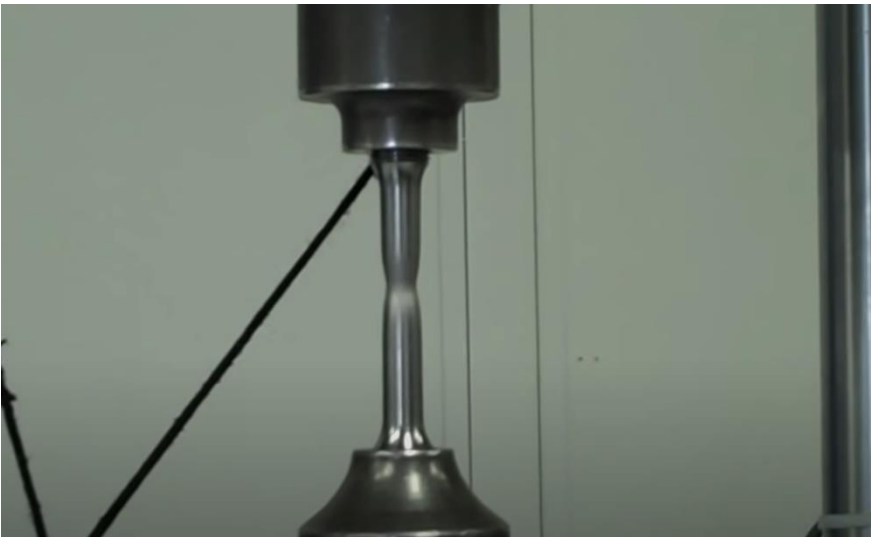
Test piece 'necking' under load.

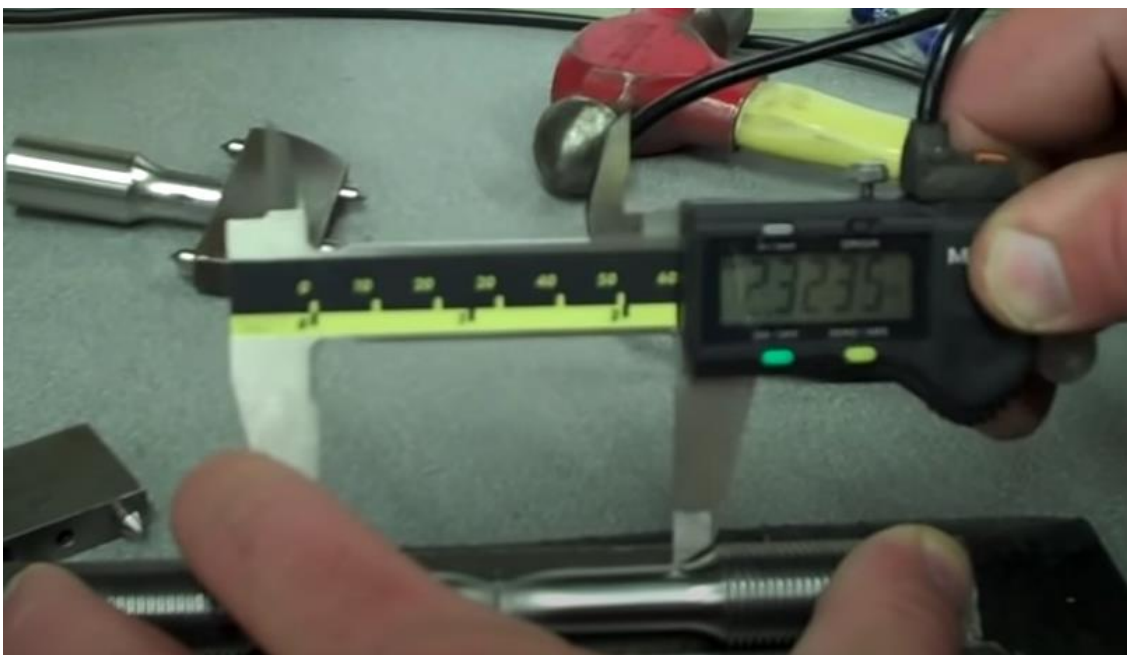
Measuring to determine and prove fracture location, this can then be scaled to an approximate location on the pylon.

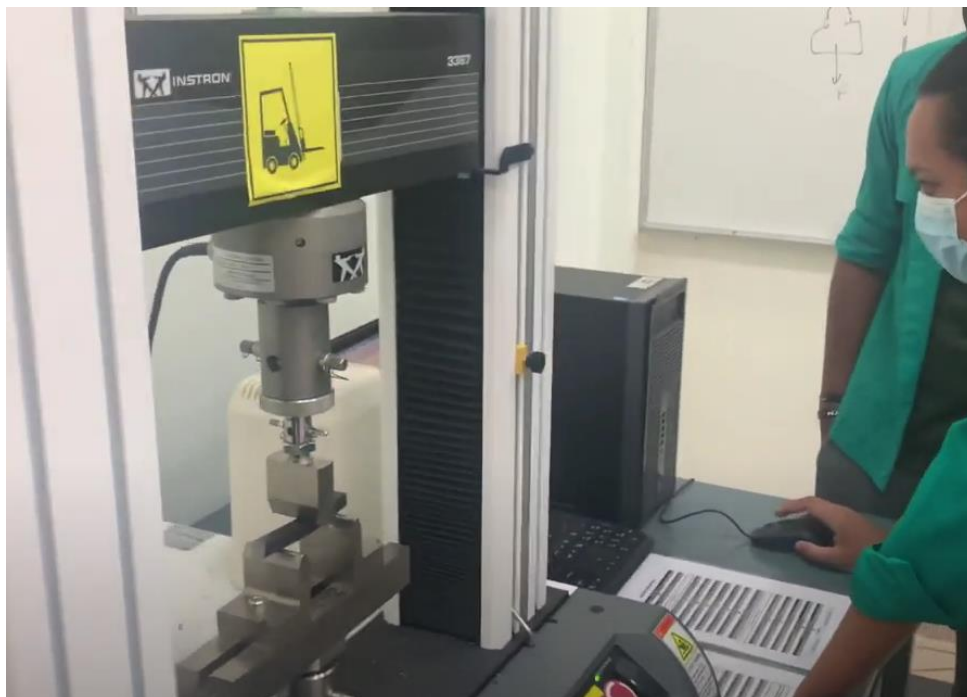
Candidate setting up the three-point bending machine using a 'known' piece to check calibration.

Applied force (N)	Vertical strain (mm)	Experimental bending stress E (N/mm ²)	Theoretical bending stress (N/mm ²)	Error
20	0.04	60	0.5	+/- 0.1
40	0.07	120	1.3	+/- 0.5
60	0.11	180	1.9	+/- 0.6
100	0.18	200	2.1	+/- 1
120	0.2	210	4	+/- 1.2
140	Young's Modulus exceeded			
160			4.3	+/- 1.5

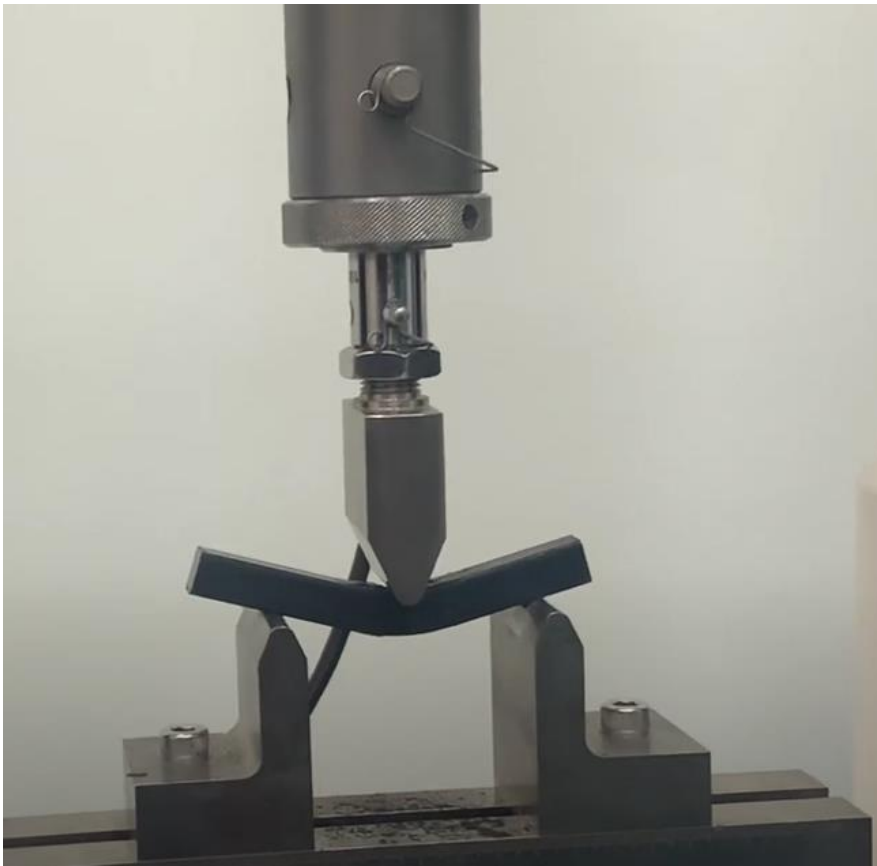
Test piece beginning to show the bend from load applied.

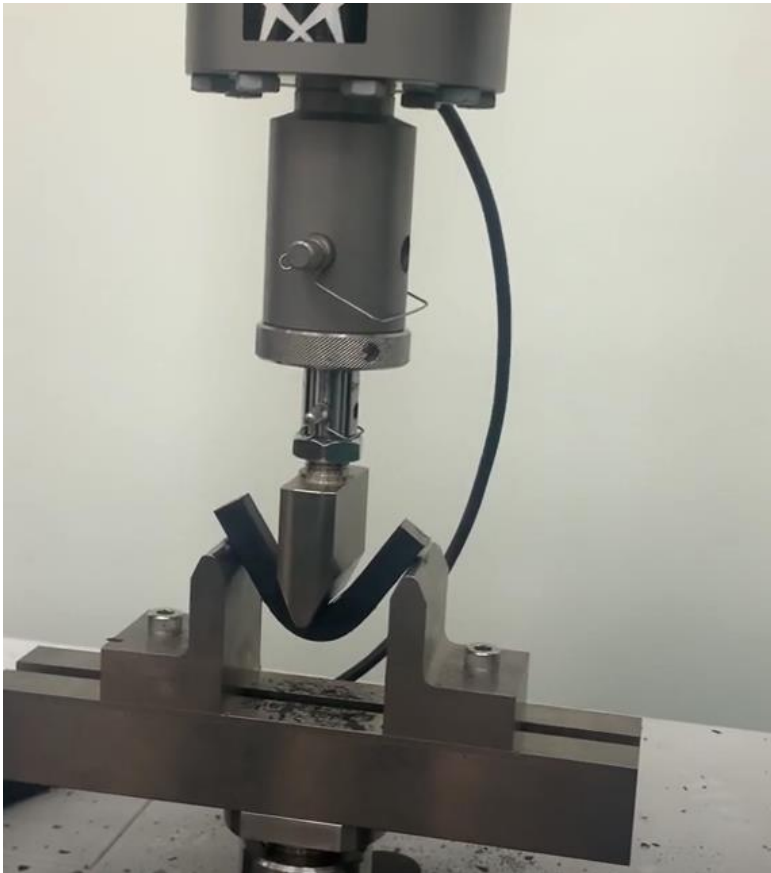
Test piece has now bent beyond Young's modulus point.
